## DESIGN REVIEW OF TDI R-4 AND RV-4 SERIES EMERGENCY DIESEL GENERATOR CYL. DER BLOCKS AND LINERS

Prepared by Failure Analysis Associates Palo Alto, California

TDI Diesel Generator Owners Group

June 1984

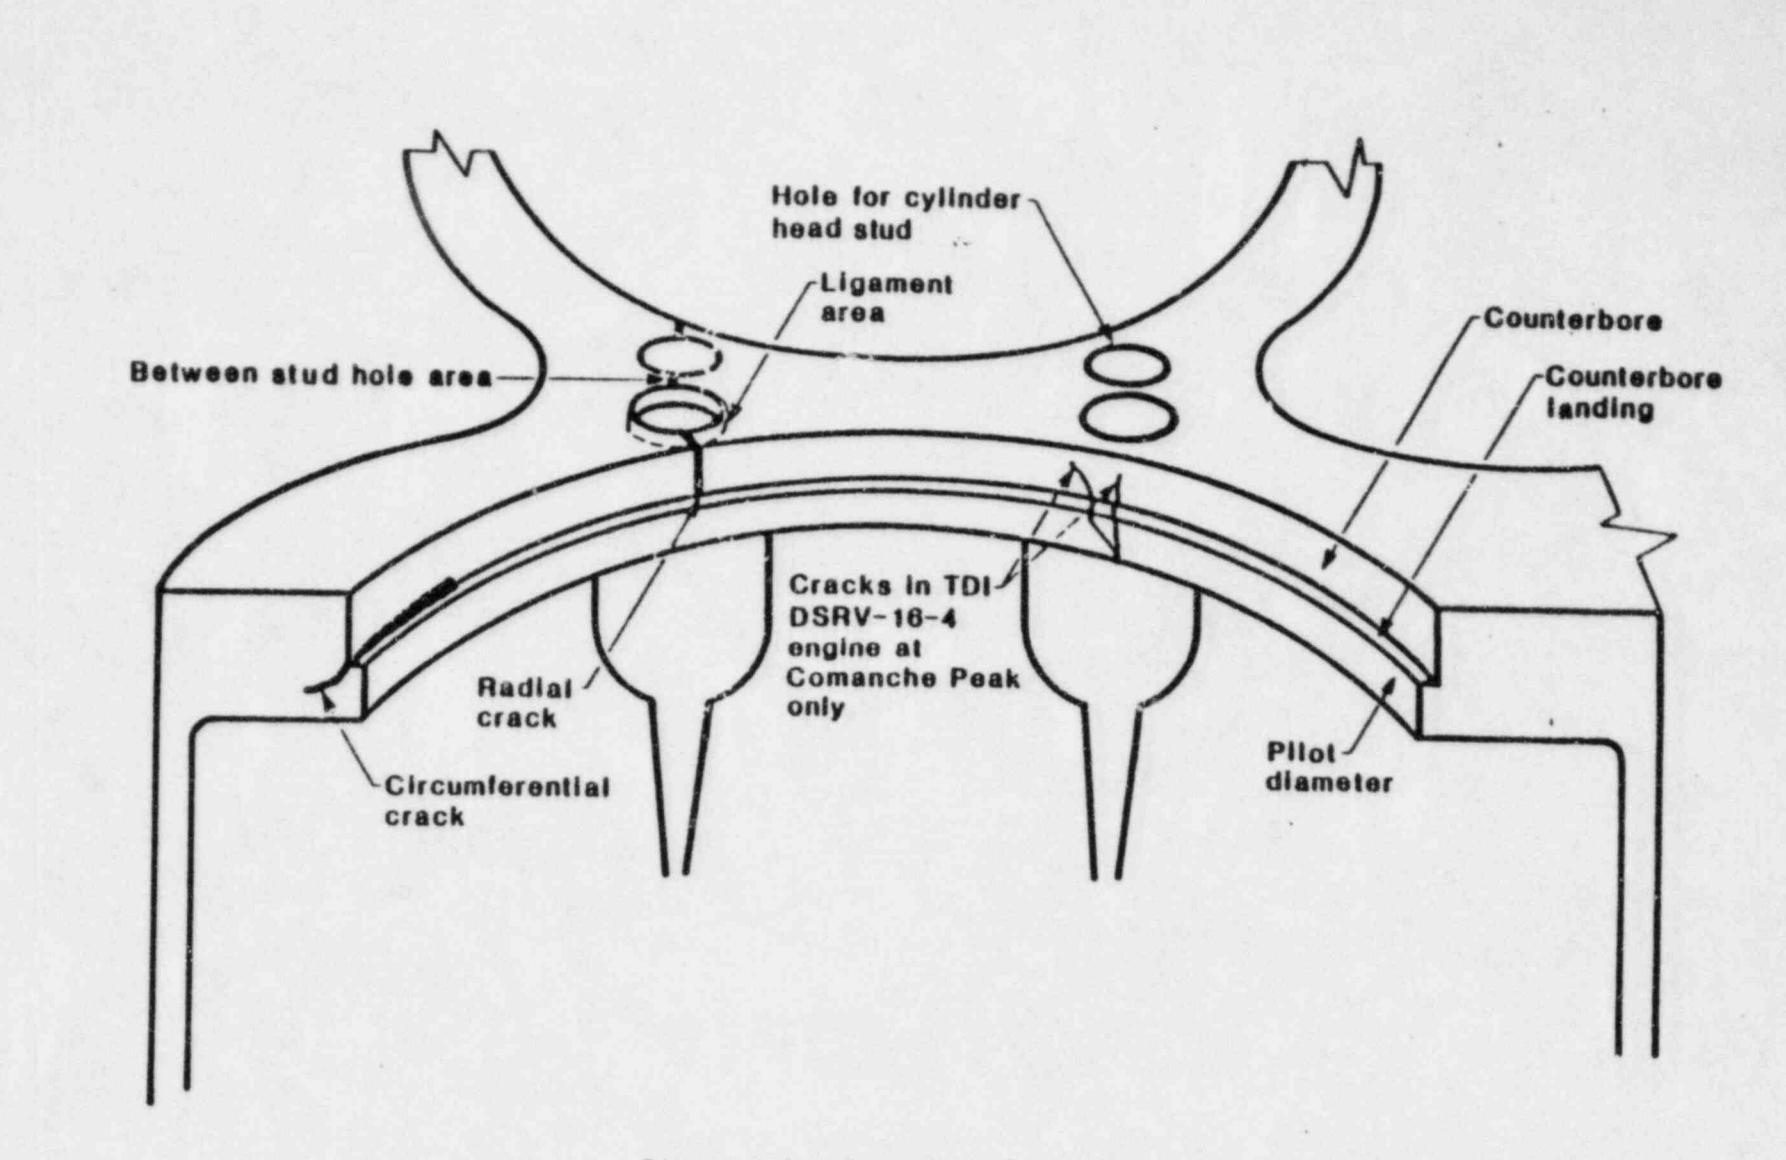
Figure 1-1. Location of cracks.

Two types of cracks have been found to occur in cylinder block tops of this design: cracks in the radial/vertical plane at the stud holes, and circumferential cracks in the liner counterbore at the liner landing ledge [1-1]. Figure 1-1 depicts the potential location of block top radial and circumferential cracks. In addition, for the in-line engines, cracks have occurred in the cam gallery above the cam shaft bearing supports. The survey of industry experience with TDI R-4 and RV-4 engines summarized in this section has not been independently confirmed by FaAA, and therefore is not subject to FaAA's usual quality assurance procedures.

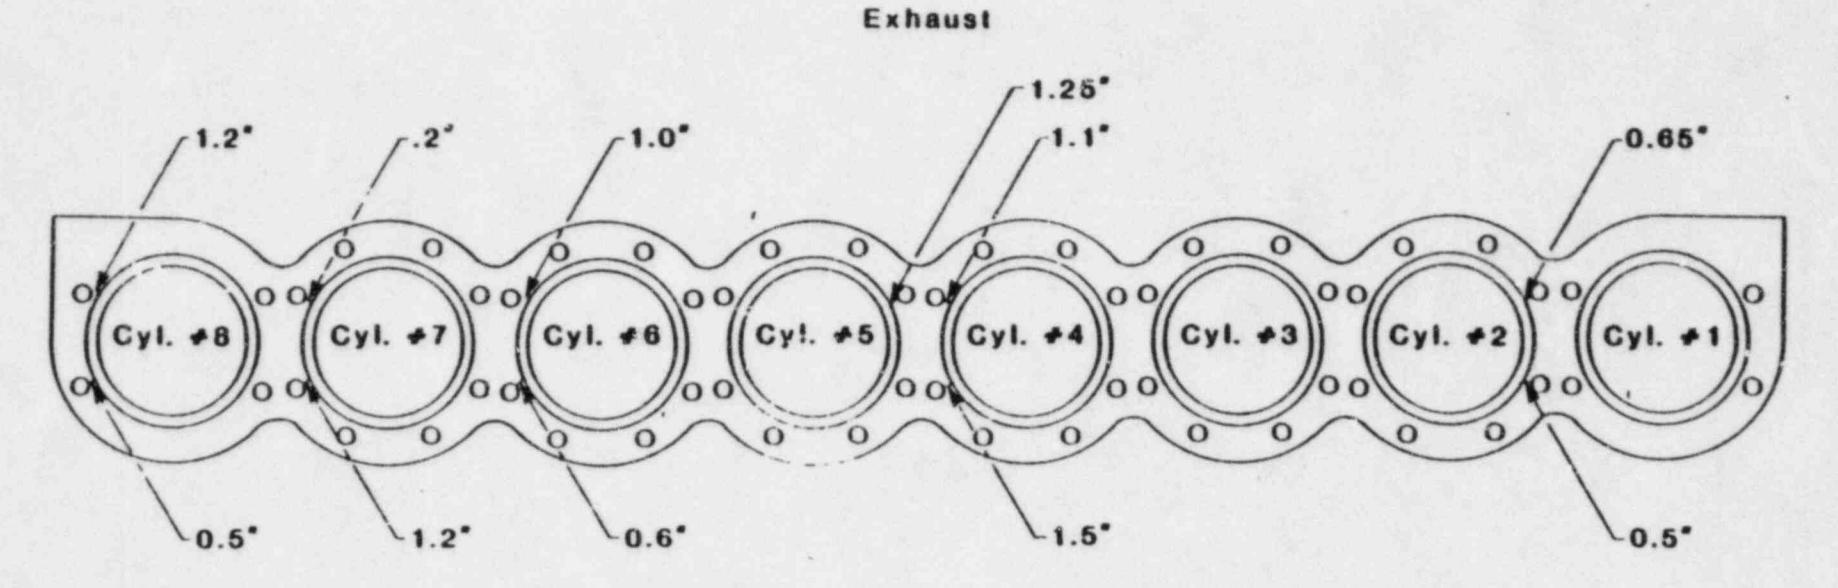
Figure 1-2. SNPS DG101 crack map.

As part of the engine requalification program after the crankshaft replacement, each engine was operated for 100 hours at or above full load and was then disassembled and inspected. During these inspections, radial/vertical cracks were discovered in the blocks of all three engines. Crack maps for DG101, DG102, and DG103 are presented in Figures 1-2, 1-3, and 1-4, respectively. No circumferential cracks were found in any of the engines. However, each block had radial/vertical cracks between the cylinder bore and the stud hole. Sixty-seven percent of the ligament cracks were between 1 and  $1 \frac{1}{2}$ inches deep. A typical example of a cross-section of a radial/vertical crack through a ligament is shown in Figure 1-5. As depicted in the figure, none of the cracks extended below the corner f: med by the counterbore and the counterbore landing. This demonstrates the apparent arrest of radial/vertical cracks that occur in the ligament region. In addition, when first inspected, the engine block from DG103 had a crack that extended between two adjacent studs on the exhaust side of Cylinder Nos. 4 and 5 as shown in Figure 1-6.

Dimensions indicate crack depth

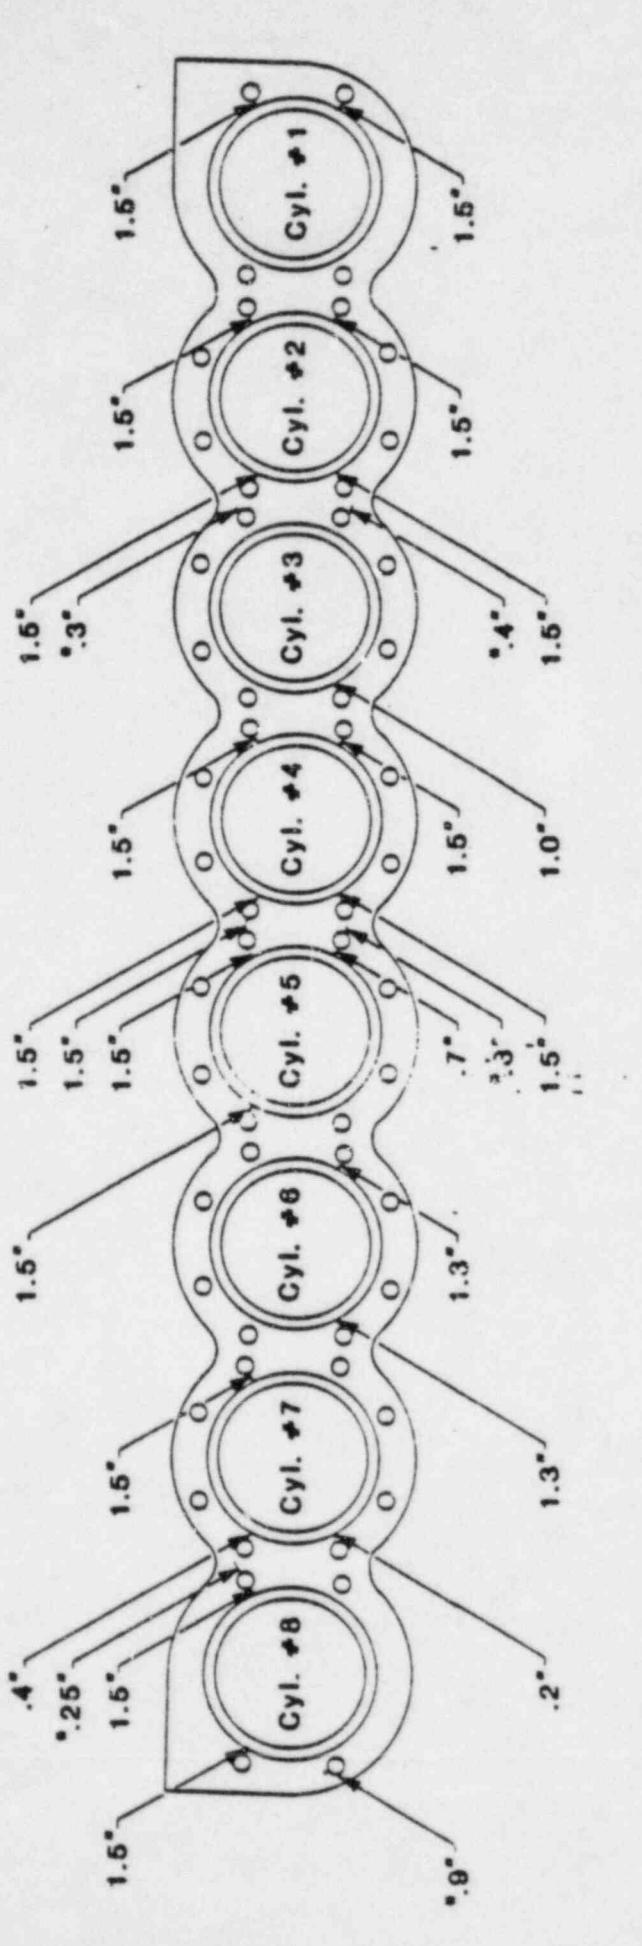
Figure 1-4. SNPS DG103 crack map as of 3/11/84.

"Top surface indication. Depth not measured Dimensions Indicate crack depth

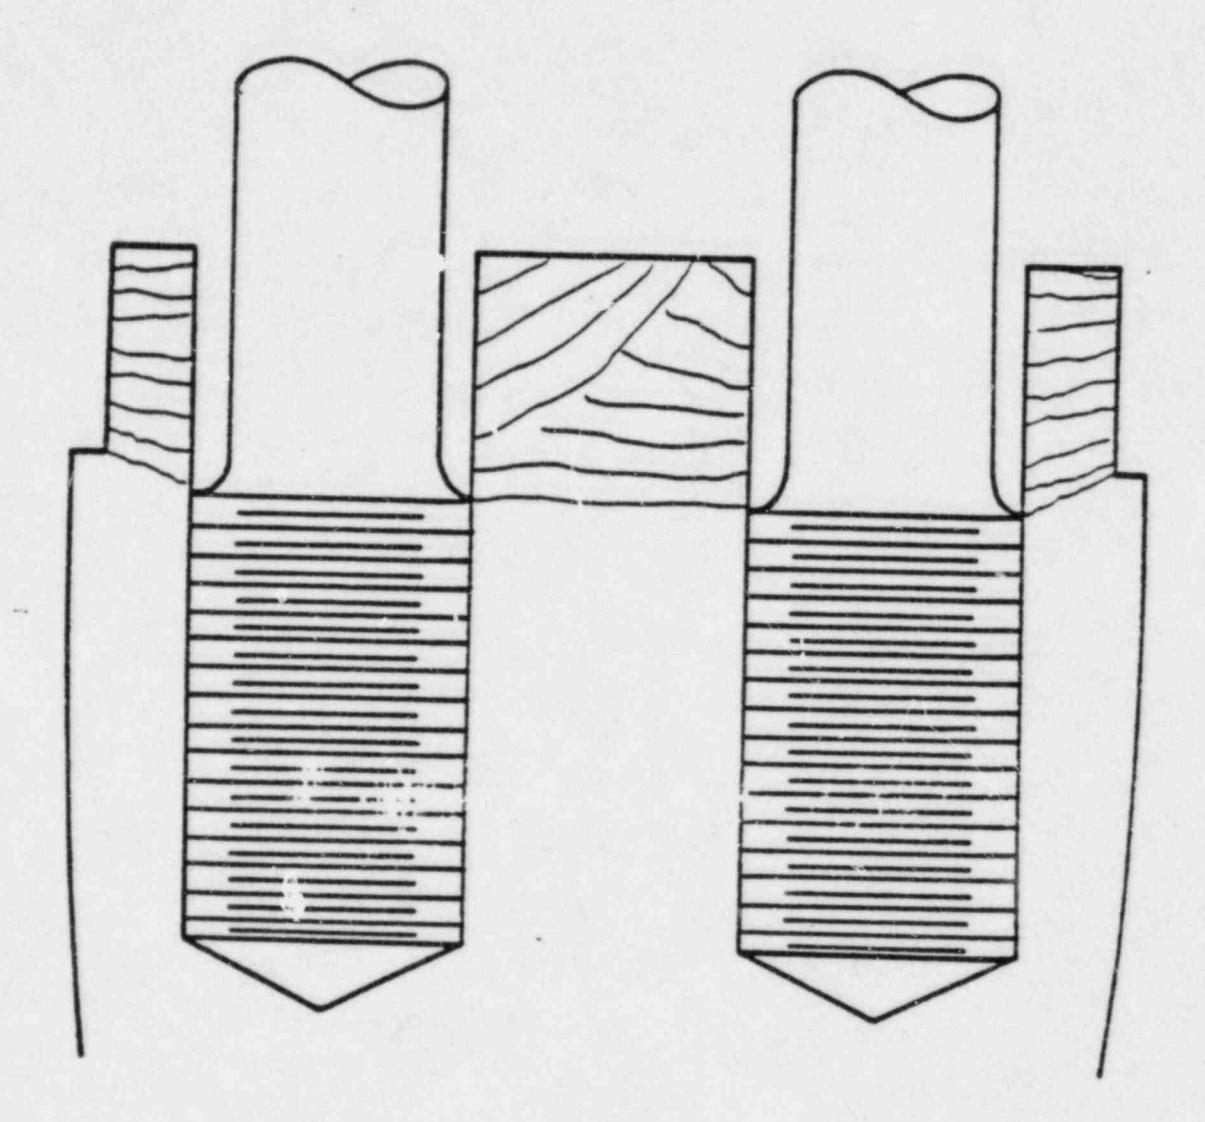
Figure 1-6. Longitudinal section between adjacent cylinders for SNPS DG103.

Inspection of the block top revealed cracks between stud holes with depth of  $1 \frac{1}{2}$  inches similar to those shown in Figure 1-6 at three locations. At four other locations, between-stud cracks developed along the top surface which did not extend to measureable depths down the sides of the stud hole. At one location a crack that previously extended 0.8 inch radially from one stud hole towards the adjacent stud hole grew to a maximum depth of 3.9 inches. In addition, the original crack between Cylinder Nos. 4 and 5 had ex-

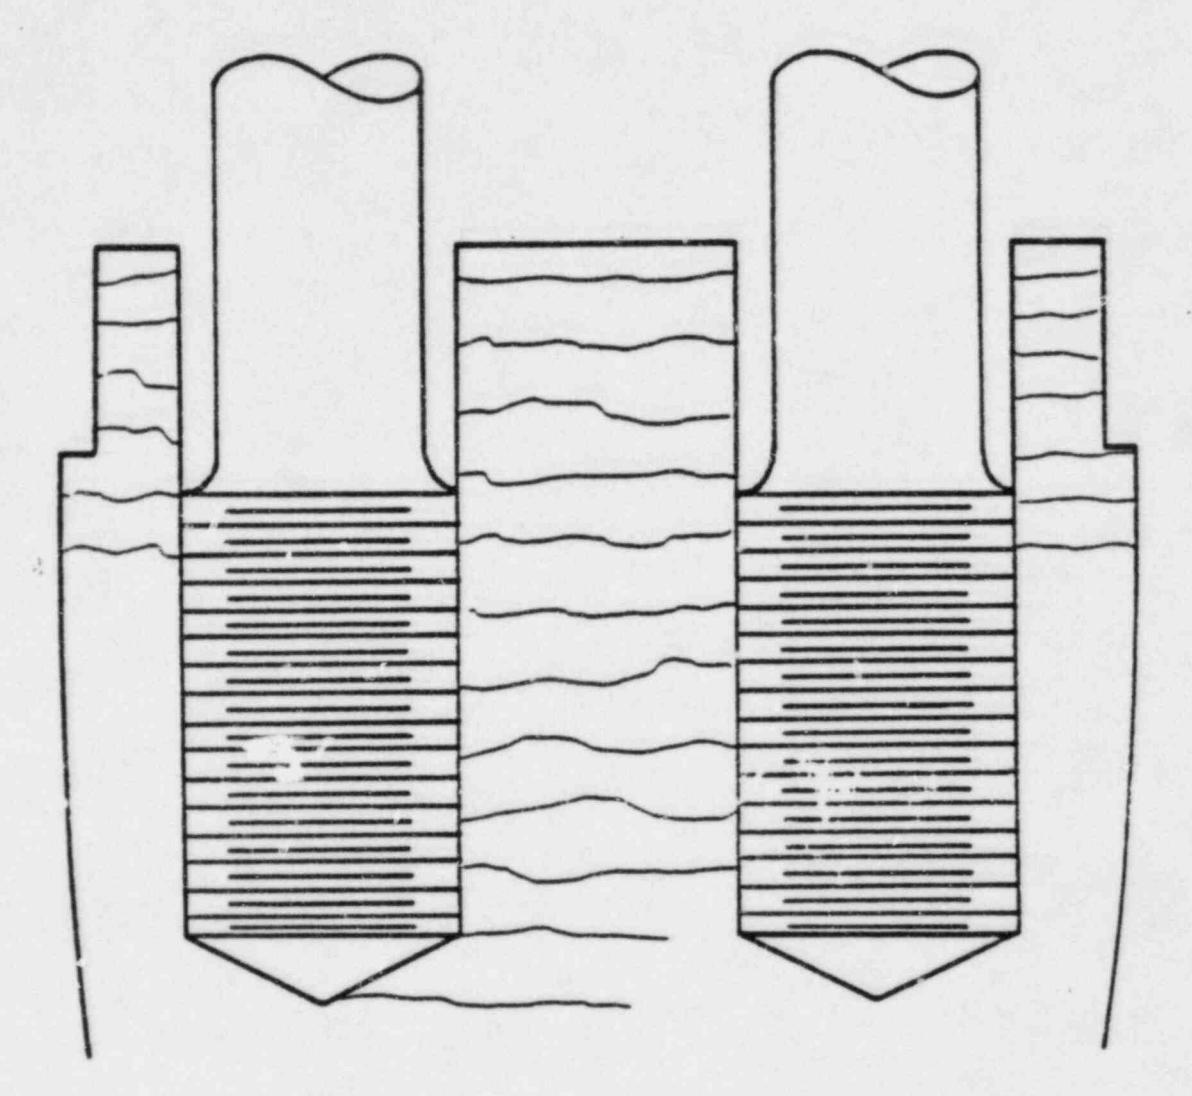
Figure 1-7. Longitudinal section between Cylinders 4 and 5 on exhaust side of SNPS DG103.

tended to a depth of at least  $5 \frac{1}{2}$  inches. As shown in Figure 1-7, the ligament cracks had also grown approximately 1 inch. Figure 1-8 is a crack map for DG103 as reinspected.

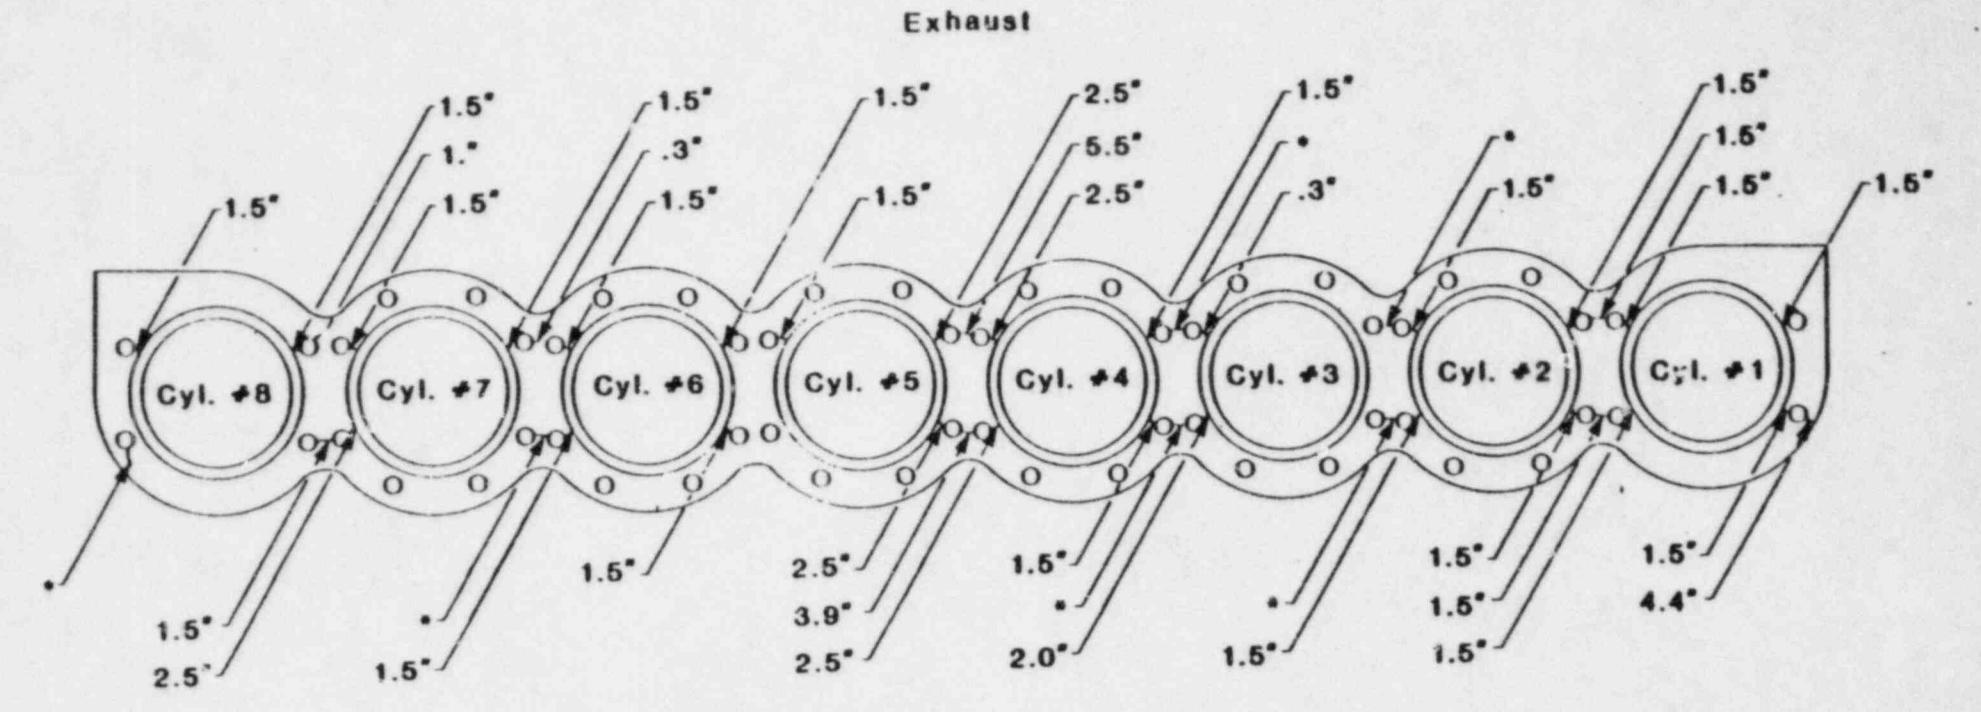
Dimensions indicate crack depth

\*Top surface indication. No depth to crack measurable down stud hole
