November 23, 1984 L-84-345

Re: Turkey Point Units 3 and 4 Docket Nos. 50-250 and 50-251 IE Bulletin 84-03

RESPONSE TO IE BULLETIN 84-03 "REFUELING CAVITY WATER SEAL"

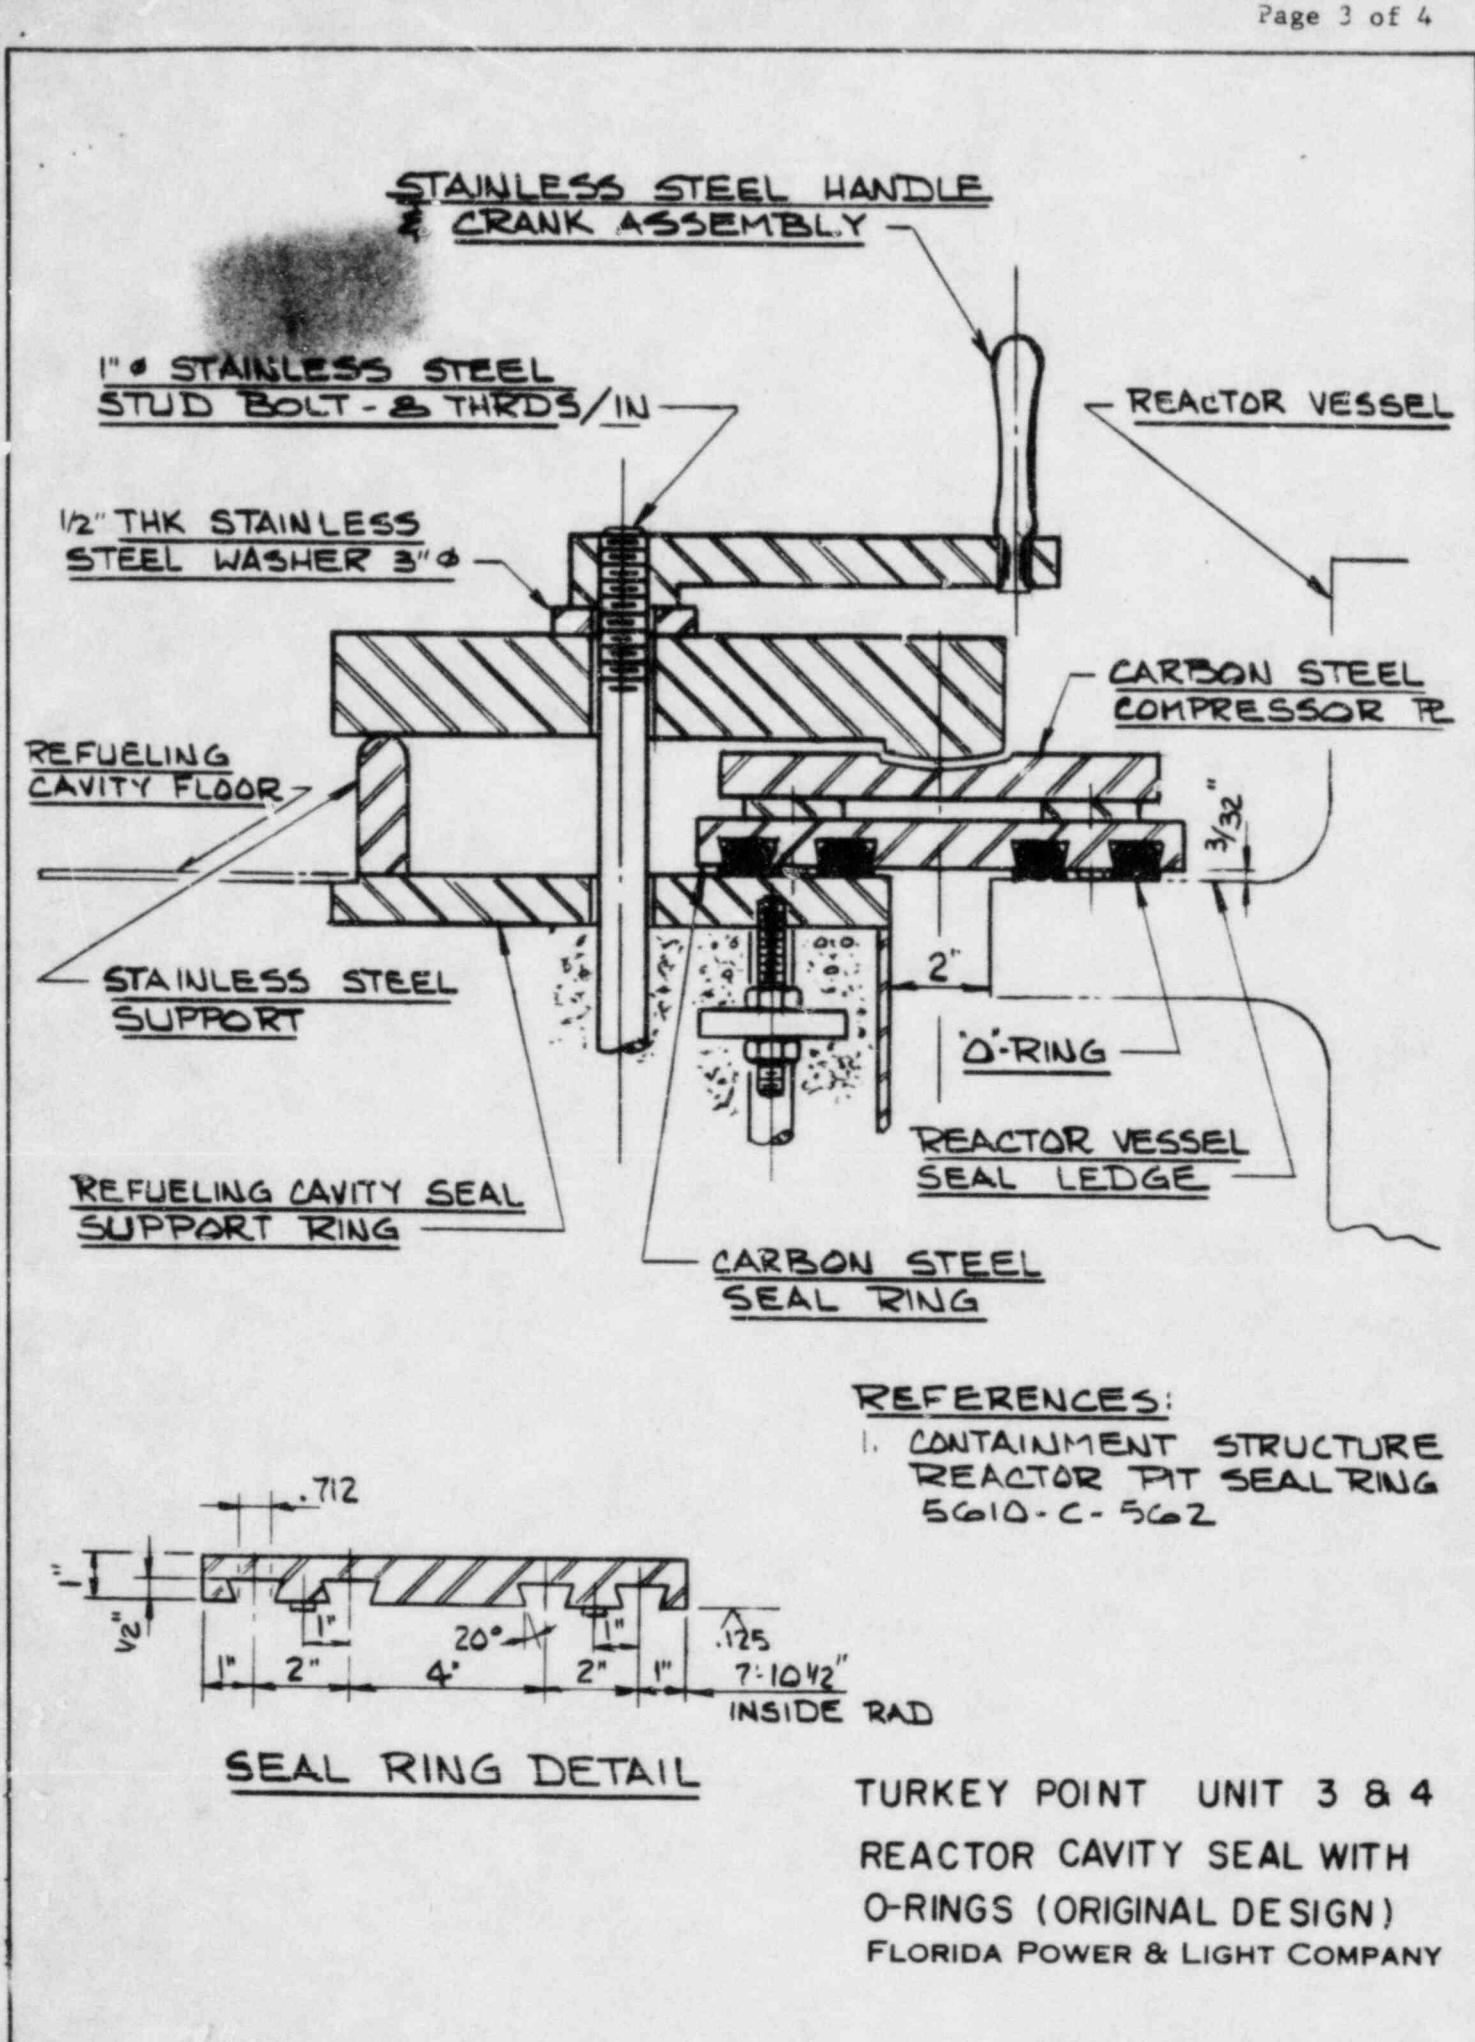
FIGURE I

The originally inscalled Turkey Point reactor cavity seal consisted of a 16 ft. 7 inch diameter carbon steel seal ring fitted with 2 pairs of O-rings (See Figure 1). The seal ring was positioned such that each pair of O-rings isolated the 2 inch annular gap between the reactor vessel seal ledge and the refueling cavity seal support ring from the refueling water. Twenty-four mechanical crank assemblies were used to apply a load to the seal plate to compress the O-rings to form the seal. Operating experience with this design showed that the irregularities in the seal ledge/seal support ring were beyond the sealing capabilities of the O-rings and leakage resulted.

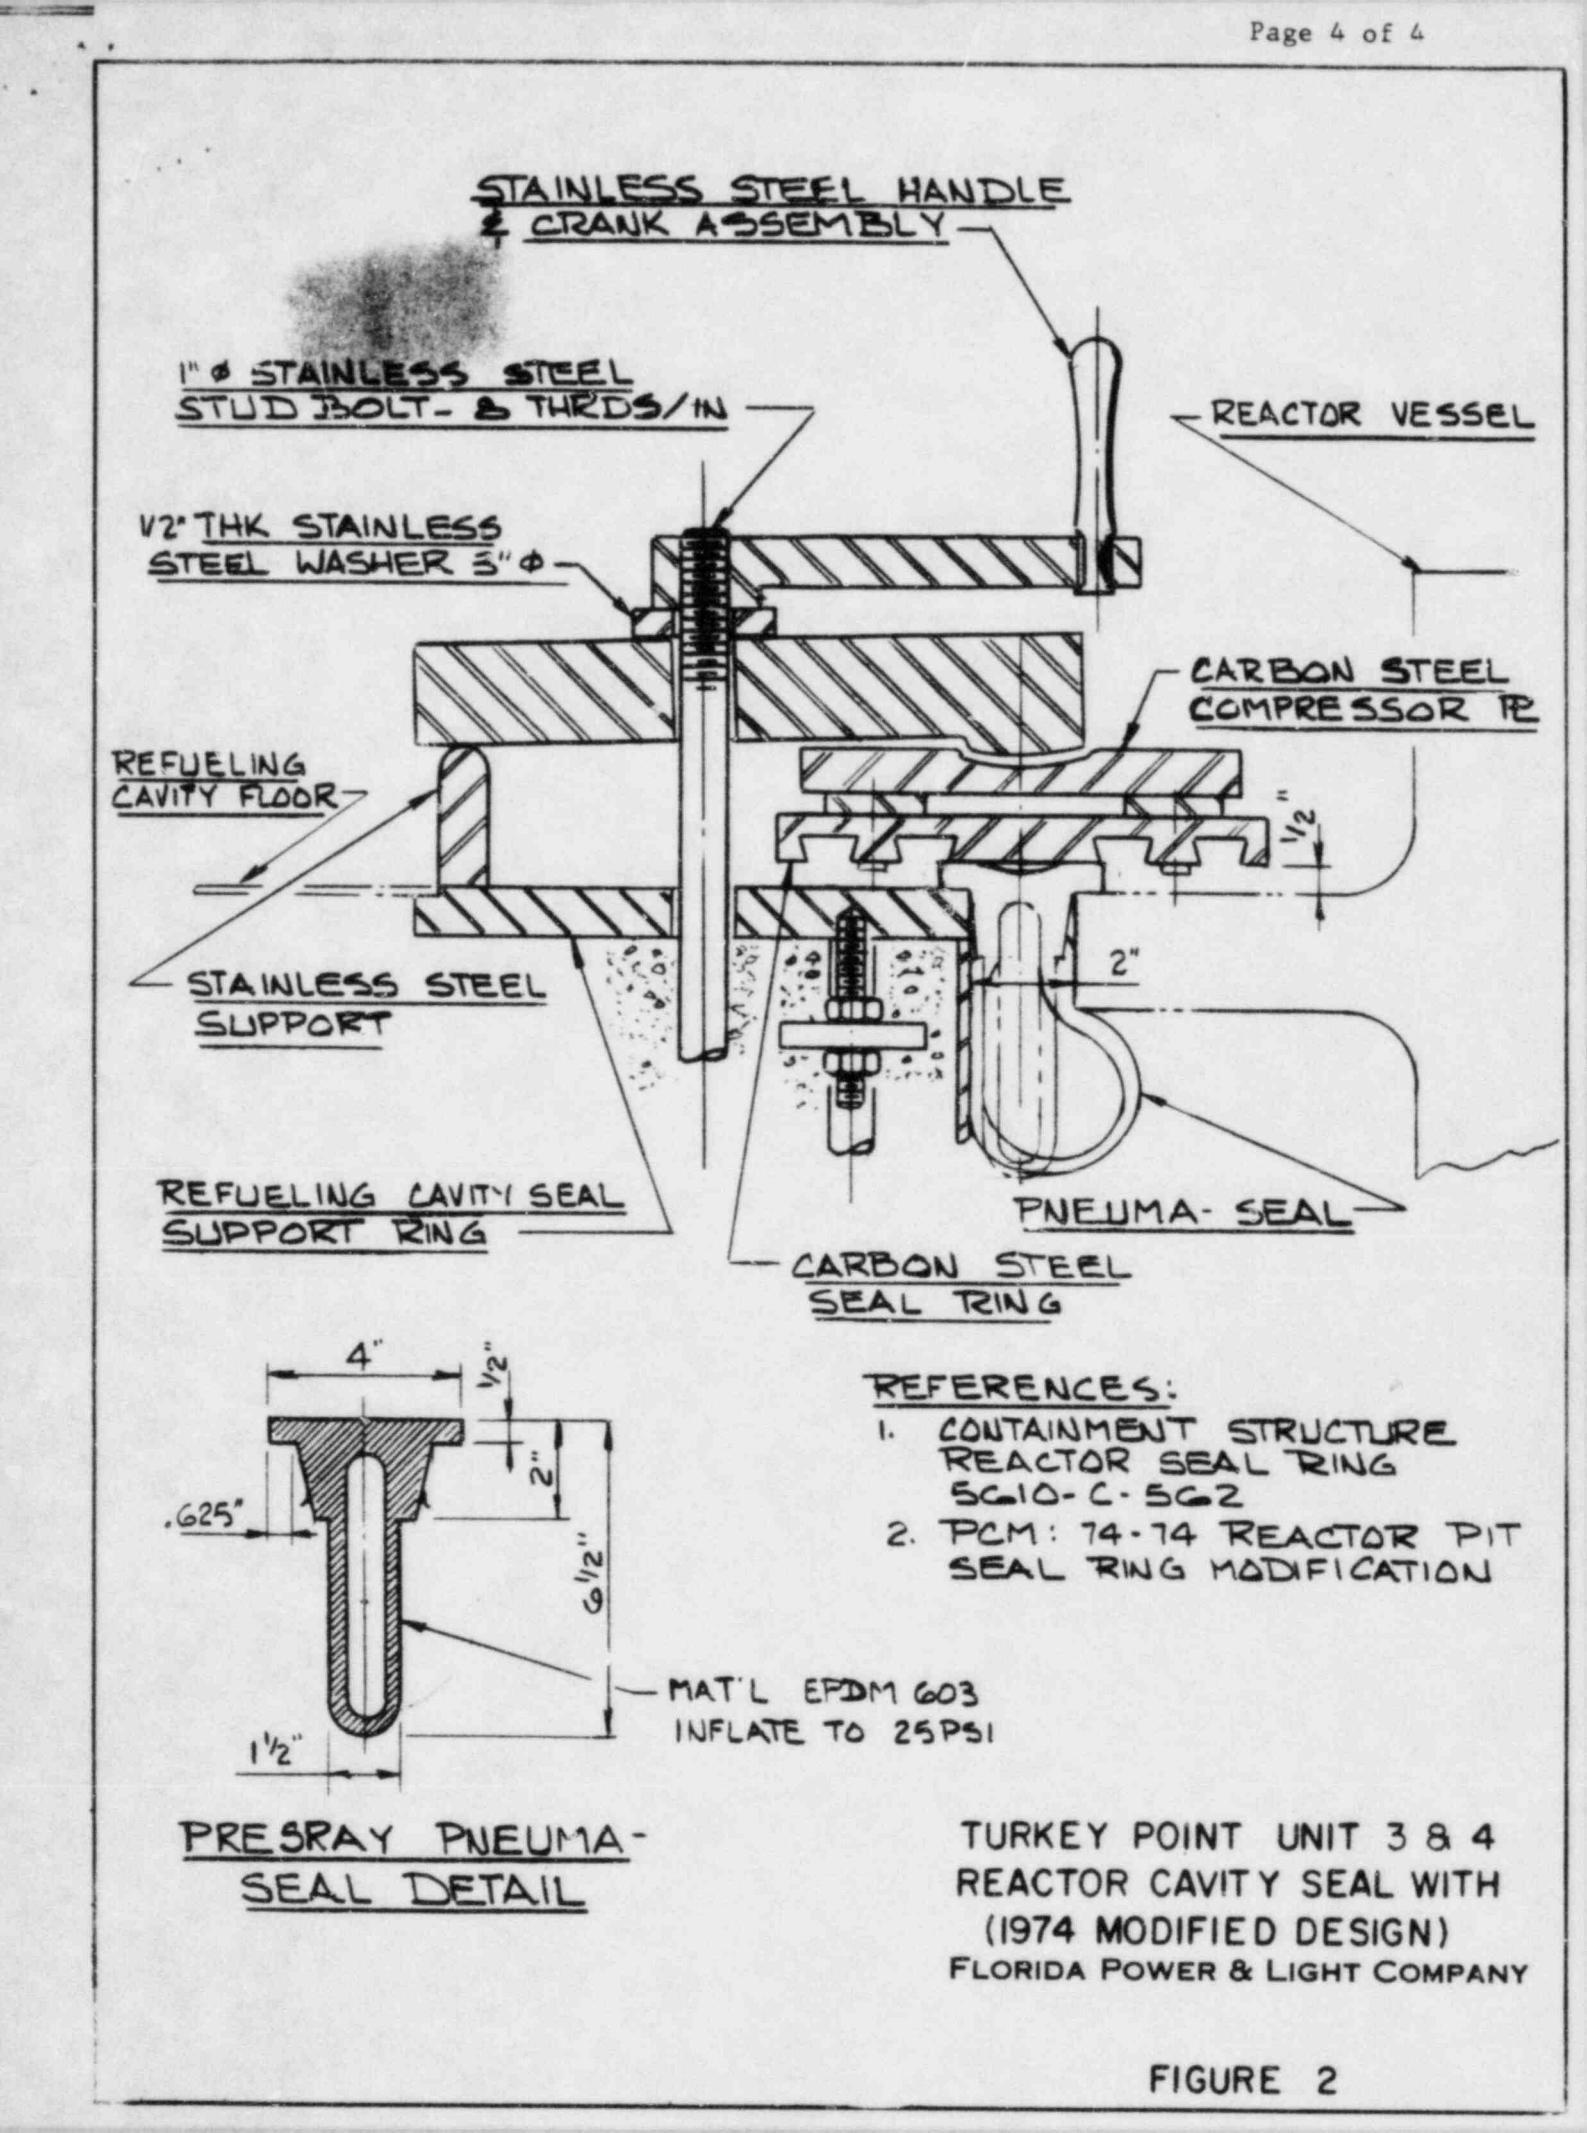
A design change was made in 1974 (PC/M 74-74) in which use of the O-rings was abandoned and sealing was accomplished through the use of a 16ft. 7 inch diameter Presray Pneuma-Seal, Model #PRS-585. The seal is made of EPDM compound E603 with nylon reinforcing which exhibits a durometer hardness of 65 (See Figure 2). The seal is installed in the two inch annular gap and once positioned, the carbon steel seal ring is placed over the seal and the same twenty four mechanical crank assemblies are used to compress the seal lips between the seal ring and vessel seal ledge/seal support ring. After installation, the Presray seal is inflated to and maintained at 25 psig. Prior to acceptance, the maintenance supervisor verifies the seal is properly fitted, no anomalies are present and air leakage from the seal is within the allowable limit. Plant Maintenance Procedure 1407.6 is the governing installation procedure.

The design of the modified Turkey Point reactor cavity seal ring provides a double seal against leakage. The primary seal is achieved by the mechanical compression of the seal ring against the top surface of the inflatable seal. This compresses the seal lips against the vessel seal ledge/seal support ring. The secondary seal is achieved by inflating the Presray Seal. Inflation of this seal both expands the upper shoulder area of the seal as well as the balloon portion of the seal against the shield wall and the vessel ledge. The inflatable seal is held in a fixed position by the mechanical crank assemblies/seal ring and does not rely on the inflatable portion for this purpose. Without taking credit for the sealing contribution of the inflated portion of the seal (i.e., 0 psig inflation), conservative calculations indicate that the seal will maintain its position. The forces tending to hold the seal in place are a minimum factor of 2.3 greater than the forces tending to extrude the seal. If air pressure is maintained, the holding forces exceed the extruding forces by a minimum factor of 5.6. These factors assure adequate sealing capabilities for the maximum height of water above the seal.
