UNITED STATES
NUCLEAR REGULATORY COMMISSION

DOCKET NO. 50-445-OL
50-446-OL

MEETING TO DISCUSS
TECHNICAL REVIEW TEAM STAFF FINDINGS - COMANCHE PEAK

Friday, January 17, 1985

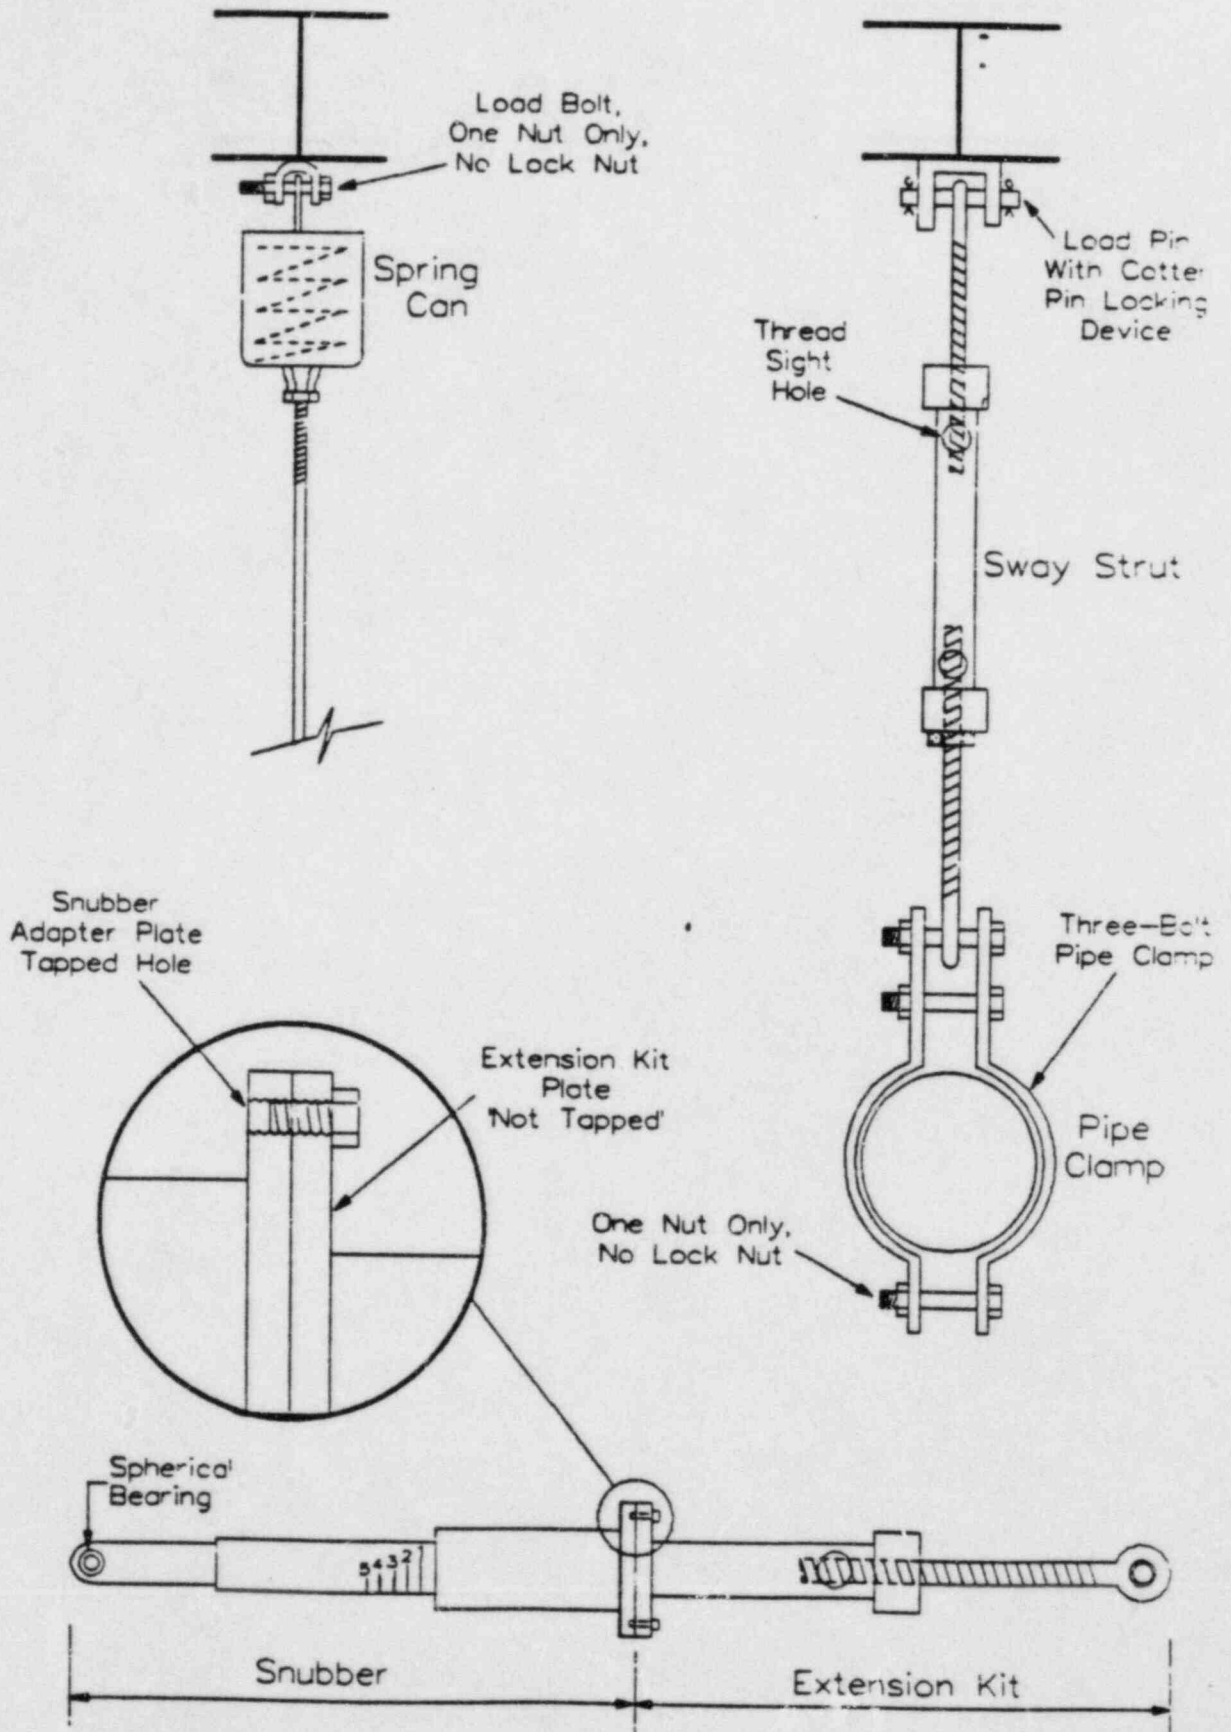
Figure 1. Hardware Examples

- 1) QC INSPECTIONS ARE INEFFECTIVE
- 2) CRAFT CONSTRUCTION IS FAULTY
- 3) HARDWARE IS NOT PER AS-BUILT DRAWINGS
- 4) HARDWARE POTENTIALLY NOT REPRESENTED CORRECTLY
IN THE FINAL STRESS ANALYSIS
