SUBJECT: UNION OF CONCERNED SCIENTISTS 2.206 PETITION ON TMI-1

TDR NO. 250

TMI-1

DOCUMENT TITLE: Review of Intermediate Building Flooding Following a Feedwater Line Break in the intermediate building of TMI Unit 1.

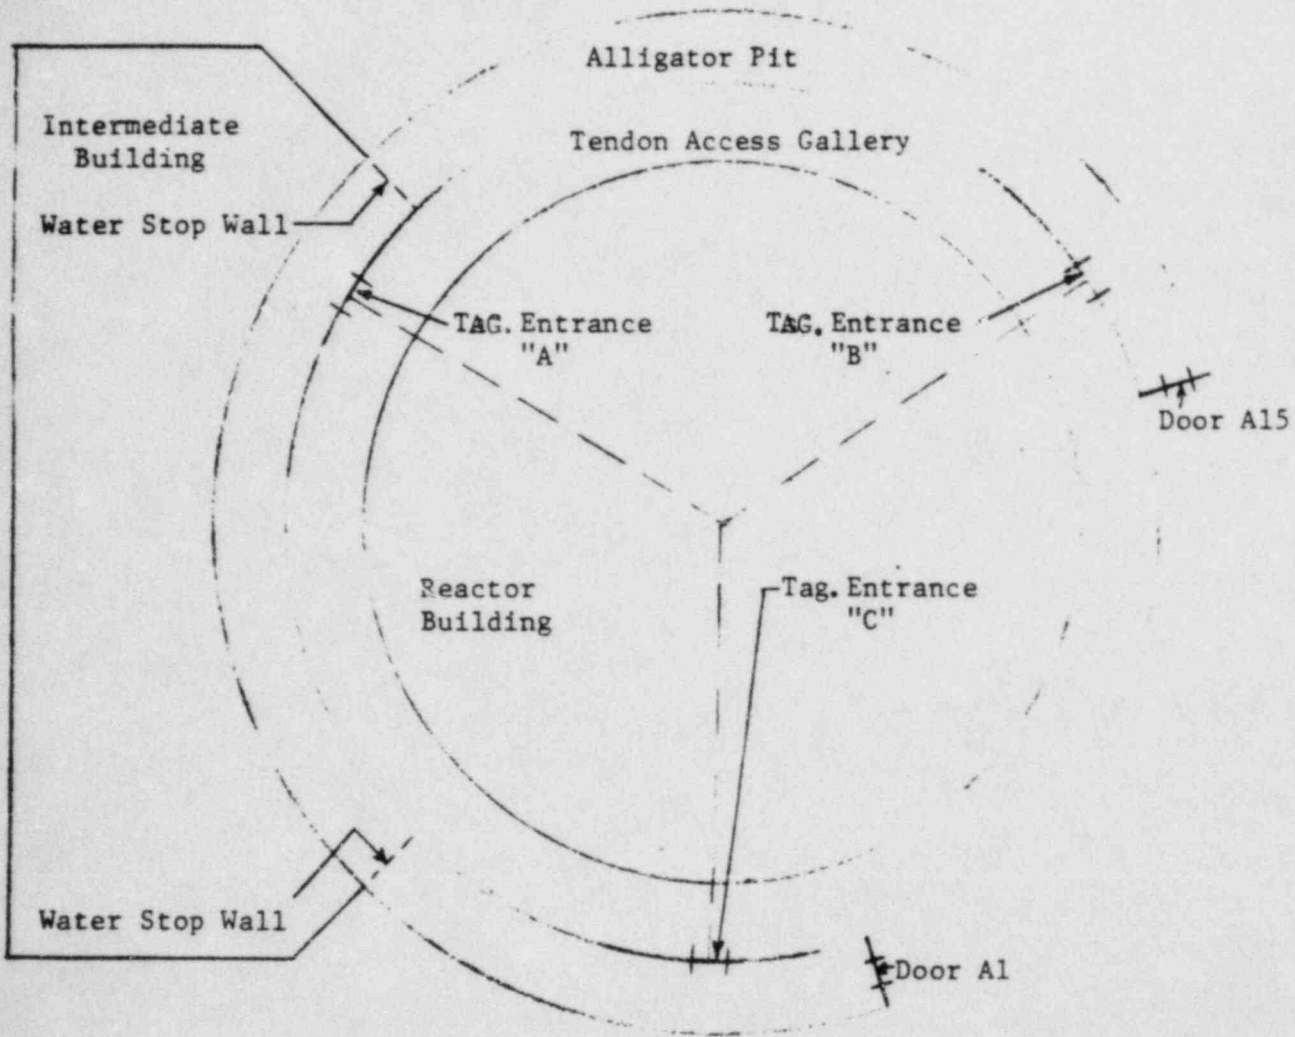
FIGURE 1: FLOOD AREAS FOR POSTULATED FEEDWATER

A review of postulated feedwater pipe breaks in the intermediate building has indicated that the plant design has left the problem of building flooding as a result of a postulated main feedwater line break unresolved. The original FSAR has been revised to address the flooding problem in the intermediate building following a feedwater line break. Since the intermediate building houses the emergency feedwater (EFW) pumps, instrument air compressors, hydrogen recombiner control panel and reactor building emergency cooler leak detection panel at floor EL. 295'-0", flooding due to a postulated feedwater pipe break is an important consideration for safe shut down.

gallery will allow approximately 15 minutes to fill the tendon access gallery and alligator pit. Without removing these walls with the present plant configuration the available time will be approximately 3.9 minutes after the break for water to reach intermediate building floor at EL. 295'. Alarms can be installed at suitable locations in the north quadrant of the alligator pit to warn the operator of a flooding event. In order to increase the drainage sink by opening the upper half of the water "stop wall" on the west side and tendon access gallery entrance will require that the alligator pit drains to reactor building gallery sump (shown on GAI dwgs. C-302-719 and E-311-813, detail 5) be blocked by control valve WDL-529 so that flooding of the alligator pit will not affect the auxiliary building area. The floor drains in the tendon access gallery under normal circumstances drain to the miscellaneous waste storage tank. There is a valve, WDL-V500, that could route the drains to the mechanical draft cooling tower effluent. However, since RML8 was removed several years ago, this path is not currently permitted for use. Also any other opening from tendon access gallery and alligator pit into auxiliary or turbine building needs to be blocked to prevent water passing into or out of these areas.

LINE BREAK IN THE INTERMEDIATE BUILDING

1. Remove the entire sealed door at the northeast entrance "A" on EL. 279' from the alligator pit to the tendon access gallery. (GAI Dwg. E-422-045)
2. Remove the entire portion of the sealed door at the entrance "B" on EL. 279' from the alligator pit to the tendon gallery (GAI Dwg. E-422-045)

3. Remove the upper half of the western water "stop wall" in the alligator pit. (GAI Dwg. E-421-301)
4. Upgrade the man-hole cover on the external access to the tendon access gallery at the west side of the Reactor Building to be water tight for flood conditions. (GAI Dwg. E-421-002)

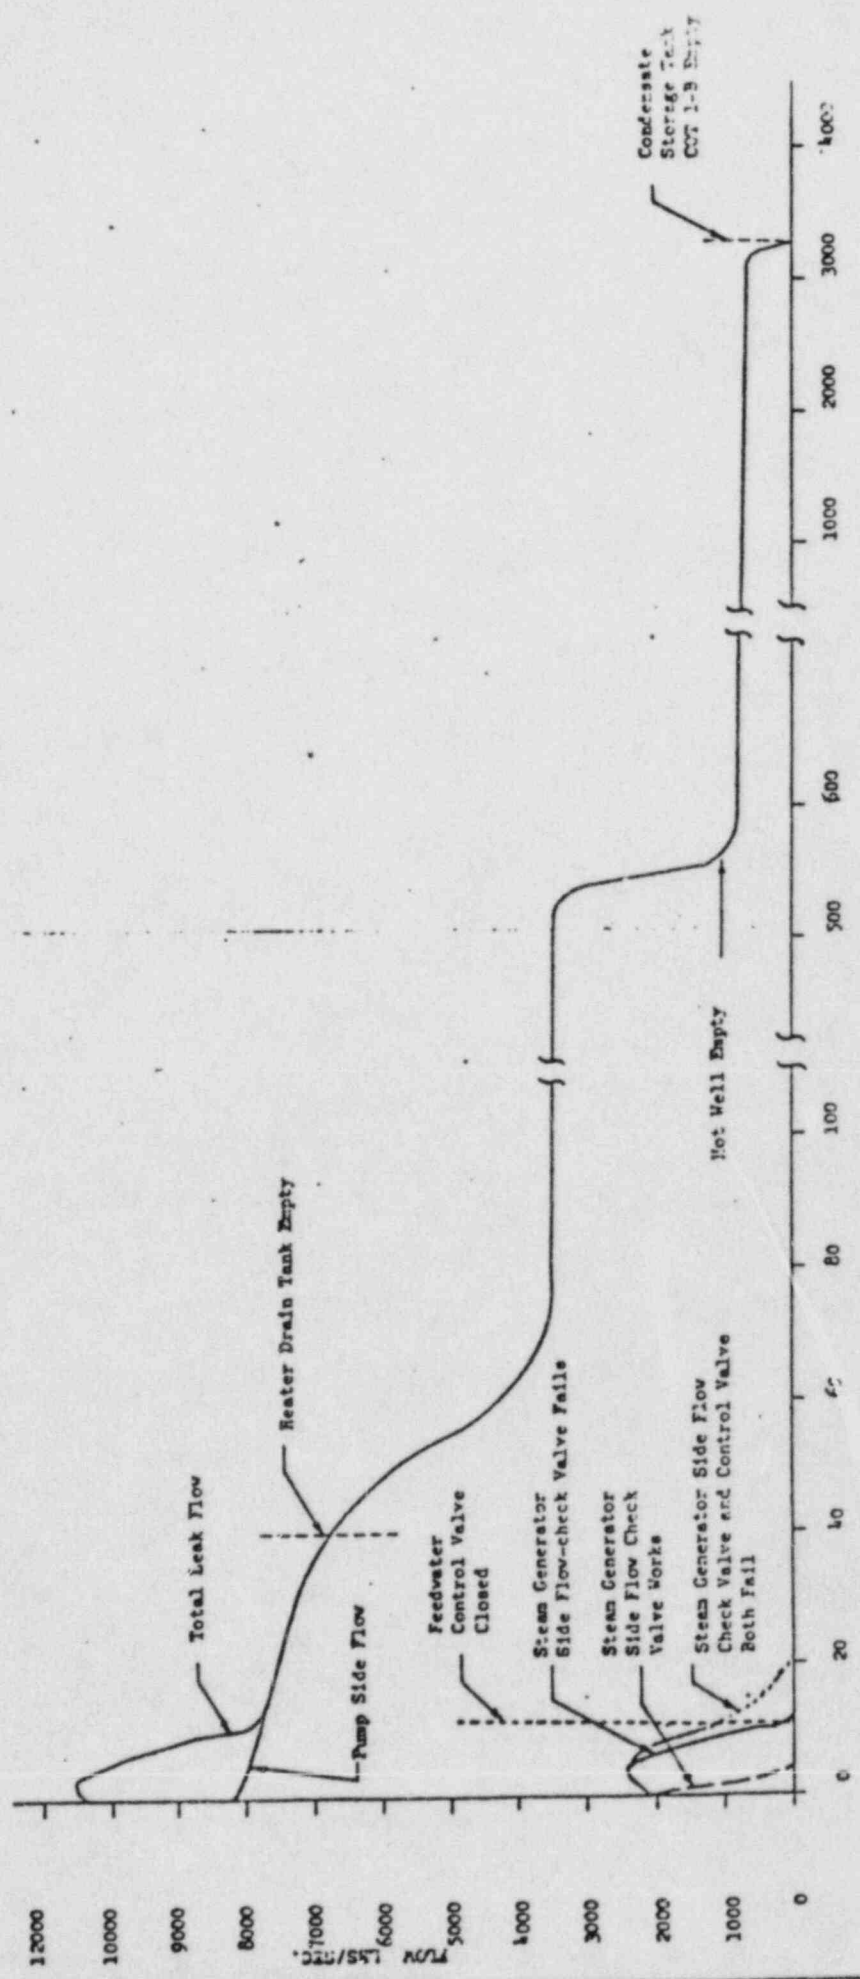
FIG-3

Feedwater flow continues at this steady state rate until the hotwell starts to empty at 530 seconds. When the hotwell is empty, water will continue to flow from the condensate storage tank COT-1B to the break at an average rate of 675 lbs/sec until condensate storage tank COT-1B is empty, approximately 54 minutes after the break. The feedwater break flow vs. time is shown in Fig. 3.

THREE MILE ISLAND FEEDWATER BREAK FLOW VS. TIME

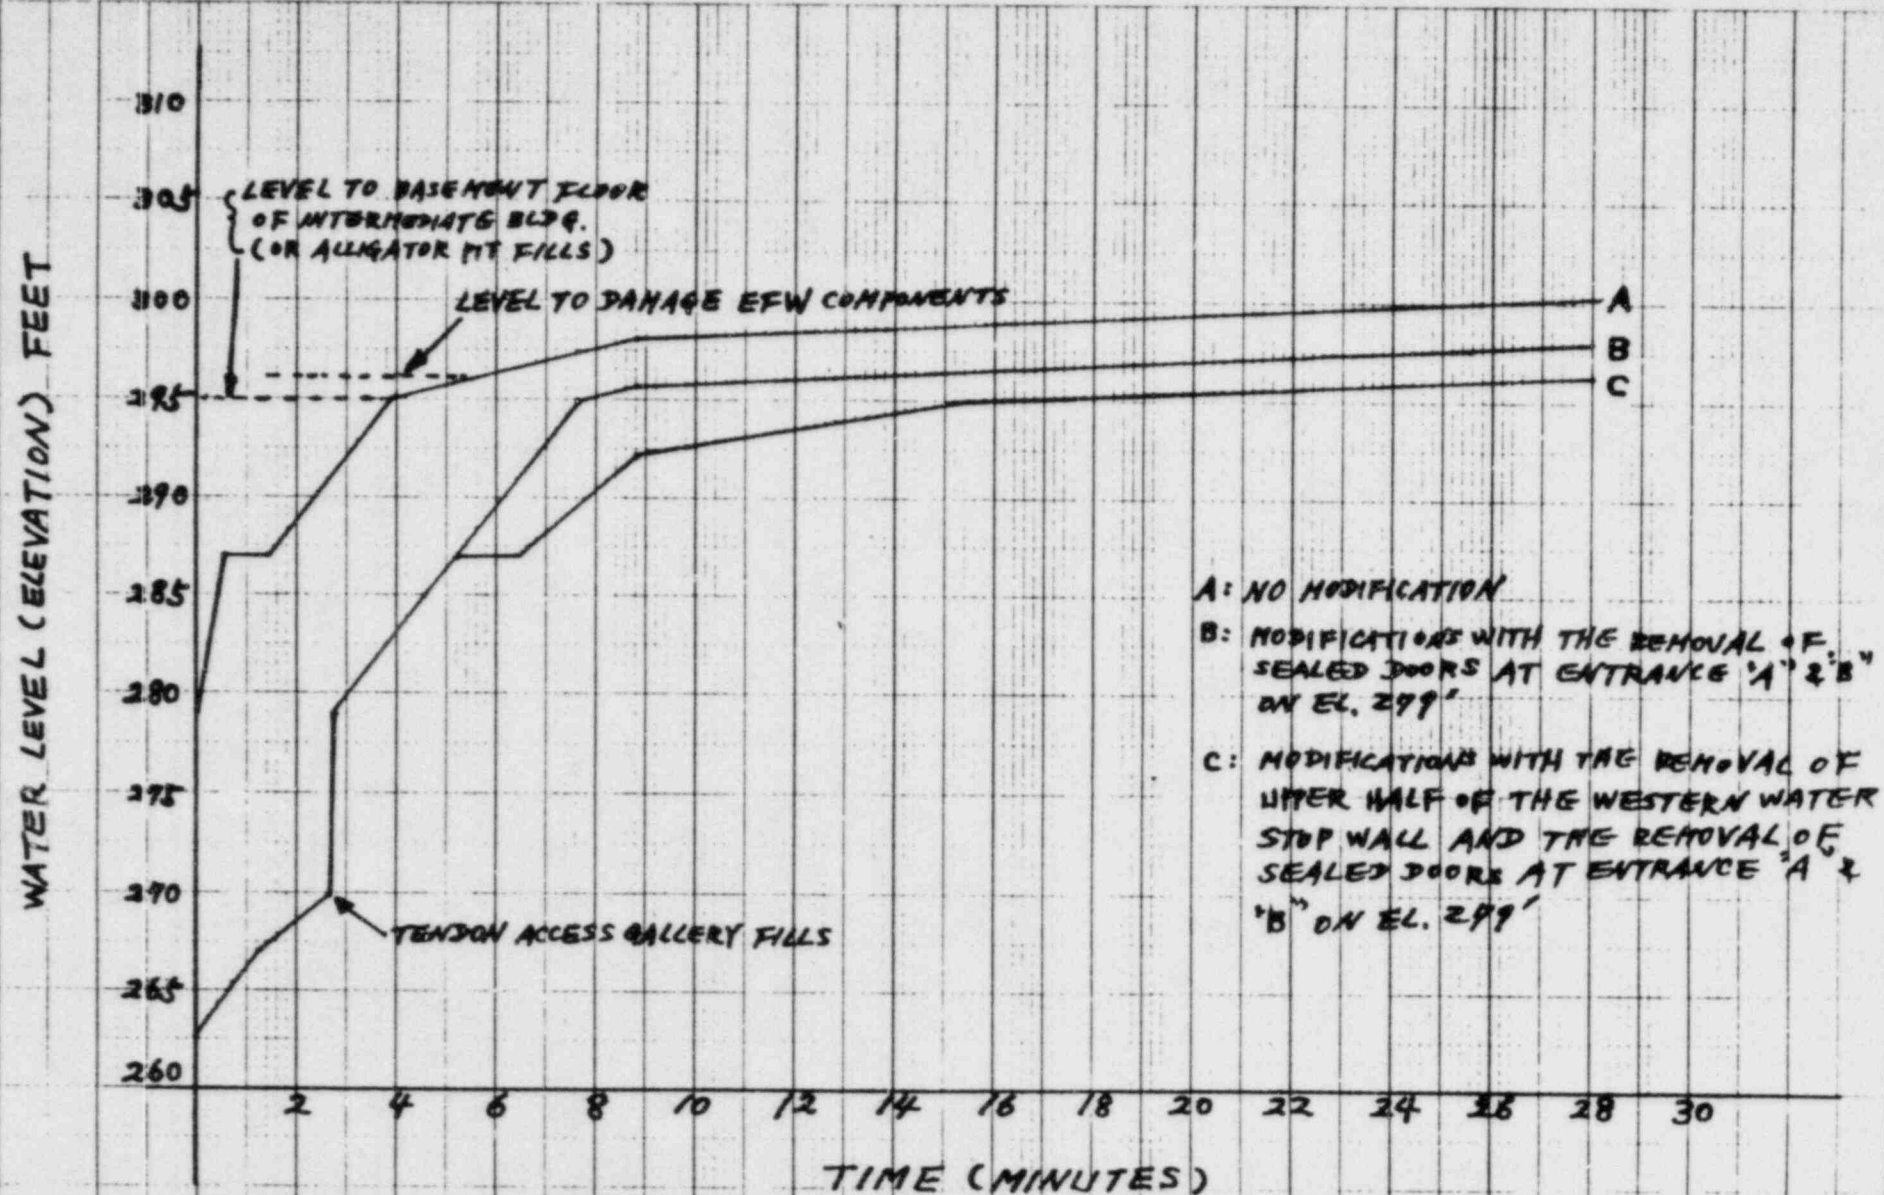
FEEDWATER LINE BREAK WATER LEVEL VS. TIME
FIG 4

The feedwater line break water level vs. time is shown in curve A of Fig. 4.

This is too short a time for an operator to respond and take action to avoid intermediate building floor flooding.

The feedwater line break water level vs. time is shown in curve C of Fig. 4.

This would provide sufficient time for an operator to respond and take action before any active components in the Emergency Feedwater system are jeopardized.
