Subject: Oyster Creek Station
Docket No. 50-219
Electromatic Relief Valve Failure

Subject: Oyster Creek Station
Docket No. 50-219
Diesel Generator 1-1

Subject: Oyster Creek Station
Docket No. 50-219
Drywell Head Manhole Cover

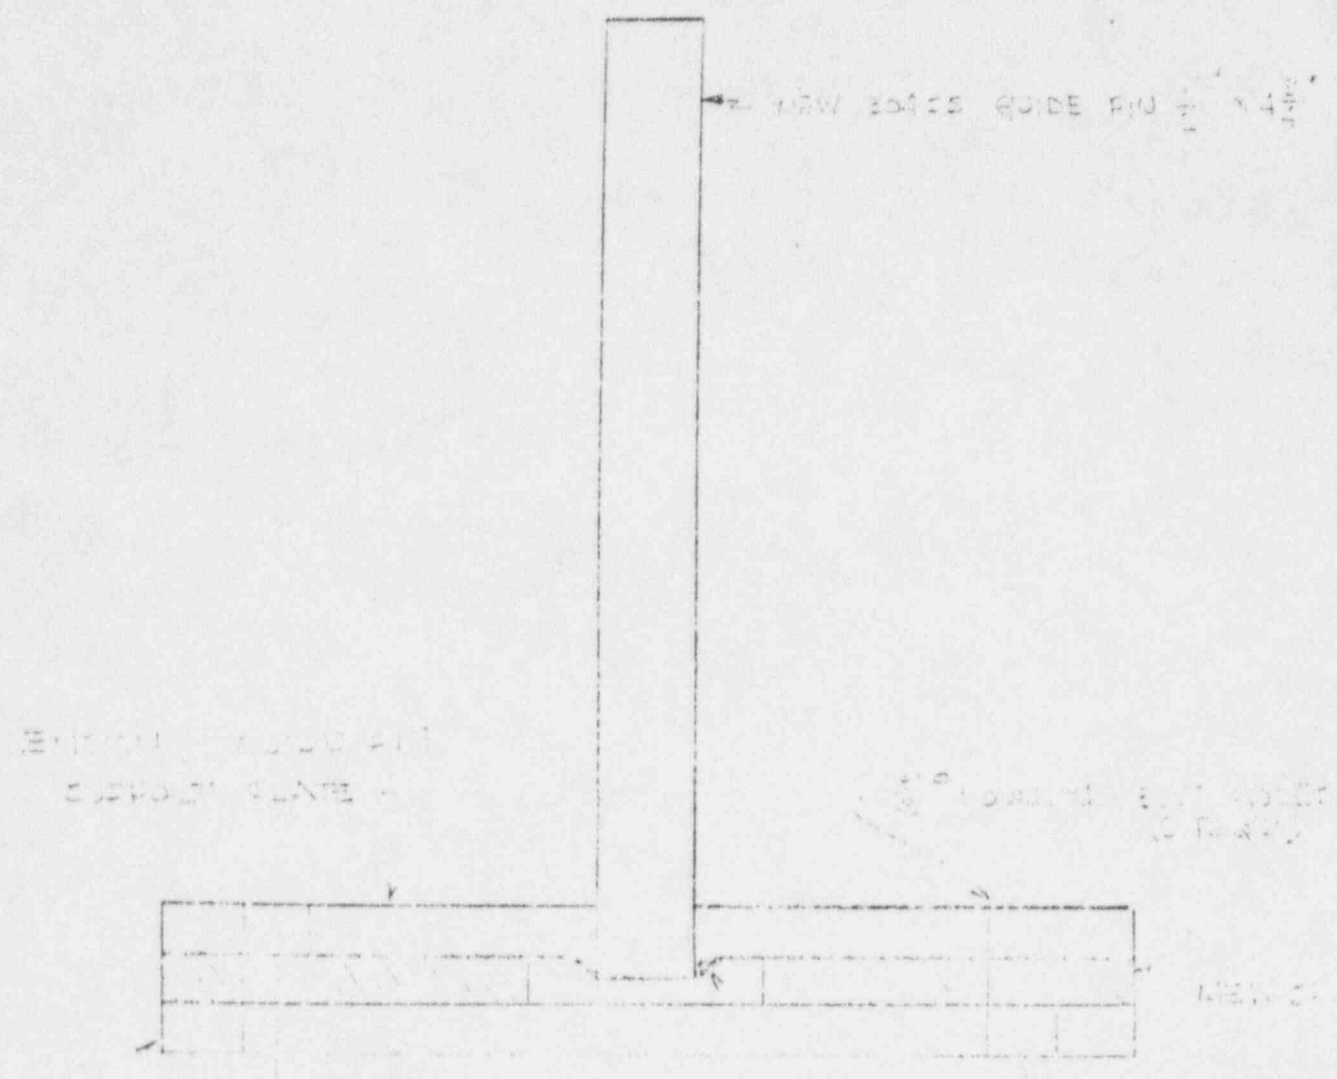
FIG. 1

This letter is intended to follow up our April 24, 1973 letter reporting one electromatic relief valve NR-108-B failed an operability test. As a result of additional investigation into this problem, the reason for the failure of the "B" electromatic relief valve to open during the test was traced to the failure of the solenoid core guide pin as previously reported. The solenoid core is guided by two 1/2" pins silver soldered to their support plates. The soldered joint failed partially because of marginal soldering. The guide pins were cocked to one side and prevented the solenoid core from moving in the trip direction as required.

To prevent this type failure from reoccurring, the following repair was made to the pins support plate assembly of all five electromatic relief valves at Oyster Creek. (Please refer to the attached drawing.) New 304SS guide pins were machined to the dimensions shown on the attached drawing. The new pins were welded to the underside of the support plates using 308L wire. New 1/8" spacers were installed between the solenoid core frame and the guide support to clear the underside weld.

Upon completion of the repair, the valves were tested satisfactorily with the reactor at rated pressure during our restart following our recent re-fueling outage.
