September 25, 1984

Subject: Byron Generating Station Units 1 and 2
Byproduct Material License No. 12-05650-18
NRC Docket Nos. 50-454 and 50-455

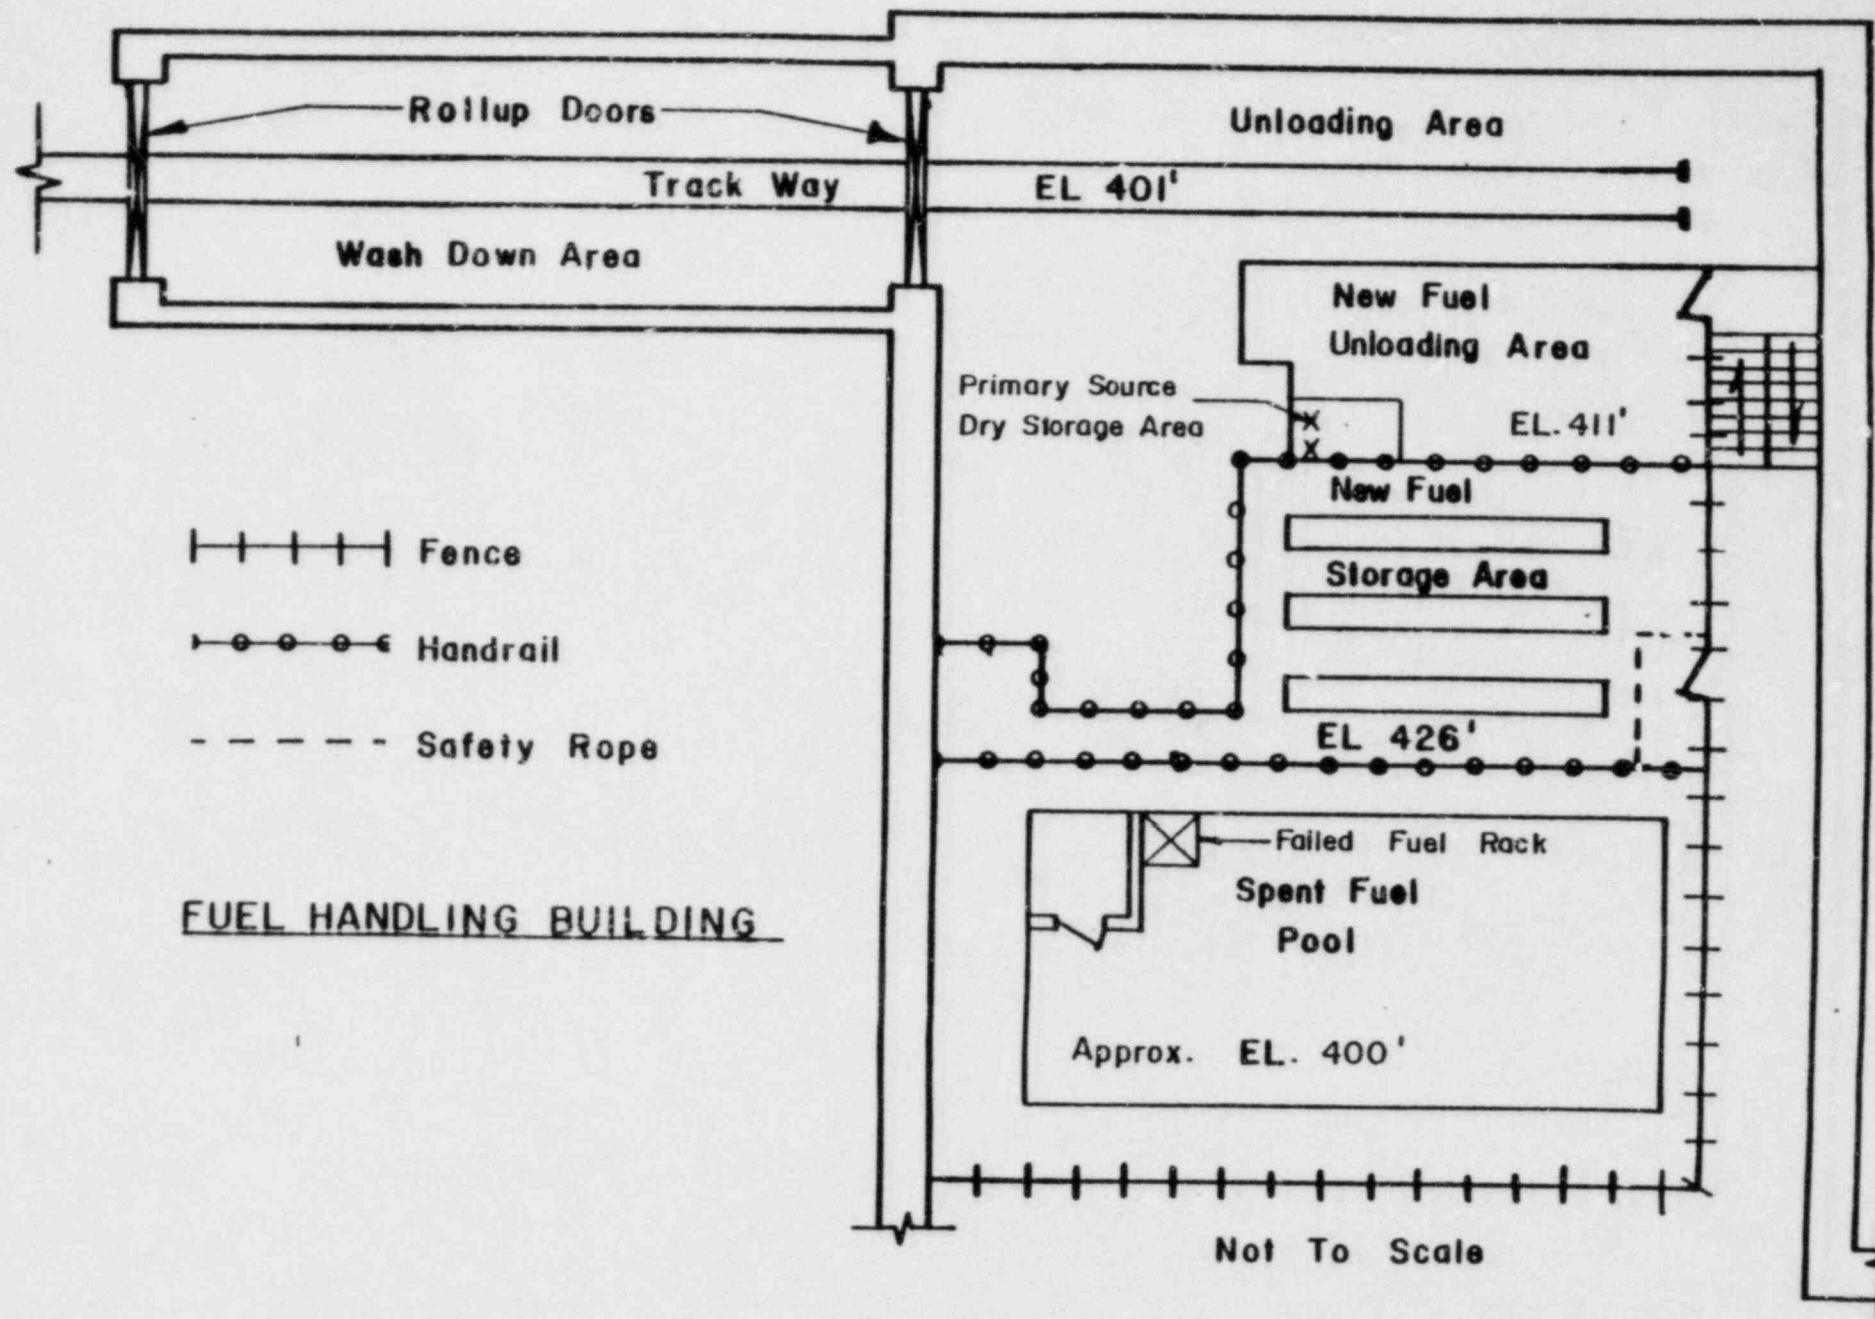
DRAWING 4
PRIMARY SOURCE DRY STORAGE AREA

The primary neutron sources are currently stored on the 411' elevation in the Fuel Handling Building (see Drawing #3). They are individually stored inside 1 inch diameter stainless steel pipes for mechanical support and protection. The source material is located in a 1 1/2 inch long section of the 12 foot long rod approximately 33 inches up from the bottom. Surrounding the steel pipes, in the vicinity of the sources, are cylindrical shields made of paraffin and borated concrete. Surrounding the pipes and containers is a concrete block wall approximately 4 feet high (see Drawing #4). This area has been thoroughly surveyed and is appropriately posted and surveilled.

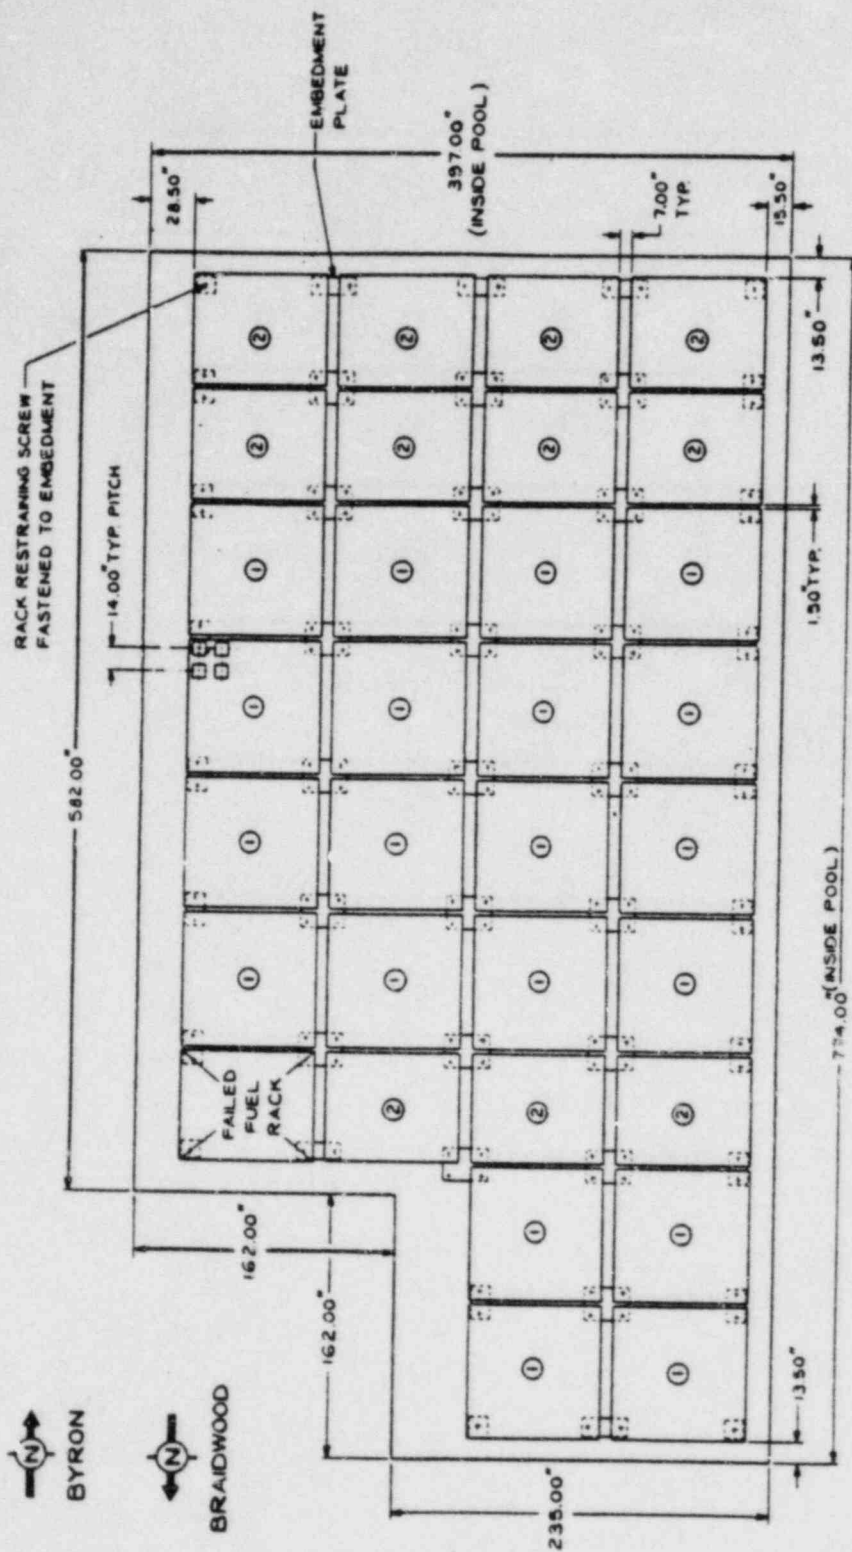
FIGURE 9.1-2

The proposed storage location for each source rod is attached to a Burnable Poison Rod Assembly located in a new fuel assembly (see Drawing #5). The fuel assemblies are stored in borated water shielding inside failed fuel containers (see Drawing #2). The failed fuel containers (see Drawing #1) are cylindrical vessels approximately 13 inches in diameter containing a internal fuel assembly support framework. The failed fuel containers are stored in pipes approximately 15 inches in diameter which make up the failed fuel container storage rack (see FSAR Figure 9.1-4 and Drawing #2). The failed fuel rack is located in the Spent Fuel Pool (see FSAR Figure 9.1.2).
