#### THE RADIOLOGICAL AND ENGINEERING ASSESSMENT

PROPERTY #ED-00915-RS

March 1984

URANIUM MILL TAILINGS REMEDIAL ACTION PROJECT OFFICE ALBUQUERQUE OPERATIONS OFFICE

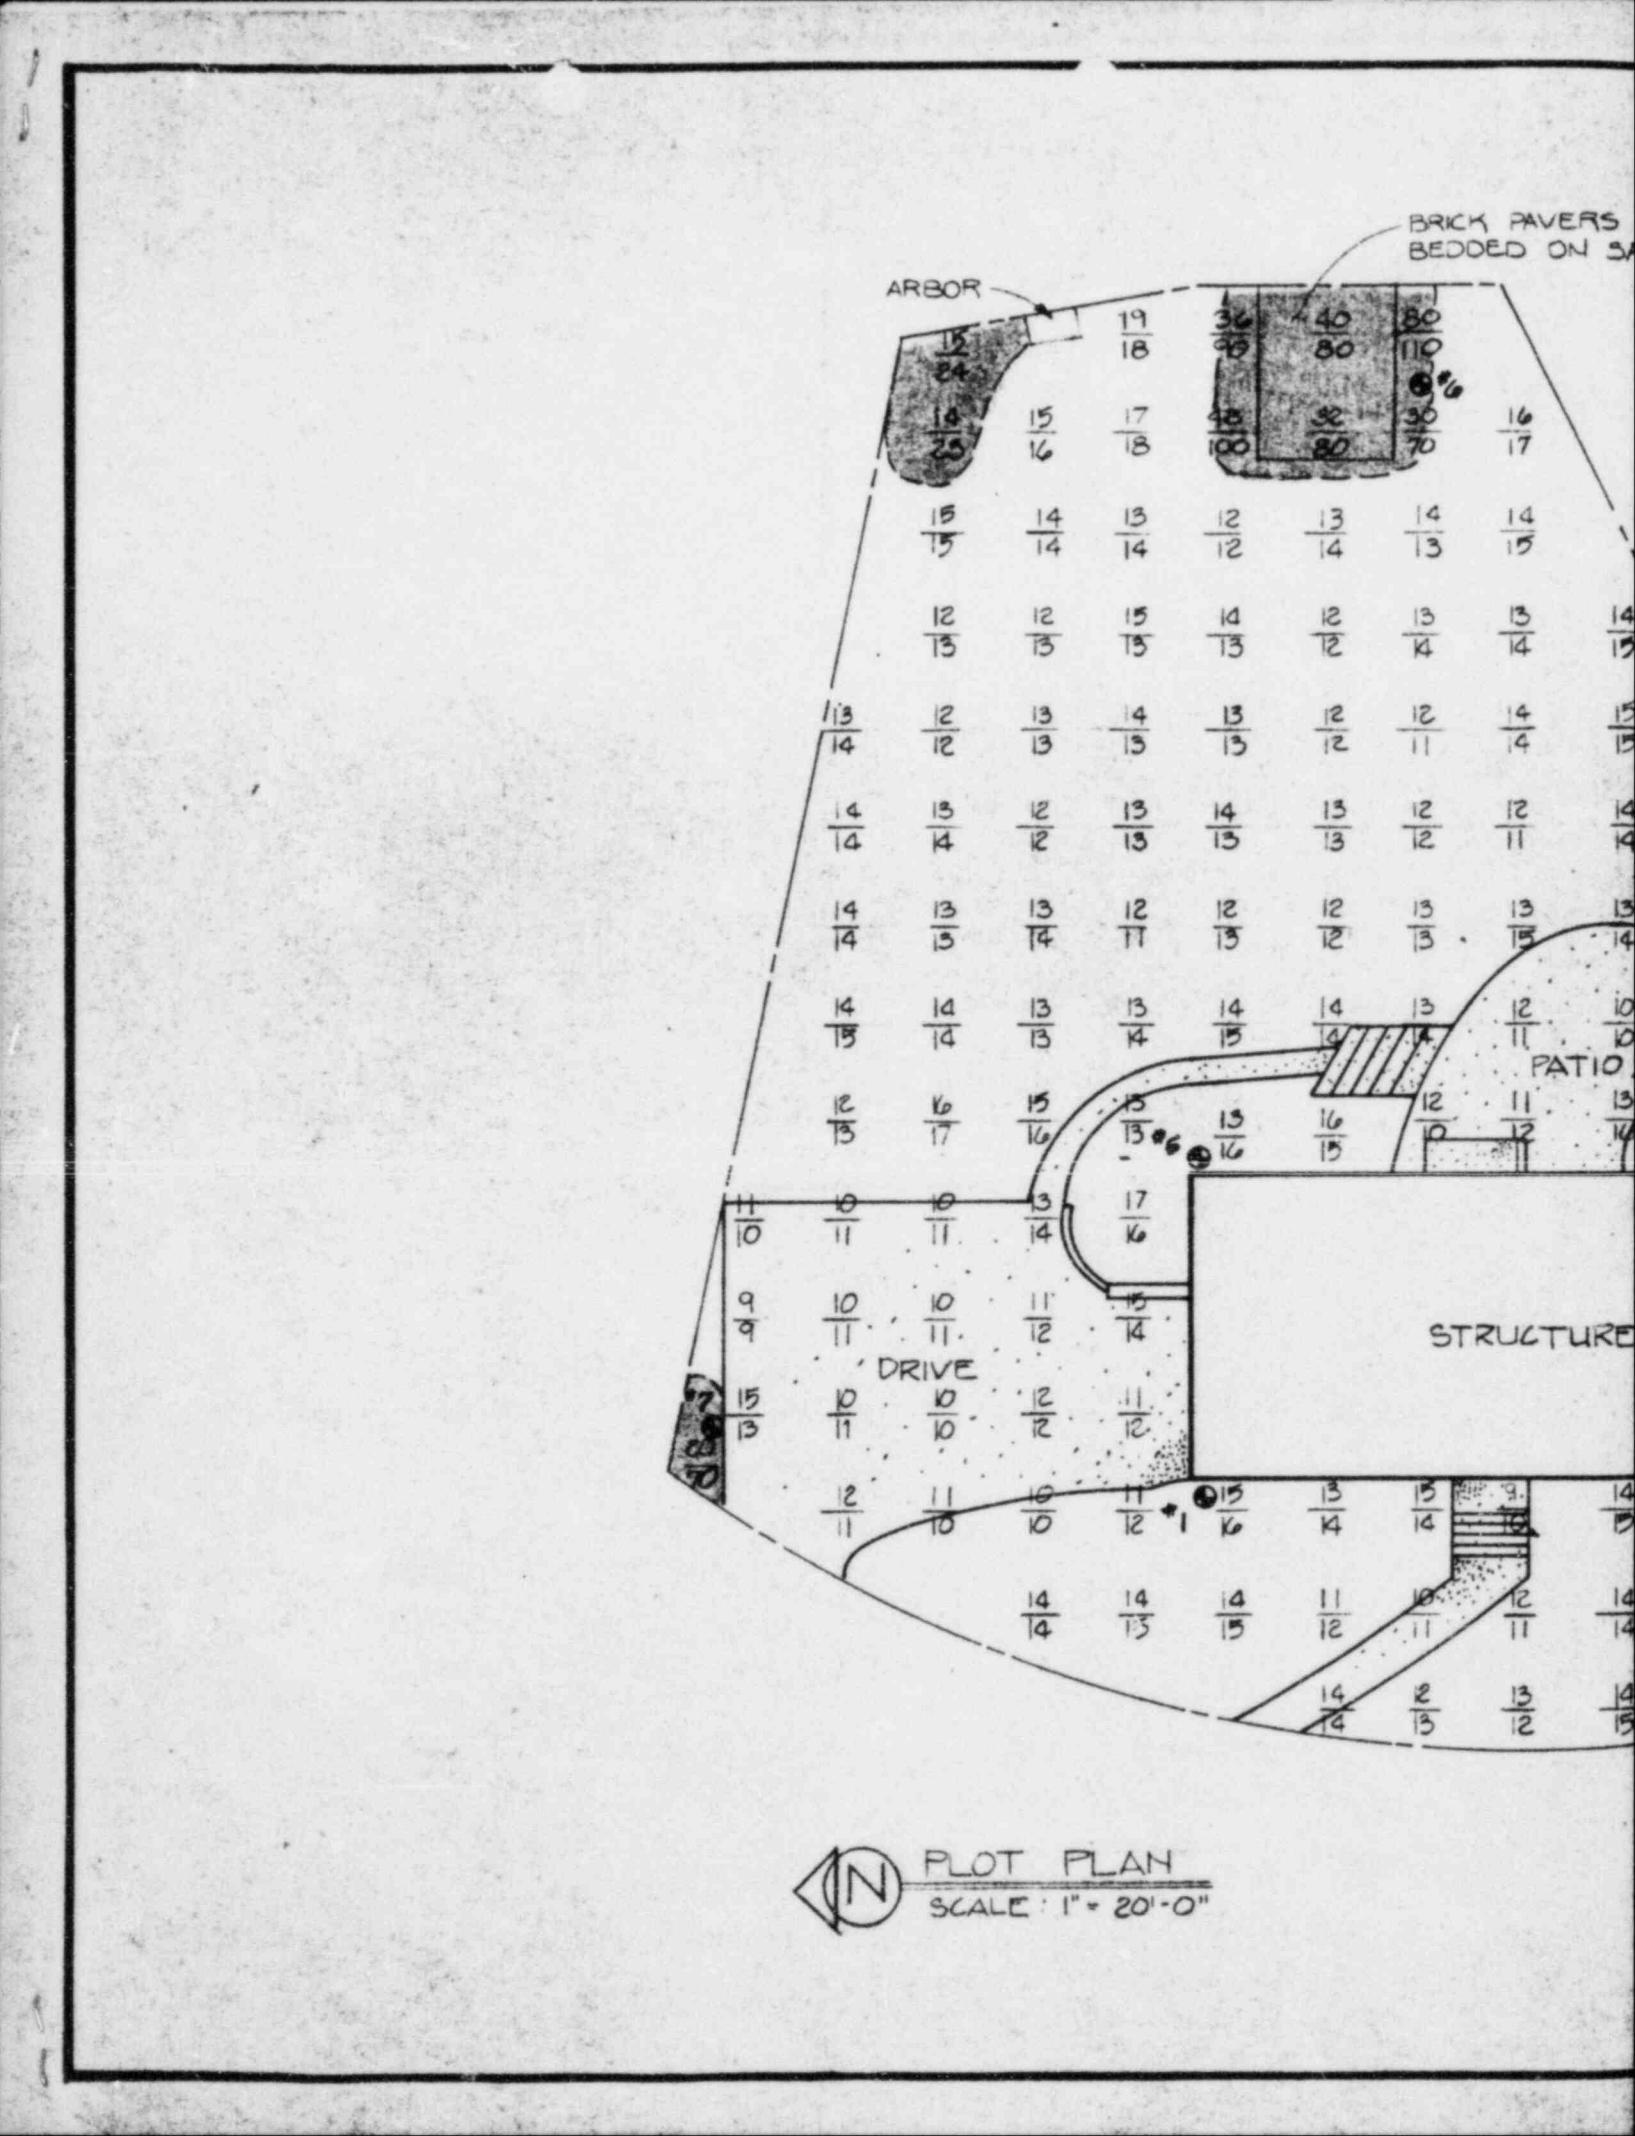
rates can be estimated by applying a scintillometer/gas proportional ionization chamber cross-calibration factor (meter reading x 0.56 + 6 = true exposure rate). Recorded data indicate that the true gamma exposure rate background on the property is about 13 micro-R/hr and the maximum true gamma exposure rate measured on the exterior property is about 68 micro-R/hr. Results of the exterior gamma radiation survey are shown on Figure 3.1.

Data from the exterior borehole logs are shown on Figure 3.1. This data shows tailings contamination exceeding EPA criteria under a decorative paving brick/antique wagon located in the east (back) yard and along the north edge of the concrete driveway to 14 inches deep. This contamination exceeds the radium-226 criteria; however, the deposit along the north edge of the driveway does not exceed the criteria when averaged over a 10 square meter area. The equivalent radium-226 concentration at borehole locations measures to 15 pCi/g in the top 15 cm soil layer and to 26 pCi/g in some subsurface layers.

delta scintillometer readings provide a differential gamma measurement by observing the reading with an unshielded detector, and then placing a 1/8 inch lead shield between the detector and surface of interest and observing the reading; the difference between the two measurements is the delta reading representing radiation emanating from the area directly below the detector. The delta gamma measurements have been cross-calibrated with laboratory soil analysis to accommodate converting the delta to equivalent pCi Ra-226/g in the surface 6" layer of scil. The delta gamma measurement is used in conjunction with borehole gamma logging to estimate radium-226 concentrations in the top 6" (15 cm) layer of soil. Delta gamma measurements related to the 7 borehole locations are shown on Figure 3.1.

Figure 3.1 shows the apparent deposition of exterior tailings contamination on the property and there is no apparent tailings

- . Contaminated soil to a depth of 14 inches adjoins the north edge of the concrete driveway; this deposit does not appear to extend beneath the concrete.
- . Contaminated soil is 12 inches deep beneath decorative paving brick located adjacent to the east (back) property boundary.
- . Contaminated soil is estimated to be 6 inches deep in a spot located in the northeast corner of the yard.

Referencing Figure 3.1, the volume of contaminated material to be removed from the property is about 19.2 cubic yards from the exterior yard area (reference Table 3.1 for volume calculations).

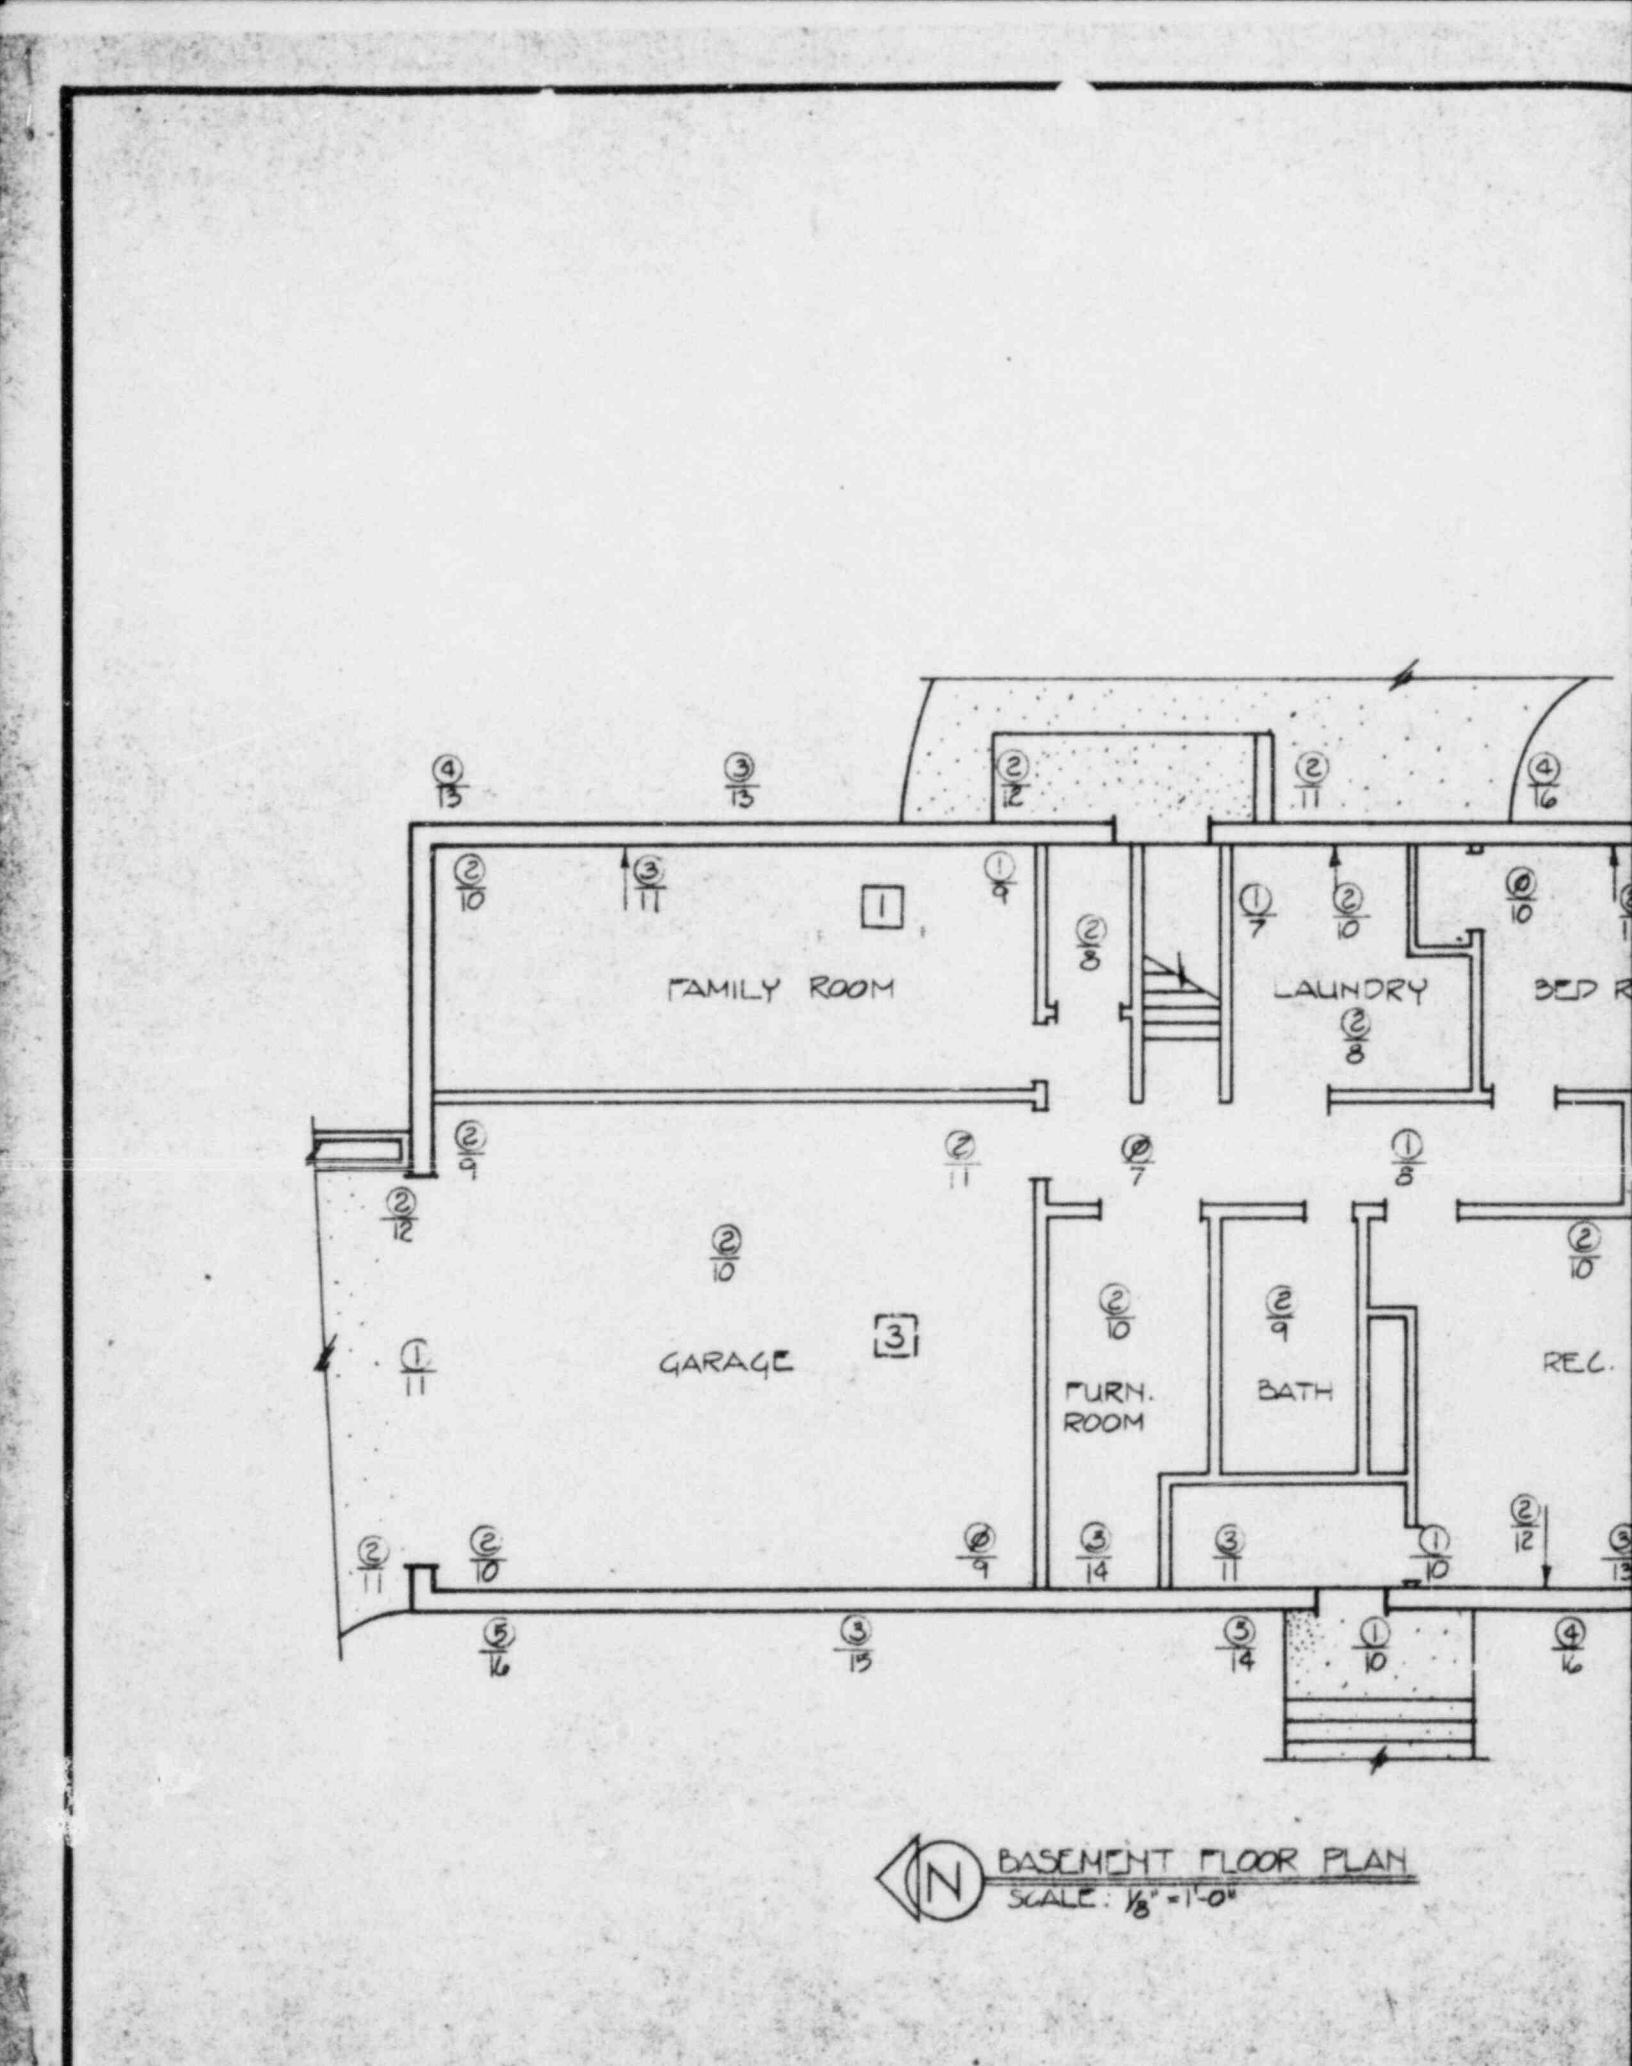
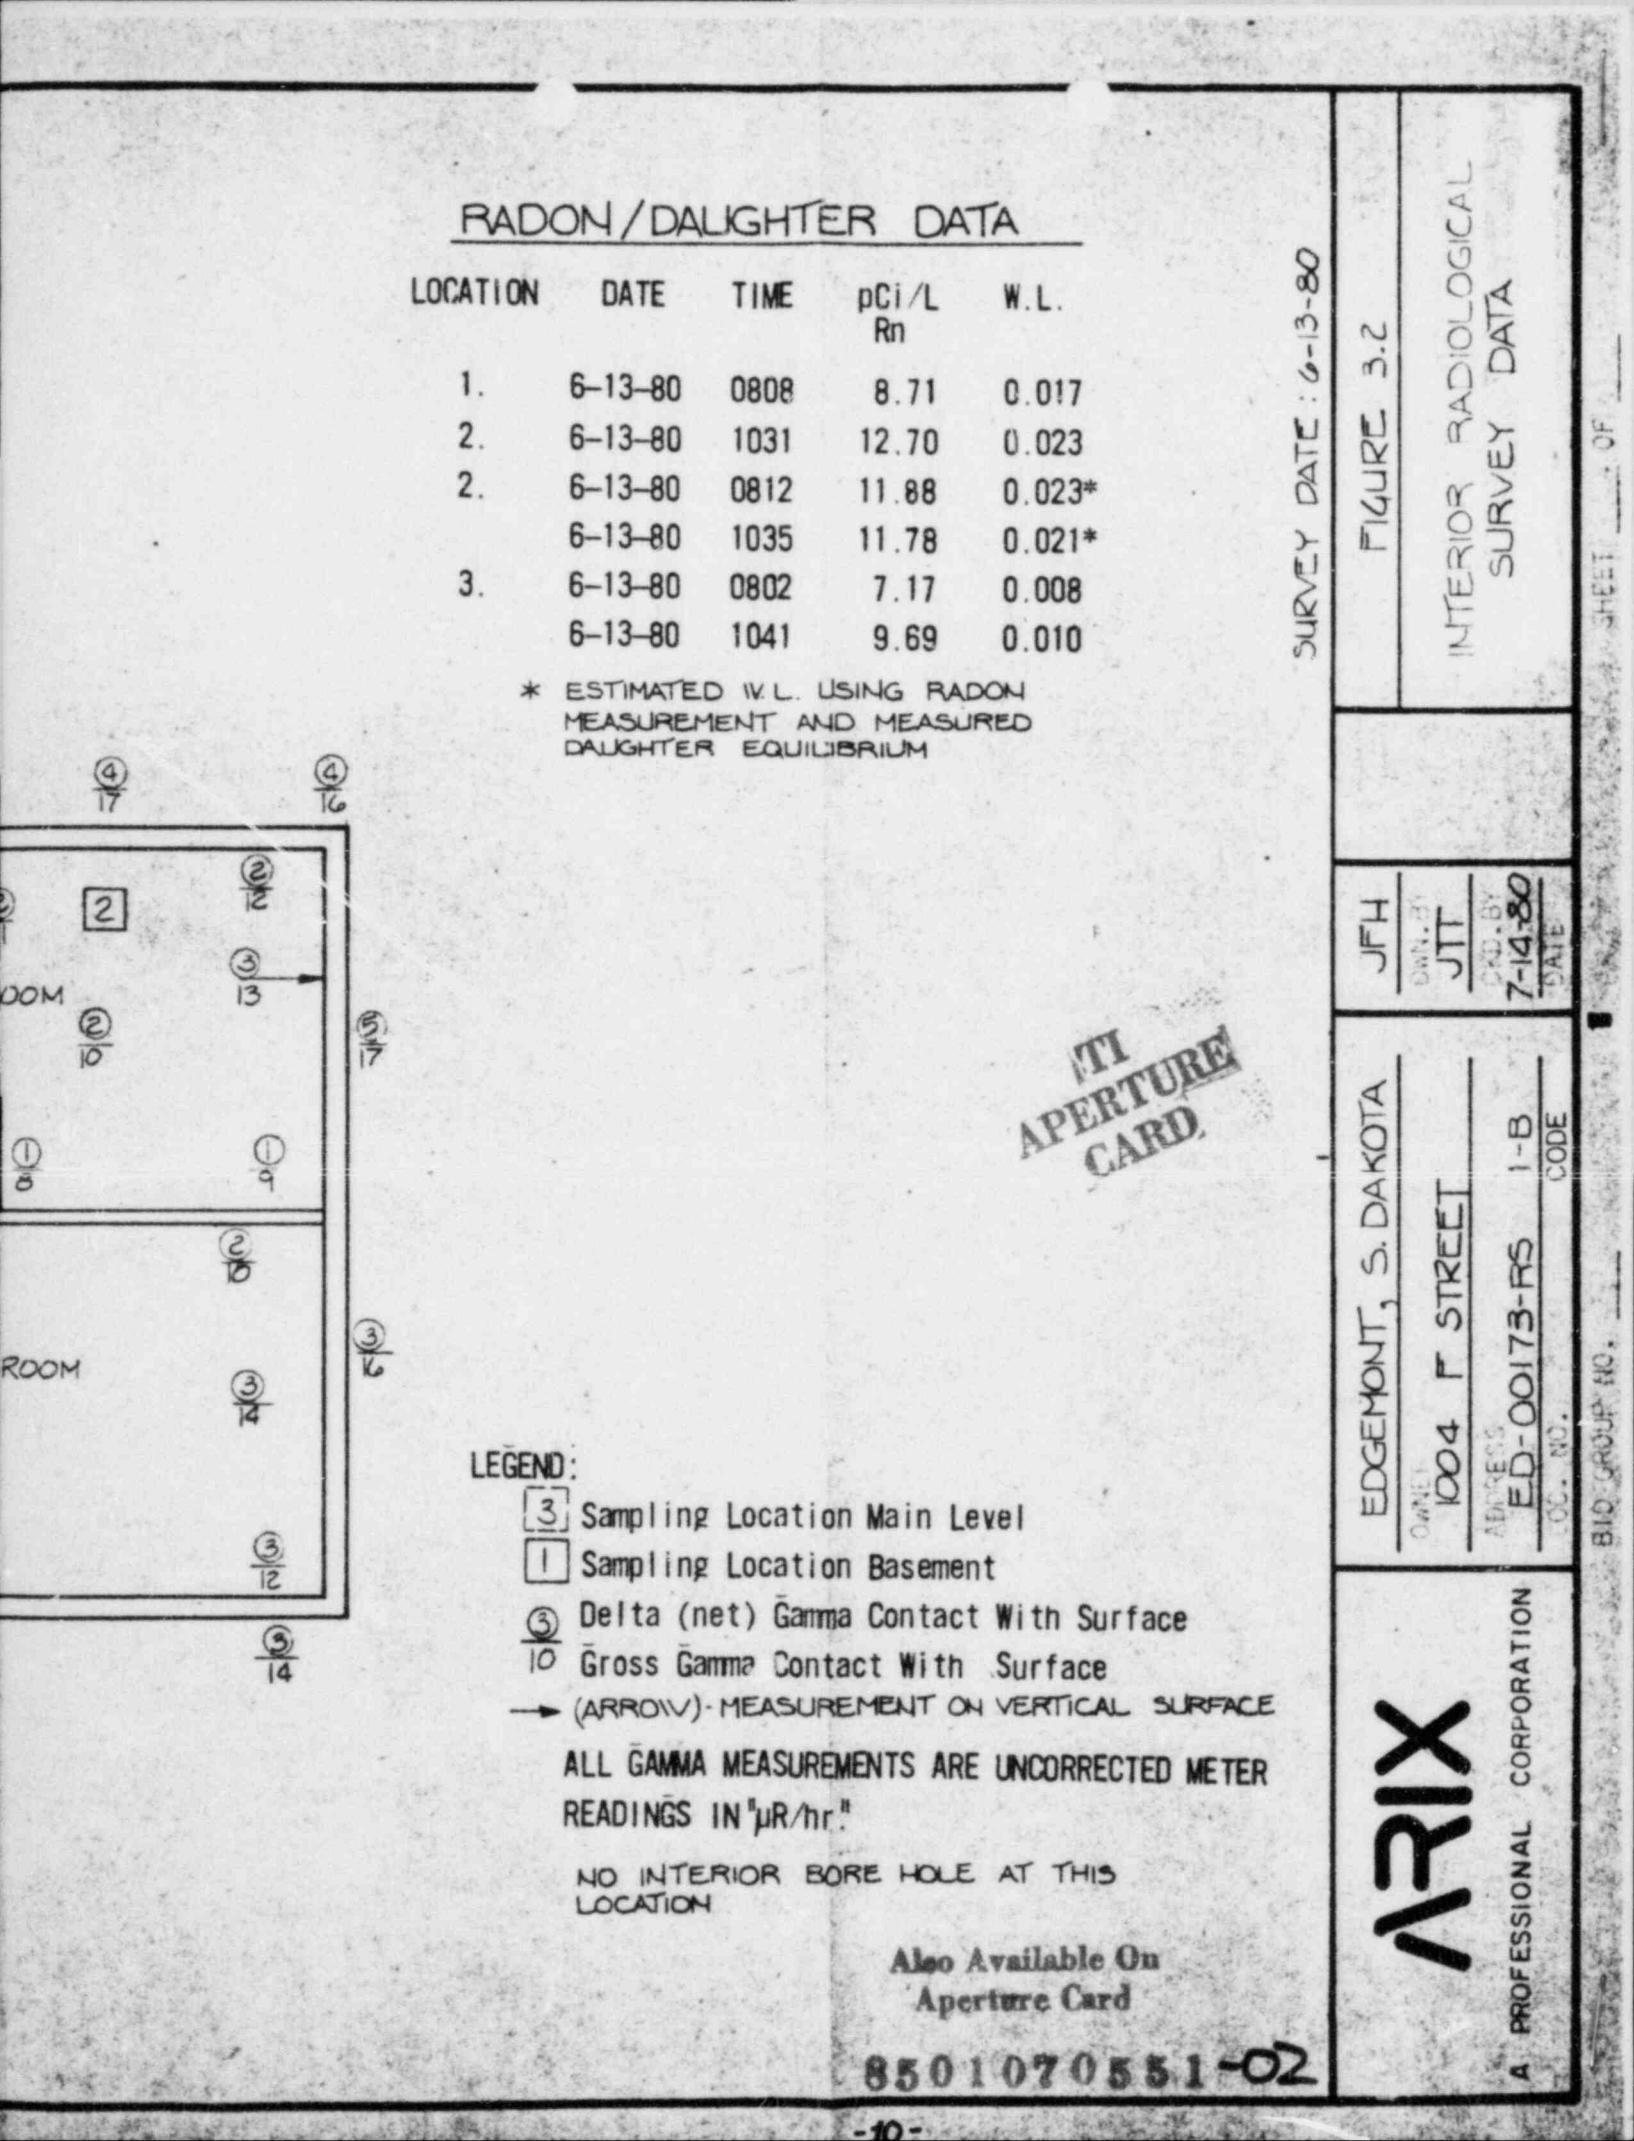
Portable scintillometers (micro-R meters) were used to scan the entire interior surface area. Gross gamma and delta gamma meter readings were recorded in sufficient numbers to characterize each habitable area of the structure that is contiguous to the ground, i.e., basement level, slab-on-grade level and/or crawl space level. Measurements were taken on floor surfaces and the foundation walls to assess tailings locations relative to these structural components. Figure 3.2 shows the results of the interior gamma survey. Data indicate that there are no gamma anomalies within the structure.

Interior gamma measurements were not taken at 3 feet above the surface, hence, exposure rate data is not available. However, the maximum interior gamma measurement (converted to true exposure) observed in contact with floor surfaces is 14 micro-R/hr; this data indicates the structure does not exceed EPA criteria for indoor gamma exposure.
