June 17, 1996

SUBJECT: REVIEW OF PRELIMINARY ACCIDENT SEQUENCE PRECURSOR ANALYSIS OF REACTOR TRIP AT PLANT COMANCHE PEAK STEAM ELECTRIC STATION, UNIT 1 (TAC NO. M72403)

SUBJECT: COMANCHE PEAK STEAM ELECTRIC STATION (CPSES)-UNIT 1 DOCKET NOS. 50-445 AND 50-446 CONDITIONS PROHIBITED BY TECHNICAL SPECIFICATIONS LICENSEE EVENT REPORT 445/95-004-01

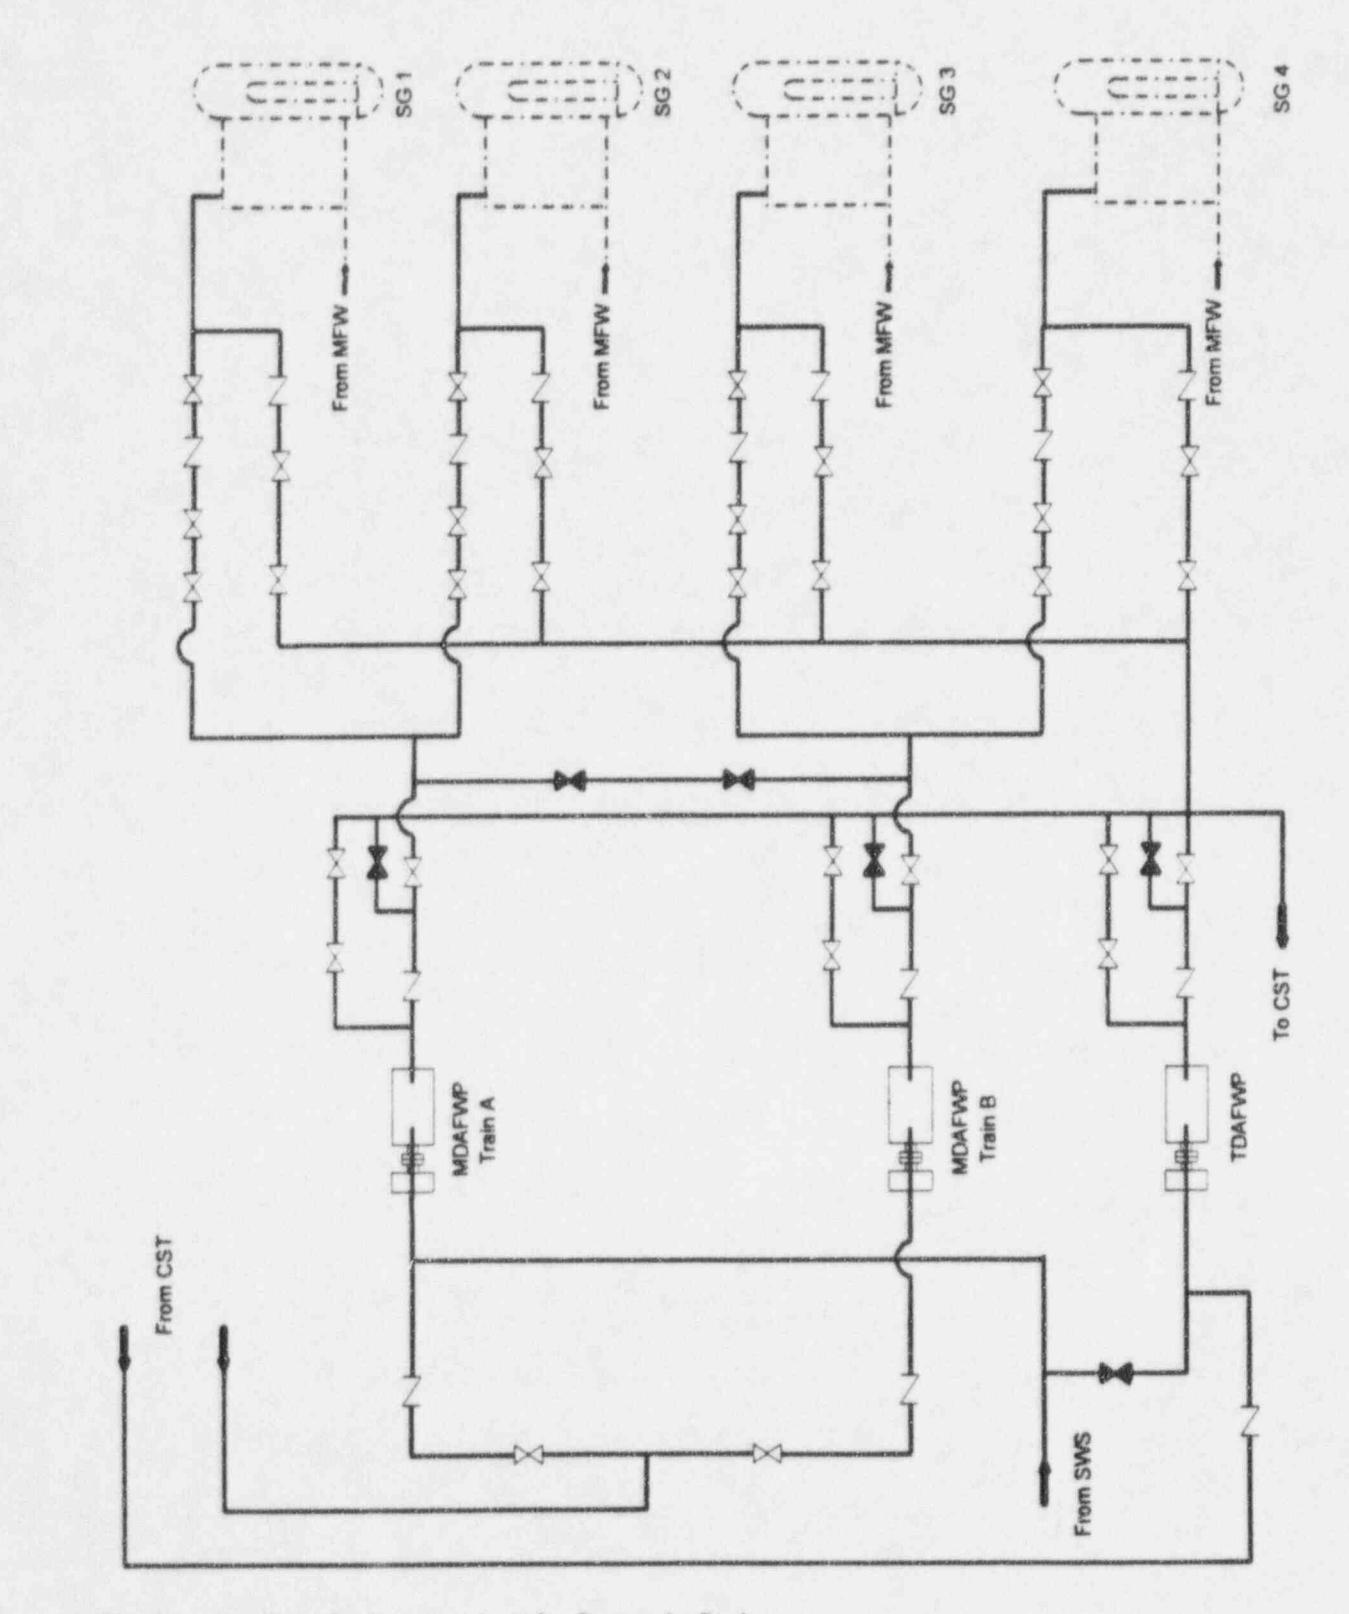
Fig. 1 Auxiliary feedwater system for Comanche Peak.

The MFP trips caused an auto-actuation of the MDAFWPs. MDAFWP 1-02 (Train B) started and supplied water to steam generators (SGs) 3 and 4 (Fig 1). MDAFWP 1-01 (Train A) was aligned to its test header at the time in and was not immediately available to supply water to the SGs. The TDAFWP started on low-low SG level but tripped on overspeed, caused by a failure of the governor valve to control turbine speed. The governor valve stem was found to be corroded and binding against the valve packing. Operators realigned MDAFWP 1-01 from the test header to its normal configuration and the pump supplied cooling to SGs 1 and 2 within about 8 minutes.

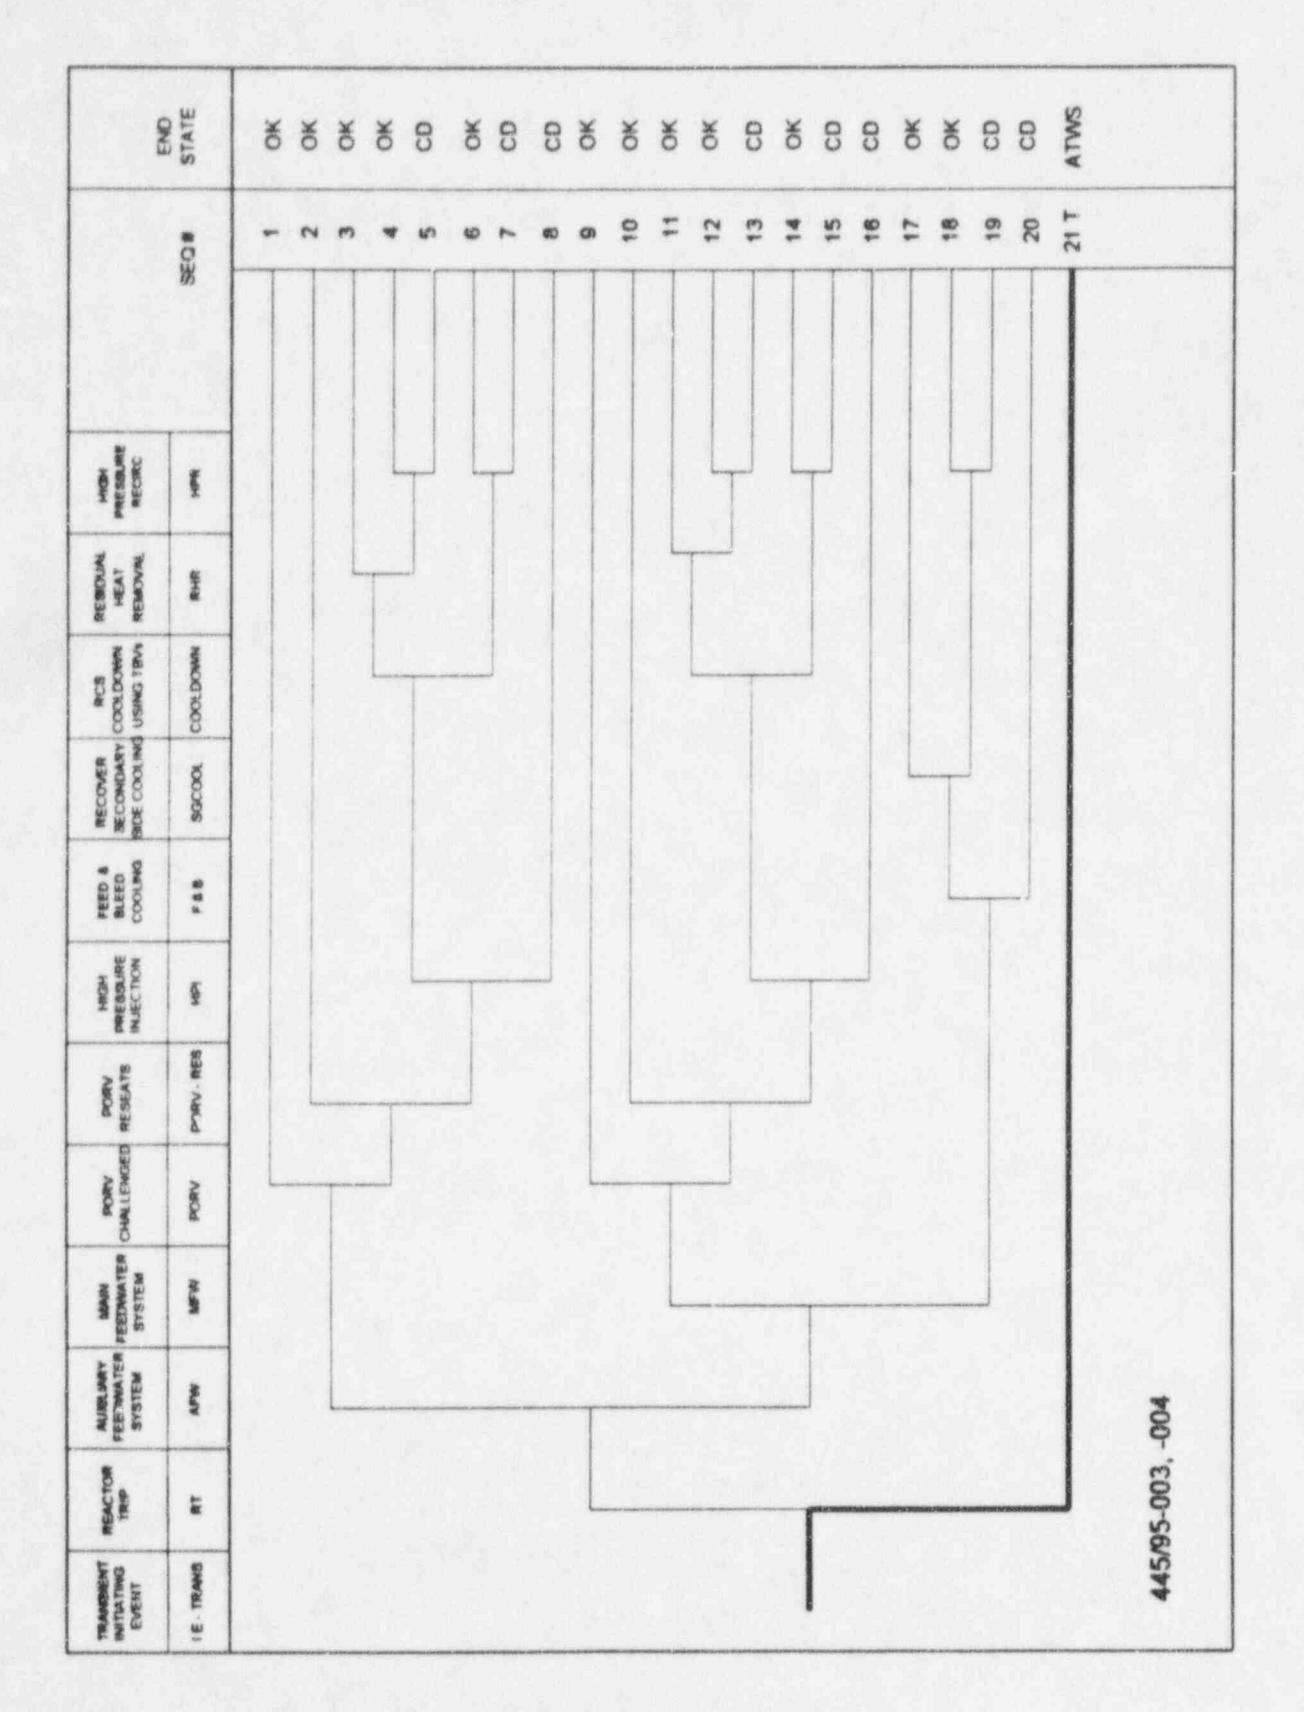
Fig. 2 Dominant core damage sequences for LERs 445/95-003, -004.

The conditional core damage probability (CCDP) estimated for this event is 3.2×10^{-5} . The dominant core damage sequence (sequence 21 on Fig. 2 and sequence 8 on Fig. 3) involves:

- failure to successfully trip,
- successful control of reactor pressure, and
- failure of AFW.

The second highest core damage sequence (sequence 20 on Fig. 2) involves:

- a successful reactor trip,
- failure of AFW
- failure of MFW, and
- · failure of feed-and-bleed cooling.
