NRC Form (9-83)	366				LIC	ENSEE EVE	NT RE	PORT	(LER)	U.S. N	UCLEAR REGULA APTROVED OMB N EXPIRES: 8/31/85	TORY COMMISSION 10. 3150-0104
FACIL TY		1							10	DOCKET NUMBER	1 (2)	PAGE (3)
	Nort	h Dor	tor Ct	ation D	nit 1					0 15 10 10	1012121	1 OF ale
TITLE (4)	MOLL	n PON	ver st	ation, U	ing Nat	tait the second	* 1			0 10 10 10	1-13 13 13	81.1010.14
	MOV	Torqu	le Ski	ton Sett	ing Not	Within Th	e Lim:	its Sp	pecified			
	BYT	ne No	orth A	nna Setp	oint Doc	cument	e (2)				WED (A)	
	an barre		ISEQUENTIA	- Insumo	HEPORT DATE (7)		CITHER PACILITIES INV			DOCKET NUMBER(S)		
MONTH	DAY	YEAR	YEAR	NUMBER	NUMBER	MONTH DAY	YEAR		PAGICITY HAR		DOCKET HOME

NAC Form 366A 19-83)	LICENSEE EVENT	U.S. 1	U.S. NUCLEAR REGULATORY COMMISSION APPROVED OMB NO. 3150-0104 EXPIRES: 8/31/85					
SILITY NAME (1)		DOCKET NUMBER (2)	LER NUMBER (6)				PAGE	
			YEAR		NUMBER	REVISION		TT
North Anna	Power Station	0 15 10 10 10 1 312 18	3 8 4	_	0   1   0	- 01 1	0 2	OF 0

Report No. LER 84-010-01

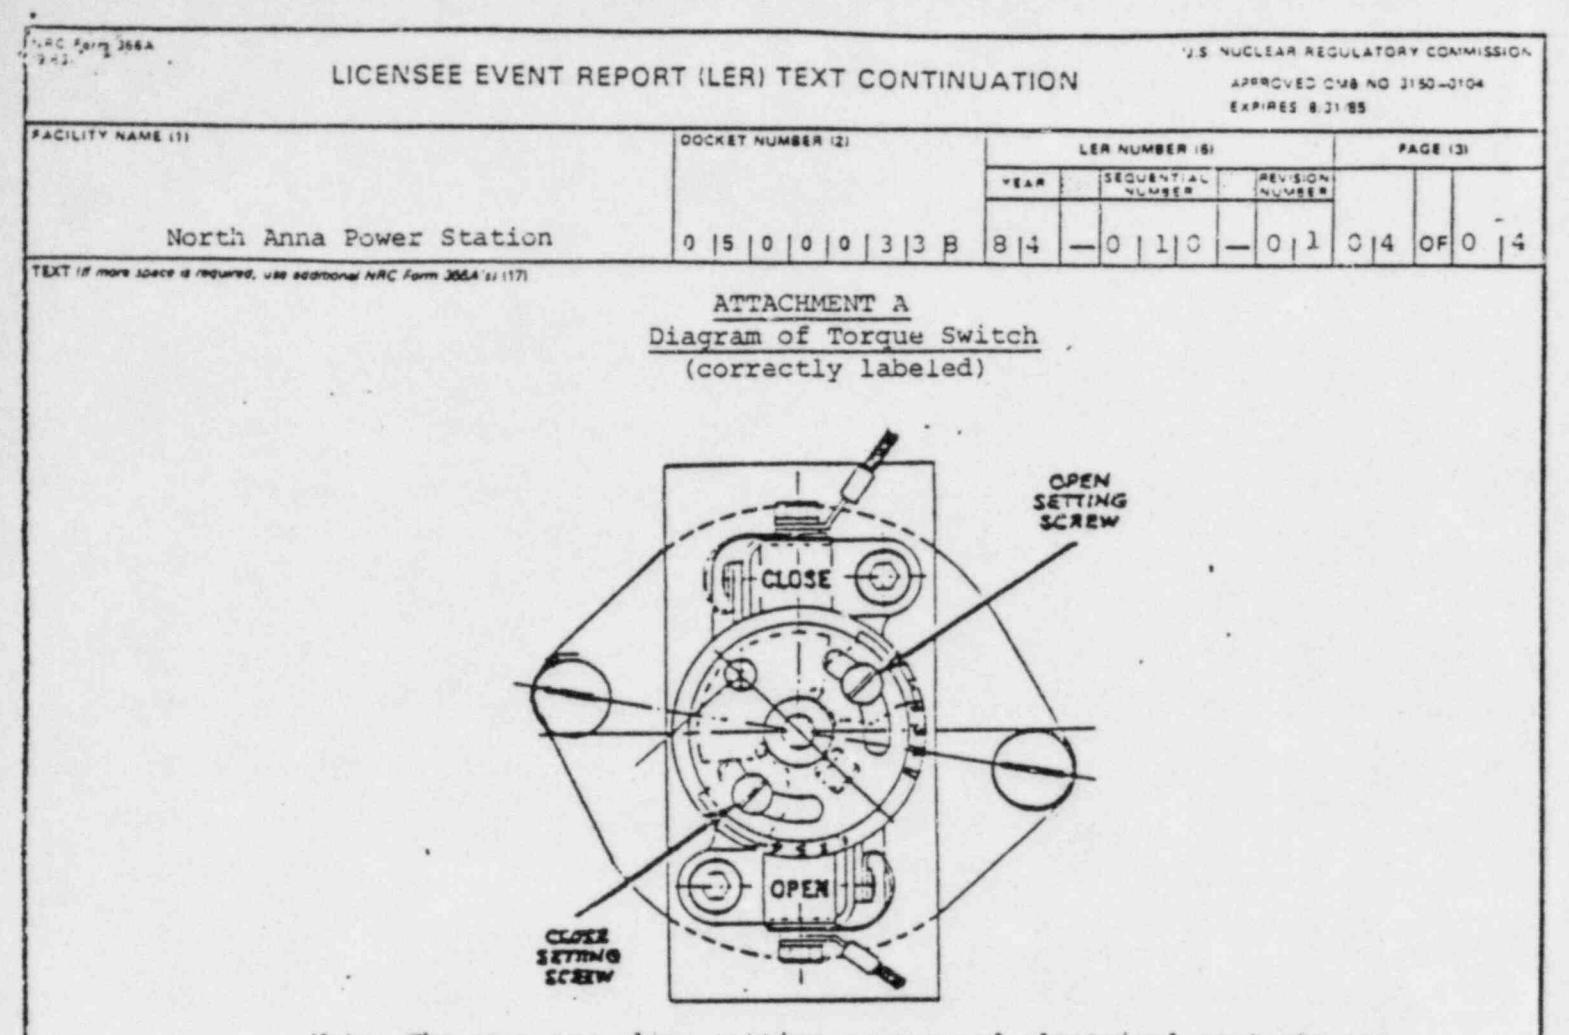
Confusion when adjusting torque switch settings for Limitorque type SMB-000 and SMB-00 MOV actuators was caused by the design of torque switch. The open and close torque switch settings are adjusted by moving screws located on a plate which is attached to the torque switch. Confusion in adjusting torque switch settings is caused by the fact the "open" electrical contacts are located near the screw used to adjust the close setting of the torque switch and the "close" electrical contacts are located near the screw used to adjust the open setting of the torque switch (See Attachment A).

Note: The open and close setting screws and electrical contacts are clearly labeled. The close torque switch setting reads increasing numbers clockwise and the open torque switch setting reads increasing numbers counterclockwise.

New maintenance procedures approved on July 26, 1984 and August 31, 1984 contained misleading torque switch diagrams which also contributed to this event (See Attachment A). An electrician using these procedures would transpose the desired open and close torque switch settings. These procedures have been revised to include a clearly labeled diagram of a torque switch. The procedure used to adjust torque switch settings prior to July 26, 1984 contained a clearly labeled correct torque switch diagram. The North Anna Nuclear Training Department has instructed electricians of the potential for confusion when adjusting torque switch settings and informed electricians that applicable procedures have been revised to include a clearly labeled diagram of a torque switch.

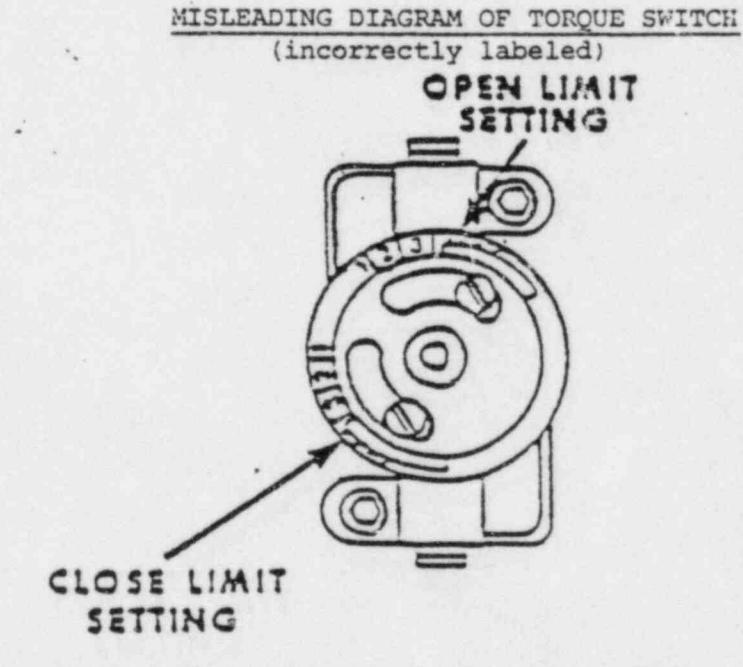
The misleading torque switch diagrams were based on a diagram contained in INPO report 83-037, assessment of Motor Operated Valve Failure. This problem has been brought to the attention of INPO. INPO has drafted an Operations and Maintenance Reminder to inform its members of this problem.

Note: The open and close electrical contacts are not labeled and the open and close torque switch settings are mislabeled. The close torque switch setting should read increasing numbers clockwise and the open torque switch setting should read increasing numbers counterclockwise.
