SUBJECT: IE INFORMATION NOTICE 83-76: REACTOR TRIP BREAKER MALFUNCTIONS (UNDERVOLTAGE TRIP DEVICES ON GE TYPE AK-2-25 BREAKERS)

> Subject: LaSalle County Station Unit 1 Request for Expedited Change to NPF-11 Appendix A Technical Specifications Regarding Reactor Feedwater Inboard Check Valves Type C Test NRC Docket No. 50-373

### CHANGE REQUEST NPF-11/83-05

#### TECHNICAL SPECIFICATION CHANGE REQUEST

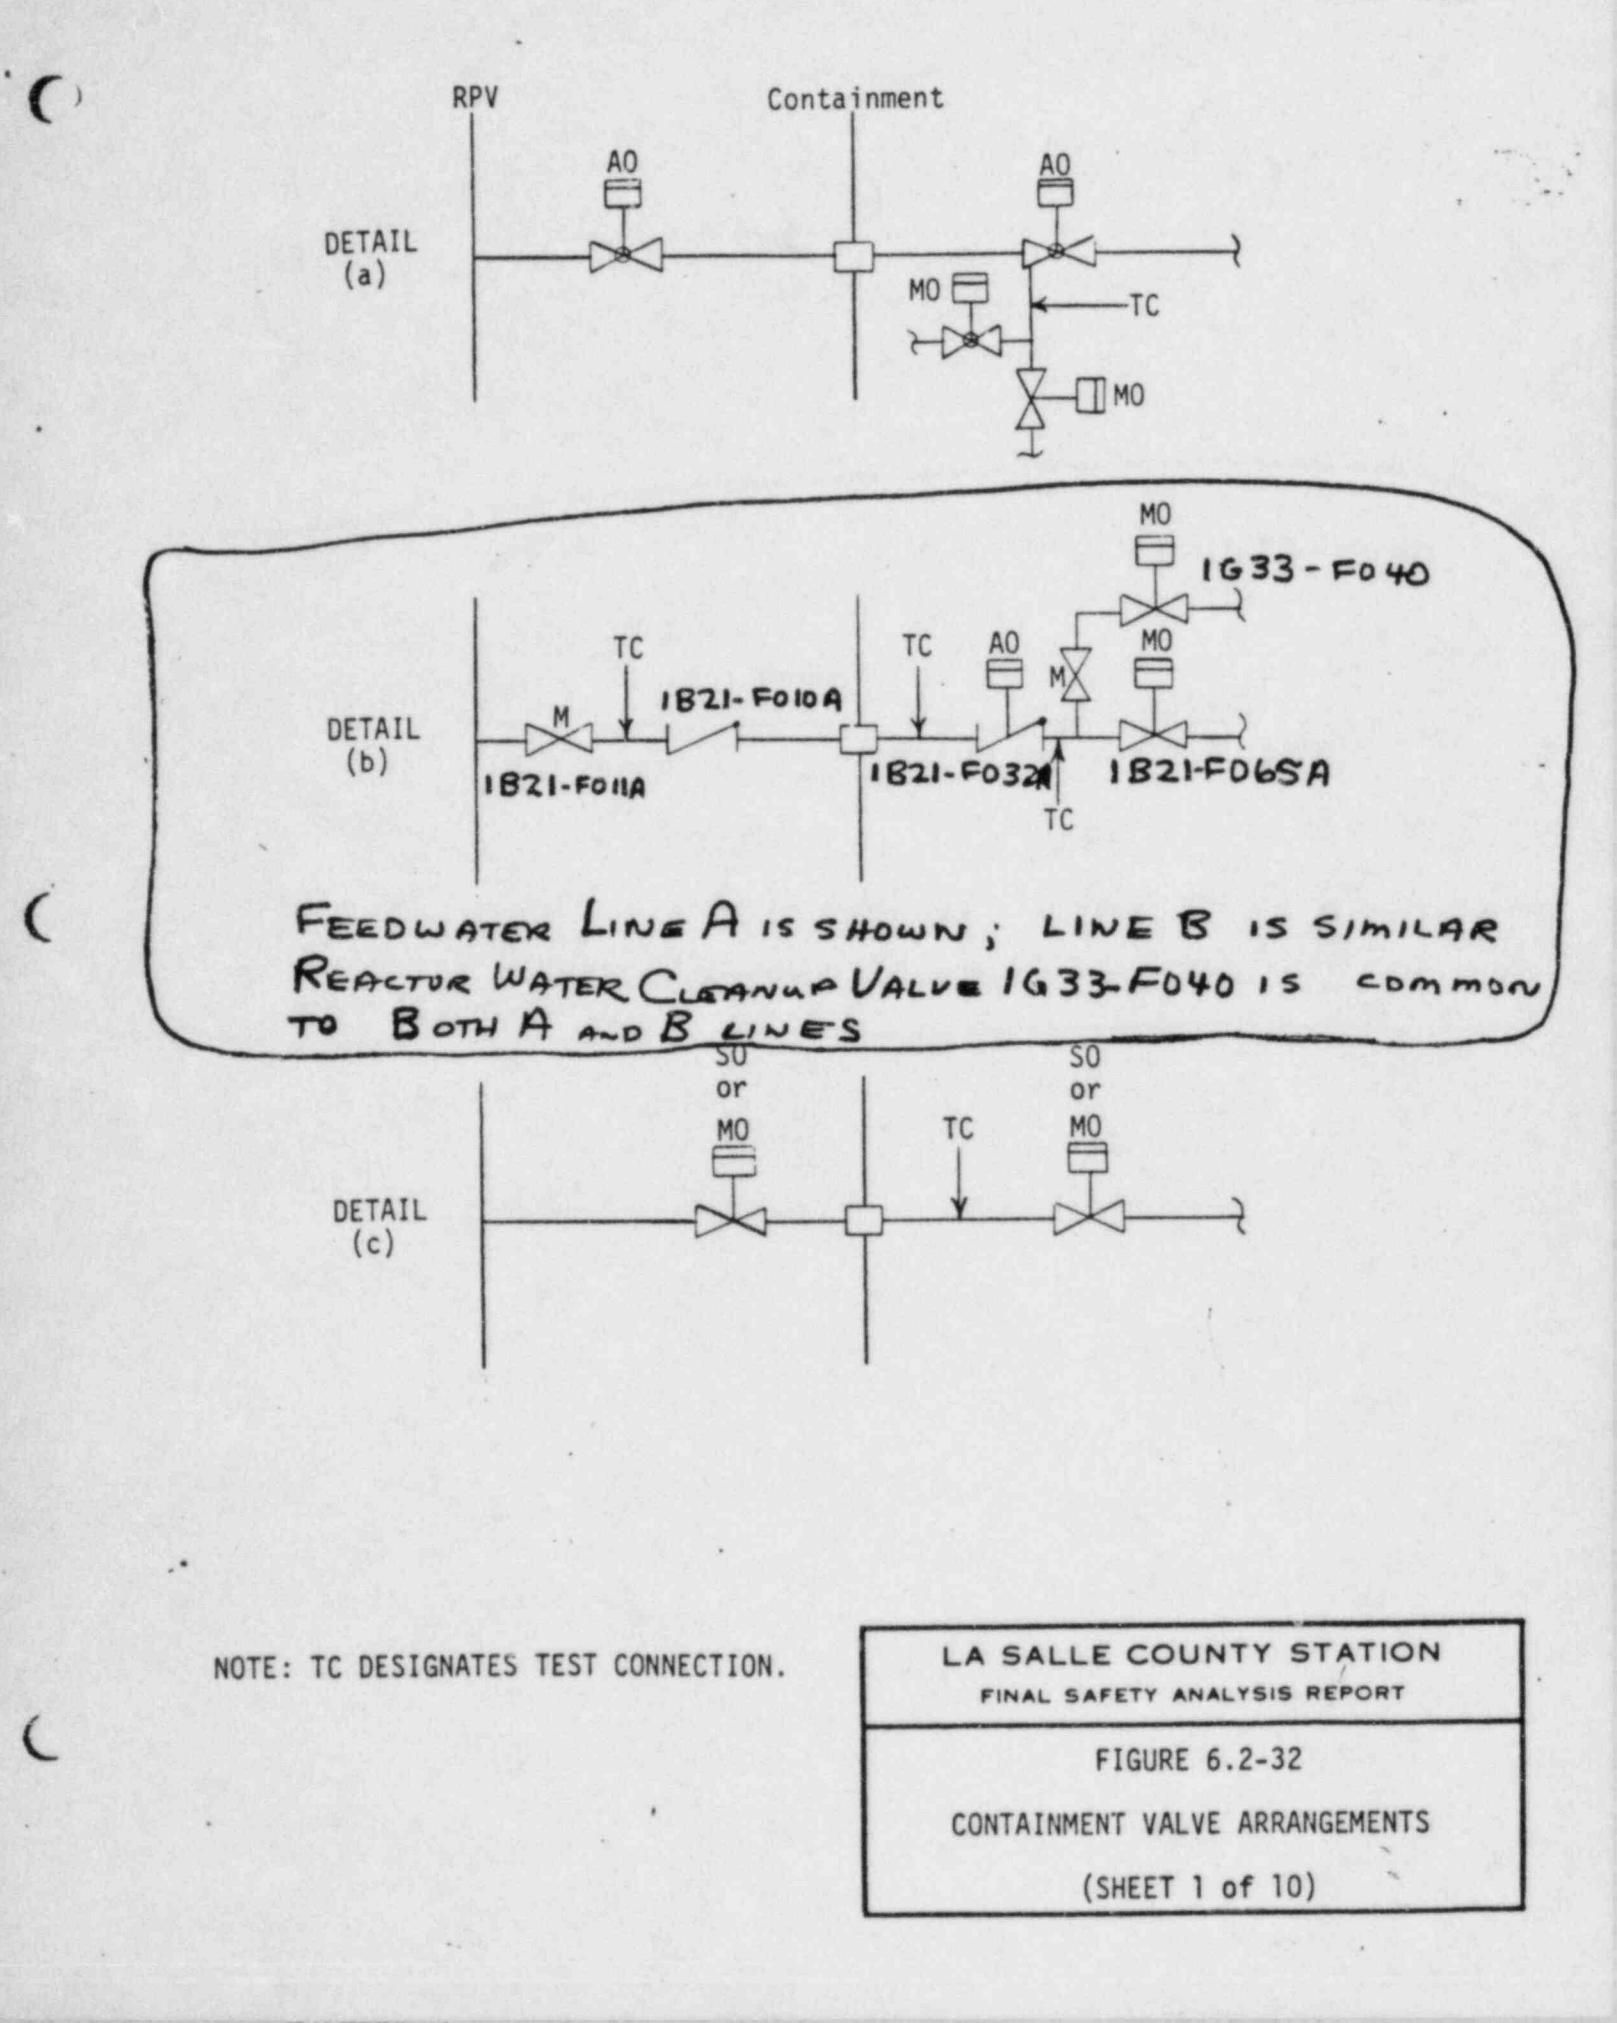
LaSalle County Station has a reactor feedwater system primary containment valve arrangement with three (3) valves per feedwater line as shown on FSAR Figure 6.2-32 Detail (b) (see attached). Each line has two (2) check valves and a motor operated gate valve. This arrangement meets the intent of General Design Criterion 55 on "the other defined basis criteria". During the postulated loss of coolant accident, it is desirable to maintain reactor coolant makeup from all sources of supply. This design preserves the reliable coolant makeup to the reactor vessel from the normal source when required and prevents inadvertent isolation of the feedwater lines. When the plant was originally designed, Commonwealth Edison believed that only two isolation valves were required on these lines per prior NRC interpretations of GDC 55 regarding feedwater make-up requirements dominating the isolation requirement.
