NRC FORM 366

LICENSEE EVENT REPORT EXHIBIT A CONTROL BLOCK IPLEASE PRINT OR TYPE ALL REQUIRED INFORMATIONI $\left(\cdot \right)$ ANO 10 101010 1110 THO: 10 0051 011 100 80 017 2 14 17 19 10 18 11 4 17 10 10.021 As a result of investigation of baseplate flexibility per IE Bulletin 1 79-02, seven restraints have been identified as having a safety factor of <2. The hangers are: 2 GCB-5-H24, LPSI Suction; 2 HBC-35-H1, Service</p> Water Loop 1; 2 HCB-2-H4, A&C Charging pump suction header; 2 HCB-34-H7, Service Water Loop 2; 2 HCB-13-H7, Bldg. Spray Loop 2; 2 HCB-241-H6, Penetration room ventilation; 2 Fcc-1-H17, Par relief. No similar Reportable per T.S.6.9.1.9(b). occurrences. IPI0 1.1.4 CIM LSIU IR 0 0 10,0 0 N NO CORRECTIVE ACTIONS (7) The systems involved, and related Tech Specs are: Pressurizer Relief, T.S. 3.4.2; Service Water, T.S.3.7.3.1; Building Spray, T.S.3.6.2.1; Low Pressure Safety Injection, T.S.3.5.2; Charging System, T.S. 3.1.2.4 Requirements of applicable Action Statements were met. See also, Attachment (h Power Escal IE Bulletin'79-02 0150 lesting 100 1 100 DF HE. ERIC (36) NA NA NA (11) 1.04(41) NA 010 (40) DESCRIPTION 1144 (45) NAVE LAST TALLY LILIIIII Chris N. Shiv

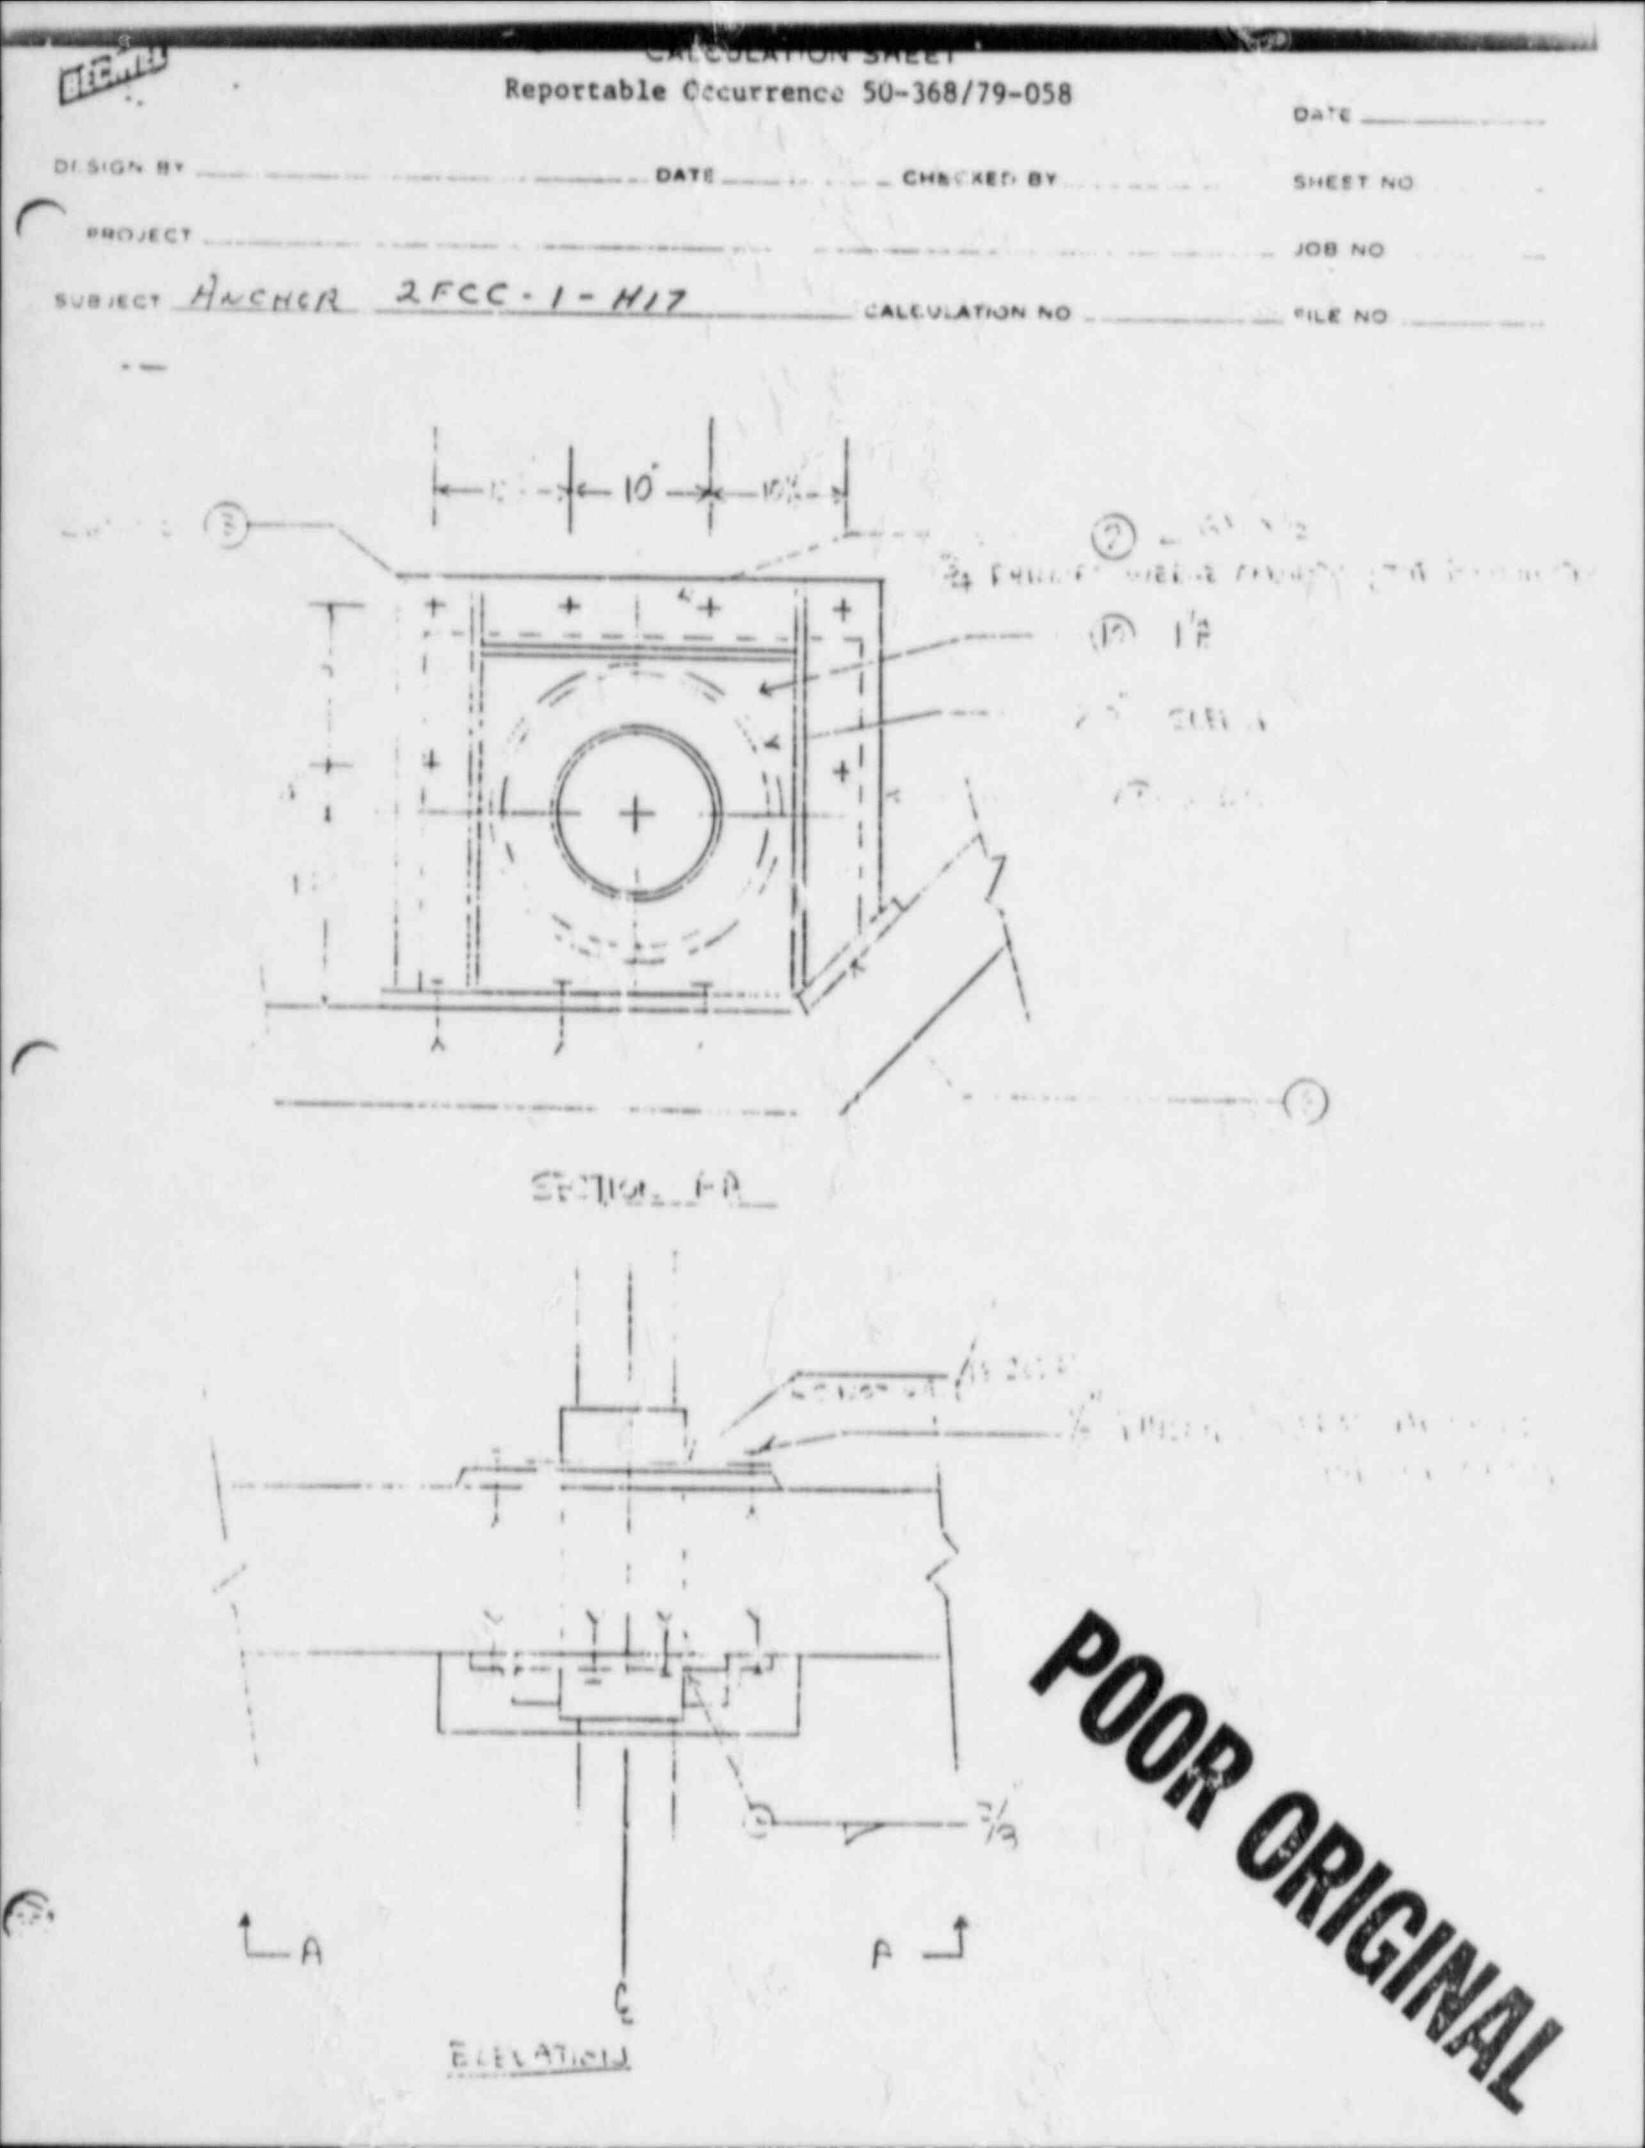
ATTACHMENT A

The forces and moments are transmitted by the pipe to the slab through the 1" plate (Item 10) to the 6" angles (Items 2, 3, 4) and the $\frac{1}{2}$ " plate (Item 6) and to the bolts. The loads and moments are transferred to the bolts through the weld connection item 10 to items 2, 3, 4, 6.

Per this method, the loads on the weld connecting item 10 to items 2, 3, 4, 6 are determined by calculating the weld force/unit length along the outer edges of item 10. The loads are transmitted along the edge in pullout and shear per unit length. The bolt loads are determined based upon a contributary length approach; i.e. it is assumed that any bolt takes half the force on total length between adjacent bolts.

In the revised method, the force on the weld connecting item 10 to 2, 3, 4, 6 are determined in the same way. However, the total force in pullout and shear is distributed evenly between the bolts depending on whether they are loaded in shear or pullout.

- 1 The size of the item 10 is small (23" x 20") and it is welded all around making the uniform load distribution assumption reasonable.
- 21 The support structure (in conjunction with the pipe welded to it) becomes fairly rigid and the load is assumed to be uniformly transferred.

This approach would probably give a more reasonable approximation to the bolt loads.
