SUBJECT : WATERFORD 3 BASE MAT

EVALUATION OF WATERFORD 3 BASE MAT

SUBJECT: WATERFORD 3 BASEMAT EVALUATION

WATERFORD 3 BASEMAT EVALUATION STRUCTURAL & GEOTECHNICAL ENGINEERING BRANCH DIVISION OF ENGINEERING

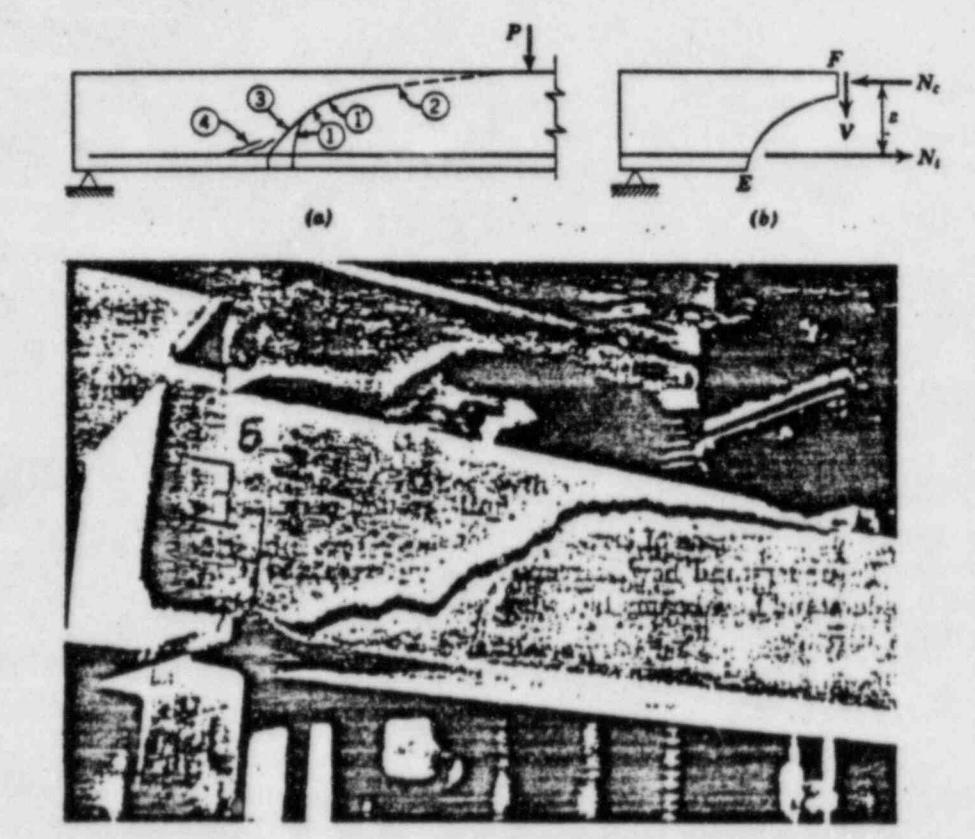
FIGURE 5.2 Development of a diagonal tension crack when loads and reactions are far apart. (a) Diagram'showing sequence in crack formation. (b) Equilbrium sketch for portion of beam. (c) Failure of beam. The failure crack developed from the flexural crack faintly seen about one beam depth from the end. This crack turned gradually into the diagonal crack, as at 1 in the sketch. The final wide crack is comparable to 2-1-3-4 in (a) (The failure picture has been inverted to make this comparison easier).
