UNITED STATES NUCLEAR REGULATORY COMMISSION REGION II 101 MARIETTA STREET, N.W. ATLANTA, GEORGIA 30323

Report No.: 50-413/85-28	
Licensee: Duke Power Company 422 South Church Street Charlotte, NC 28242	
Docket No.: 50-413 License No.: NPF-35	
Facility Name: Catawba Unit 1	
Inspection Conducted: June 24 - 28, 1985	
Inspector: P. T. Burnett	Date Signed
A d by: F. Jape, Section Chief Engineering Branch Division of Reactor Safety	?/10/85 Date Signed

SUMMARY

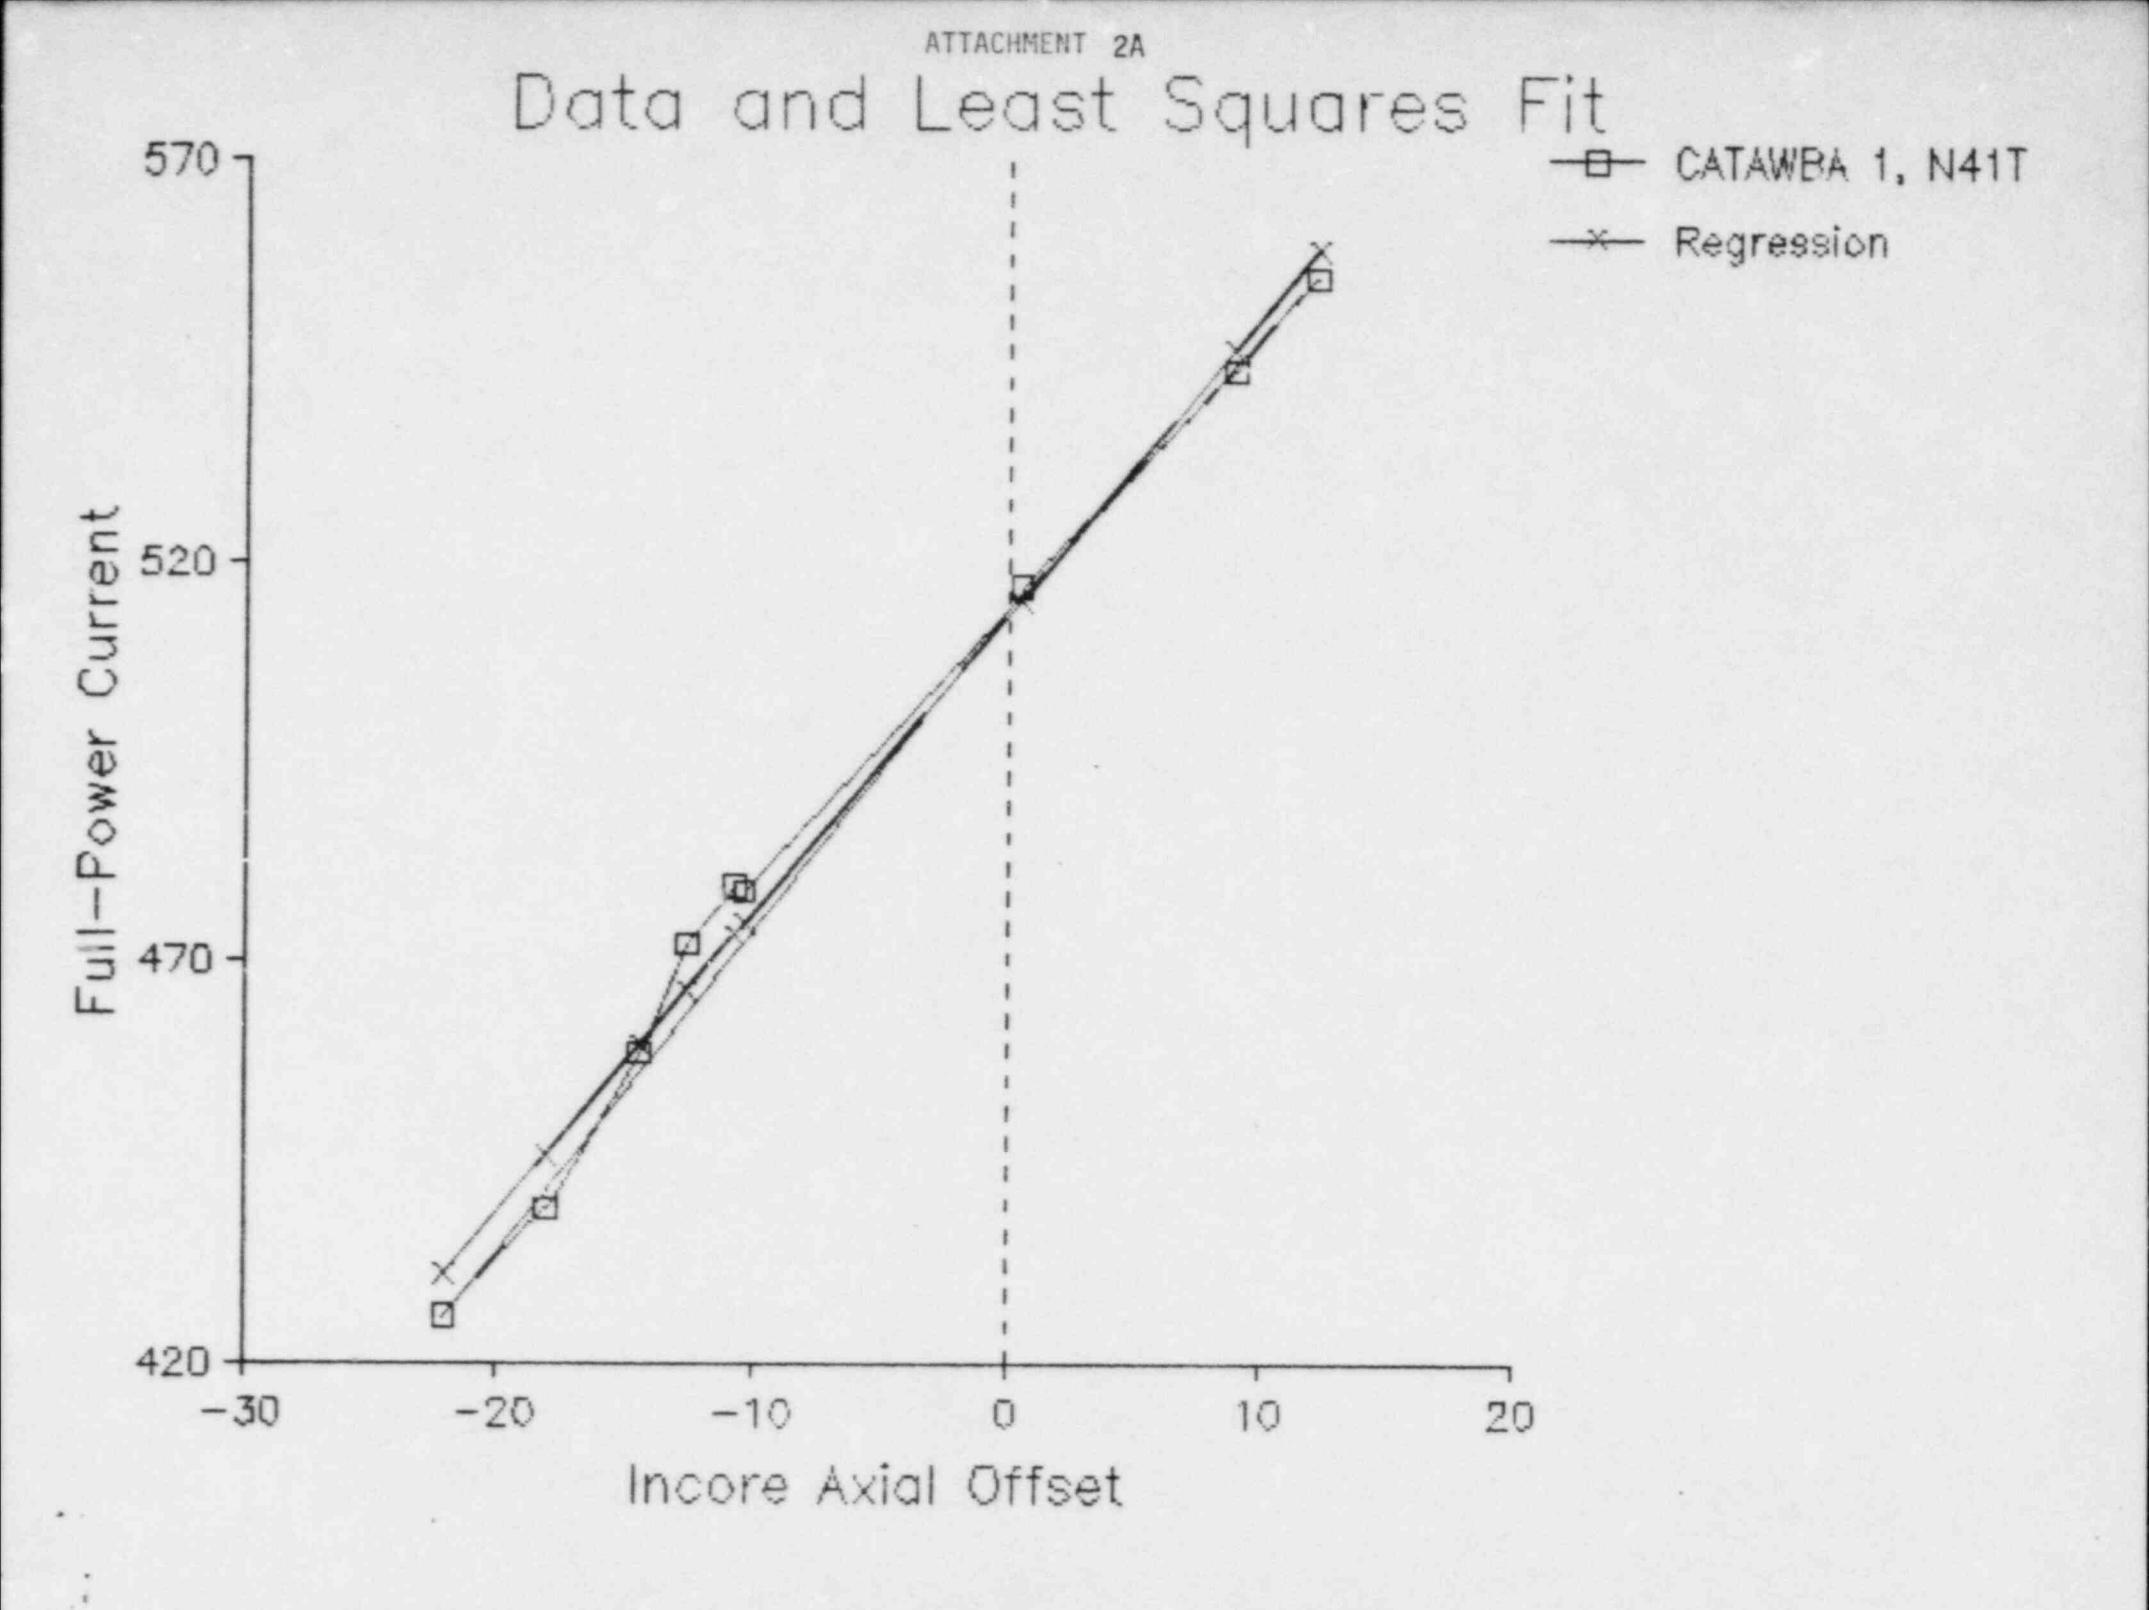
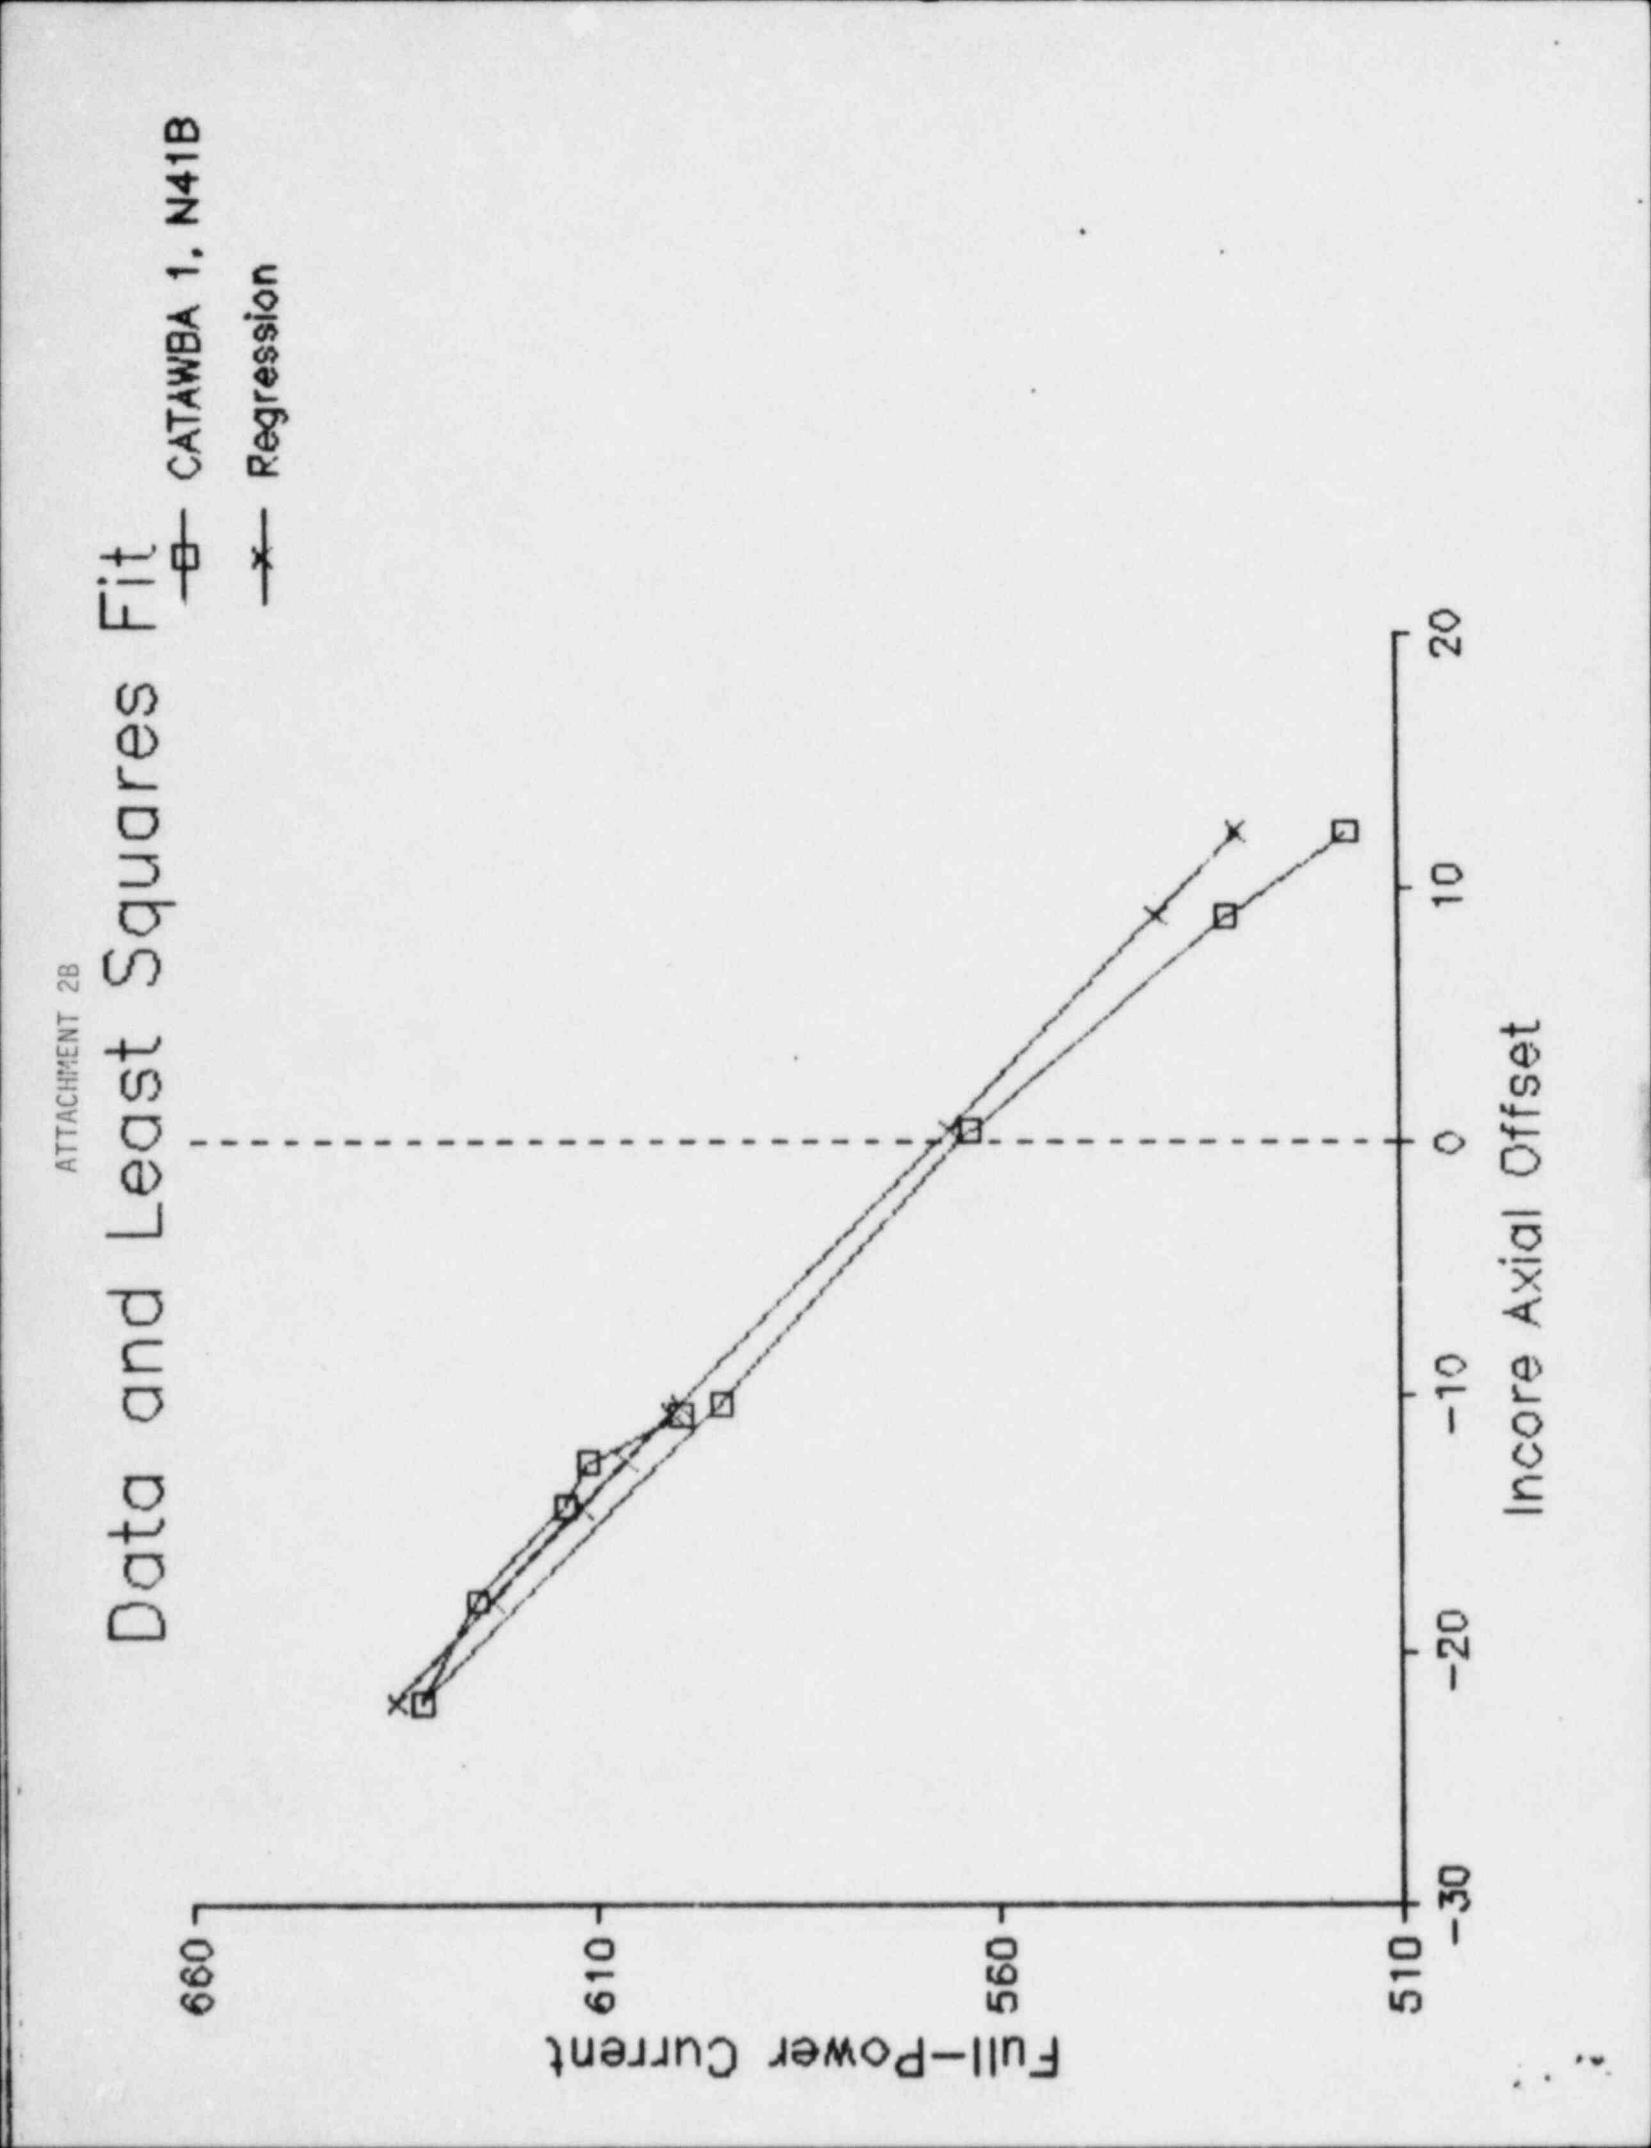
The inspector chose to investigate the quality of fit for a representative detector, N41, using the SUPERCALC 3 (Release 2) program and a least squares spreadsheet provided with that program. The results are shown in tabular and graphic form in Attachment 2. The quality of fit is acceptable for the application.
