Oyster Creek Core Spray System Inspection Program - 16R

Topical Report No. TR-110 Project No. 328382

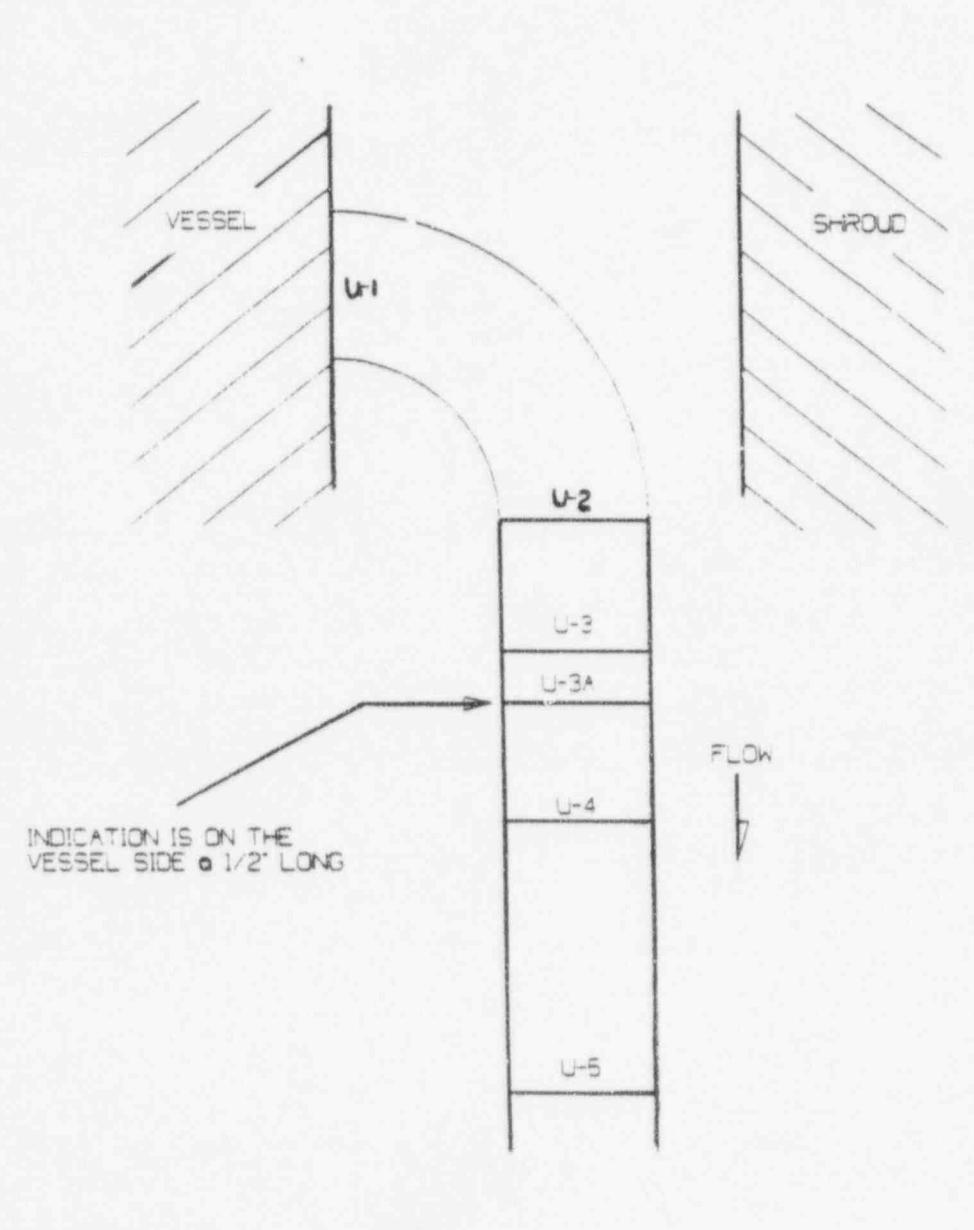
CORE SPRAY PIPING WELD LD S INDICATION AT WELD U-3A

- Two linear indications originally observed during outage 14R in the annulus piping in system II, weld U-3A appear to be a weld past between 2 beads, as determine after cleaning. No changes and no air bubbles were observed emanating from this location during the air test.

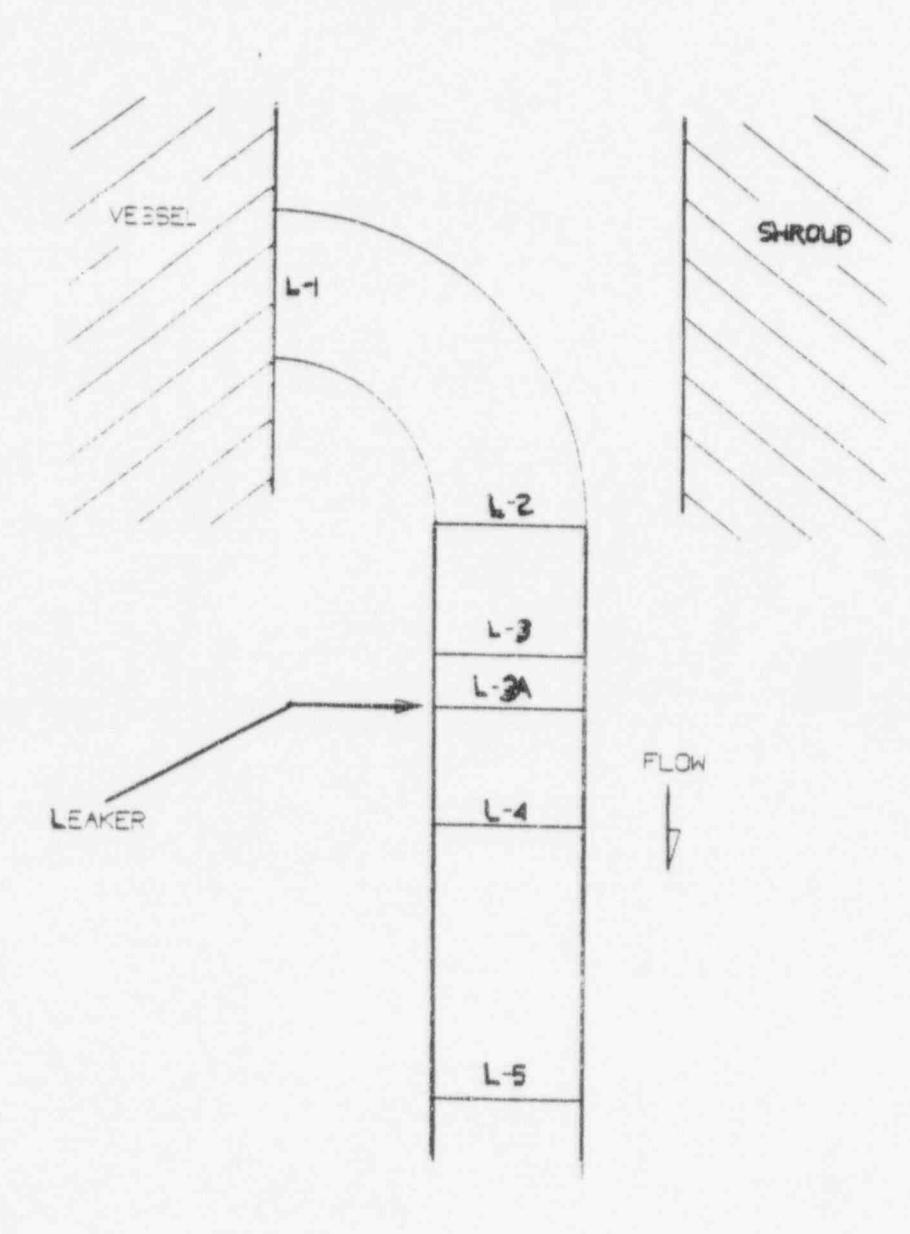
CORE SPRAY PIPING WELD ID'S

- One rounded, through wall, indication was observed in the toe of weld designated as L-3A. This weld is in System I of the annulus piping. Visual examination during 16R and previous air test during 15R revealed no change in this indication since it discovery in 14R. This indication was determined to be a fabrication flaw.
