UNITED STATES NUCLEAR REGULATORY COMMISSION REGION II 101 MARIETTA STREET, N.W. ATLANTA, GEORGIA 30323

Report No.: 50-269/91-08, 50-270/91-08, and 50-287/91-08 Licensee: Duke Power Company Docket No.: 50-269, 50-270, 50-287 License No.: DPR-38, DPR-47, DPR-55 Facility Name: Oconee Nuclear Station Units 1, 2, and 3 Inspection Conducted: March 12-15, 1991 Team Members: C. Goodman, Senior Human Factors Specialist, NRR B. Kaufer, AEOD/ROAB G. Lanik, AEOD/ROAB L. Mellen, Reactor Inspector, RII F. Wright, Radiation Specialist, RII Accompanying Personnel: D. Gertman, Idaho National Engineering Laboratory (INEL) O. Meyer, INEL Team Leader: G. Belisle, Chief Dáte

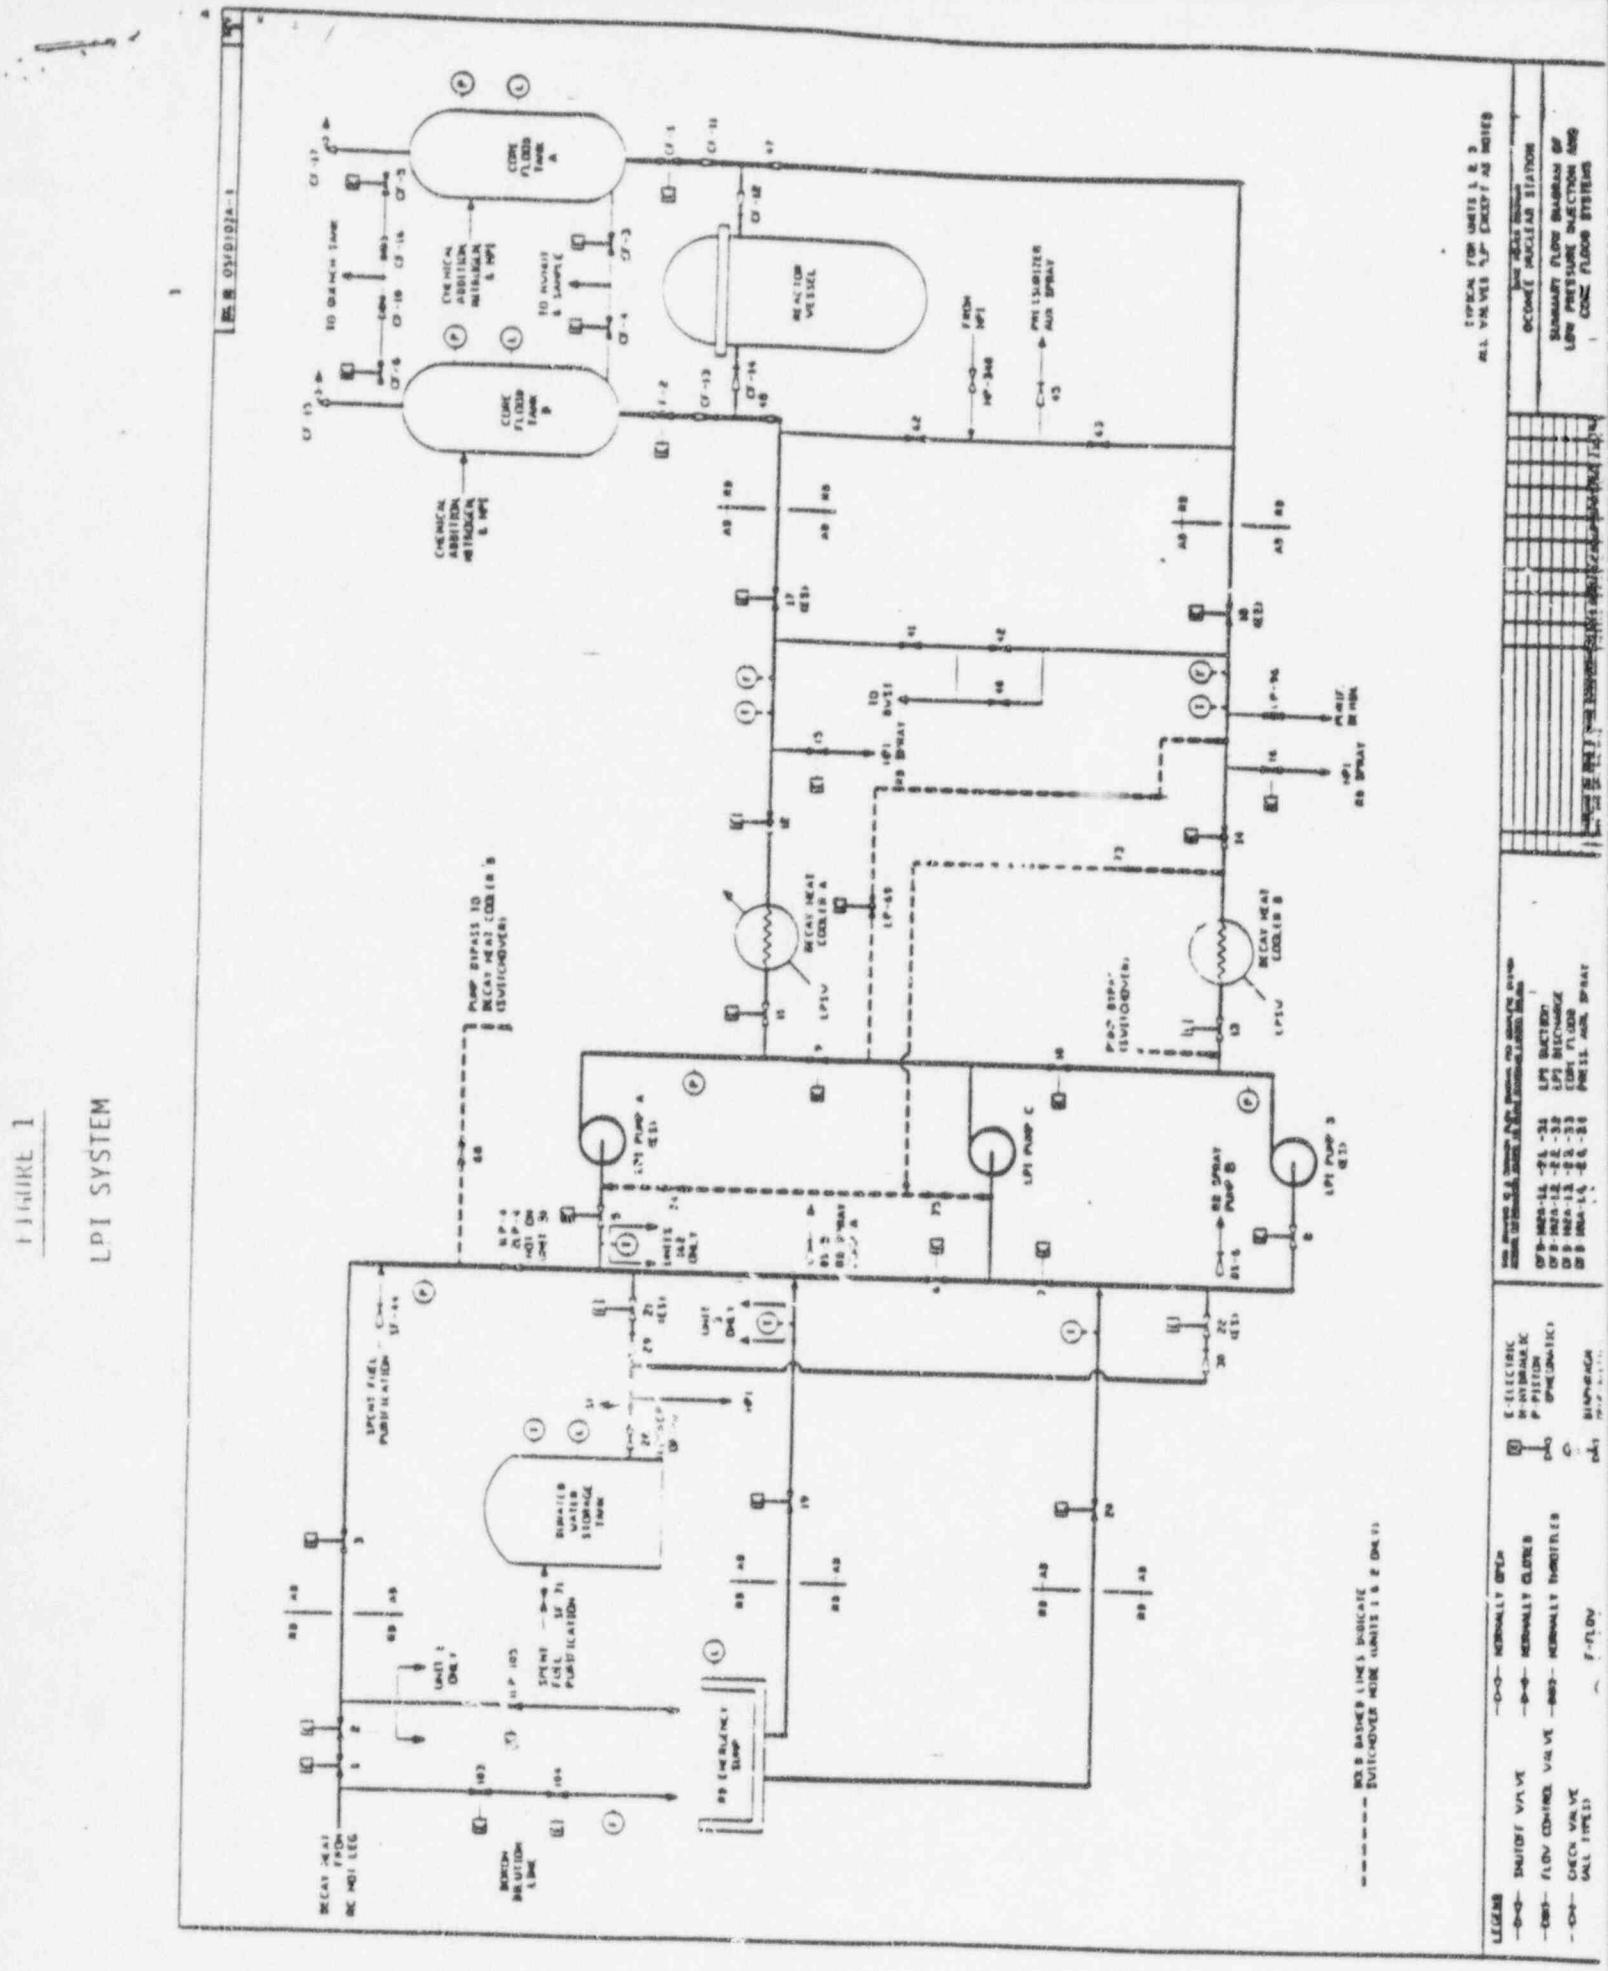
F FIGURE 1

The unit was in day 24 of a refueling outage. The fuel had been reloaded into the core and the transfer canal had been drained. Preparations were being made to lower the reactor vessel level to 64 inches for installing the upper core internals. Primary system temperature was 94 degrees as indicated on the LPI pump suction. Reactor vessel level was at 76 inches as read on LT-5, reactor vessel level instrument. The 3A LPI pump was in operation in the DHR mode. The 3C pump and train B were available at the time (See Figure 1).

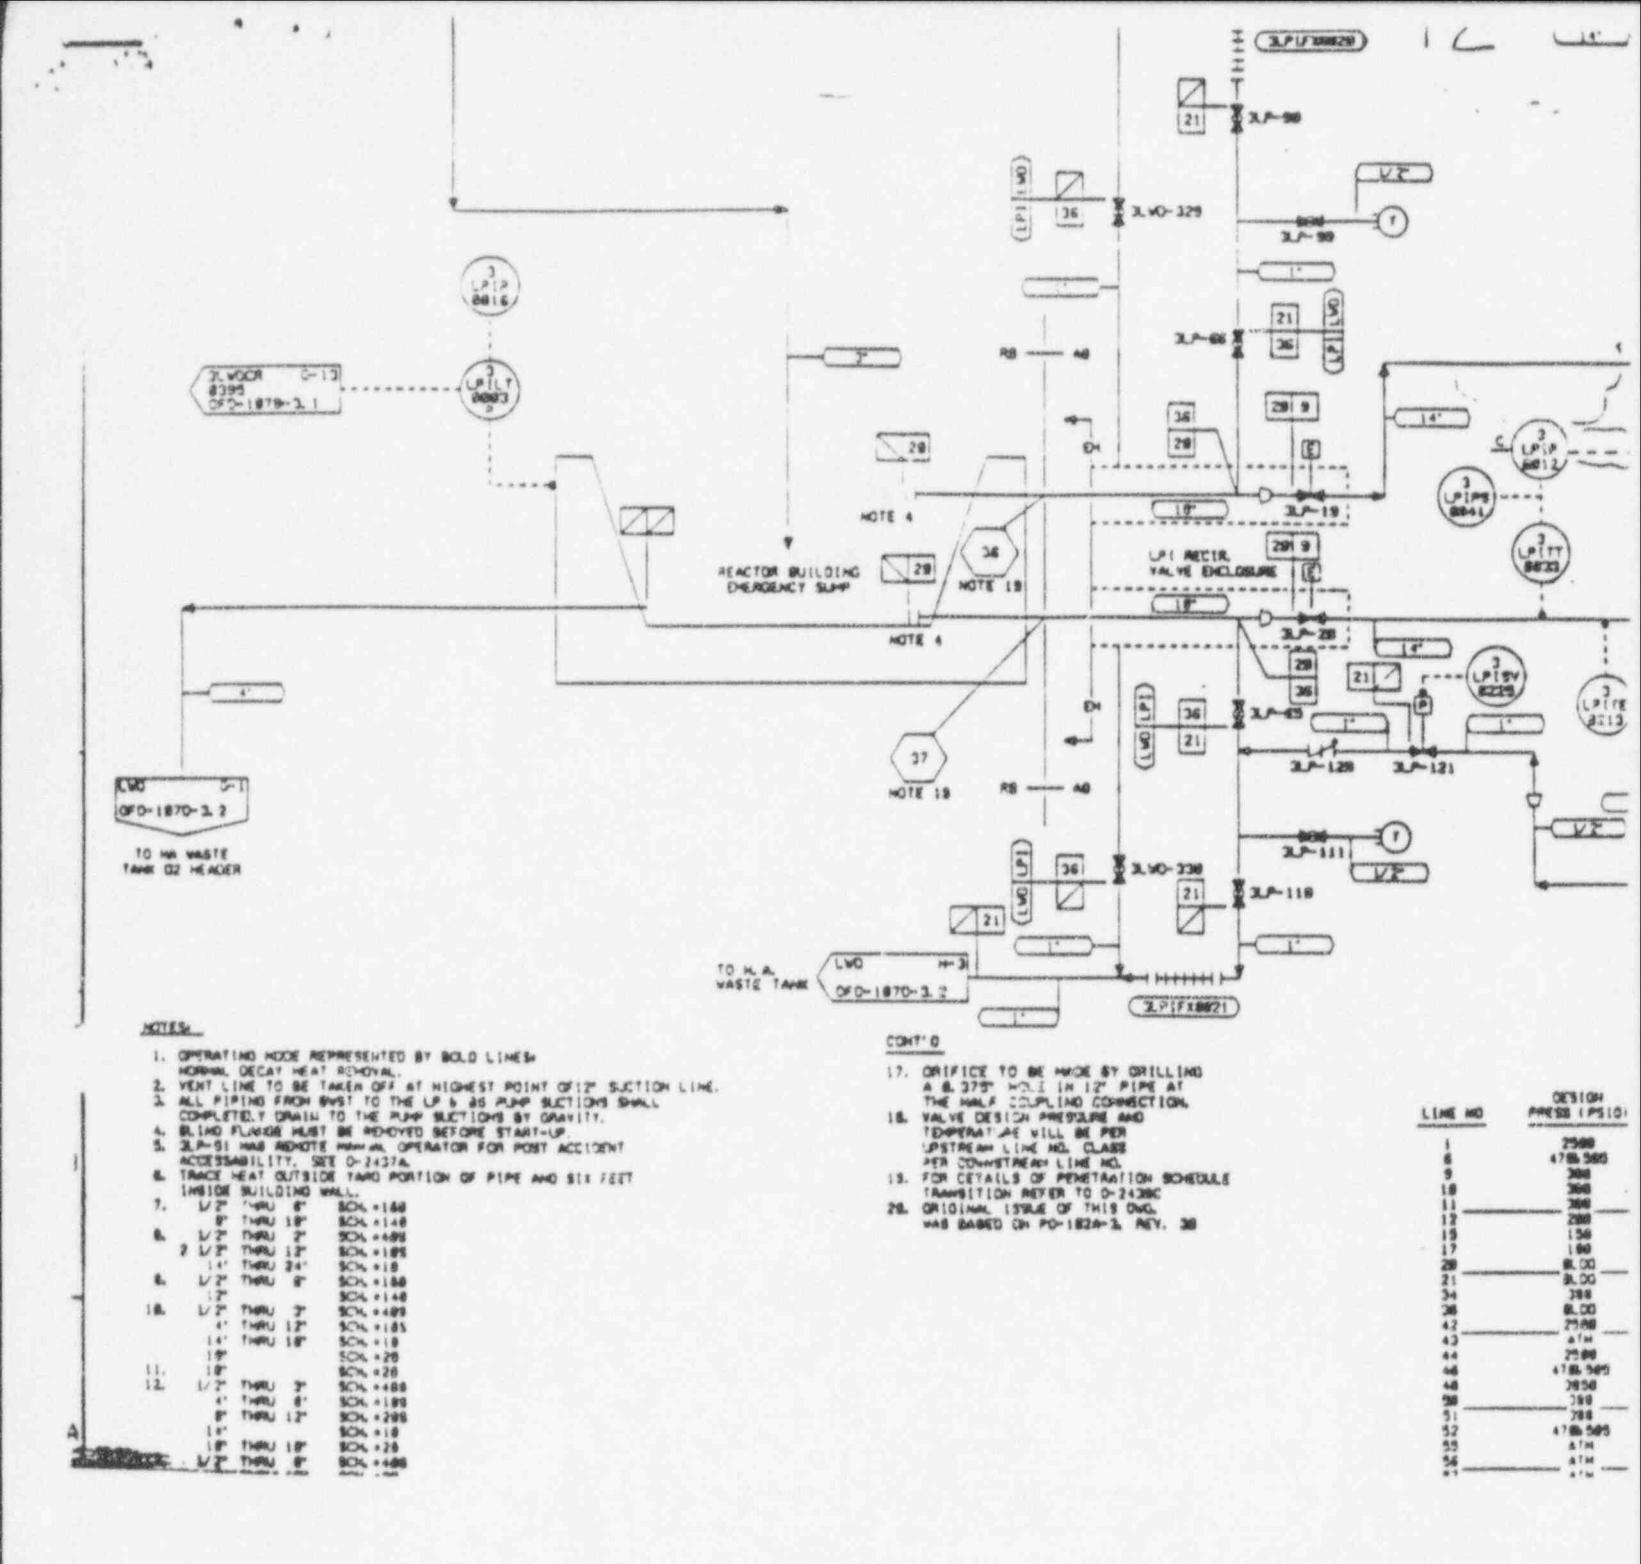
FIGURE 2

The licensee's investigation into this event determined that a blank flange was installed on 3LP-20 instead of 3LP-19. This was due to a labeling error and miscommunications between the workers installing the flange and their supervisor.

- 2/22/91 Maintenance technicians questioned the maintenance supervisor concerning 3LP-19 suction piping location. The maintenance supervisor used flow diagram OFD-102A-3.1, to determine the emergency sump LPI suction line's physical layout. The maintenance supervisor told the technicians that the 3LP-19 line was the west (left) pipe. (See Figure 2)

- 2/22/91 Maintenance technicians entered the RB, then identified and verified the 3LP-19 suction line location per MP/0/A/1800/105, using the maintenance supervisor's directions and a handwritten indication on the RB wall. The marking on the RB wall was in indelible ink and indicated that 3LP-20 was 3LP-19. The maintenance technicians installed the flange on the west (left) line that was identified as 3LP-19 suction line by the marking and by their supervisor. This was actually the 3LP-20 suction line.

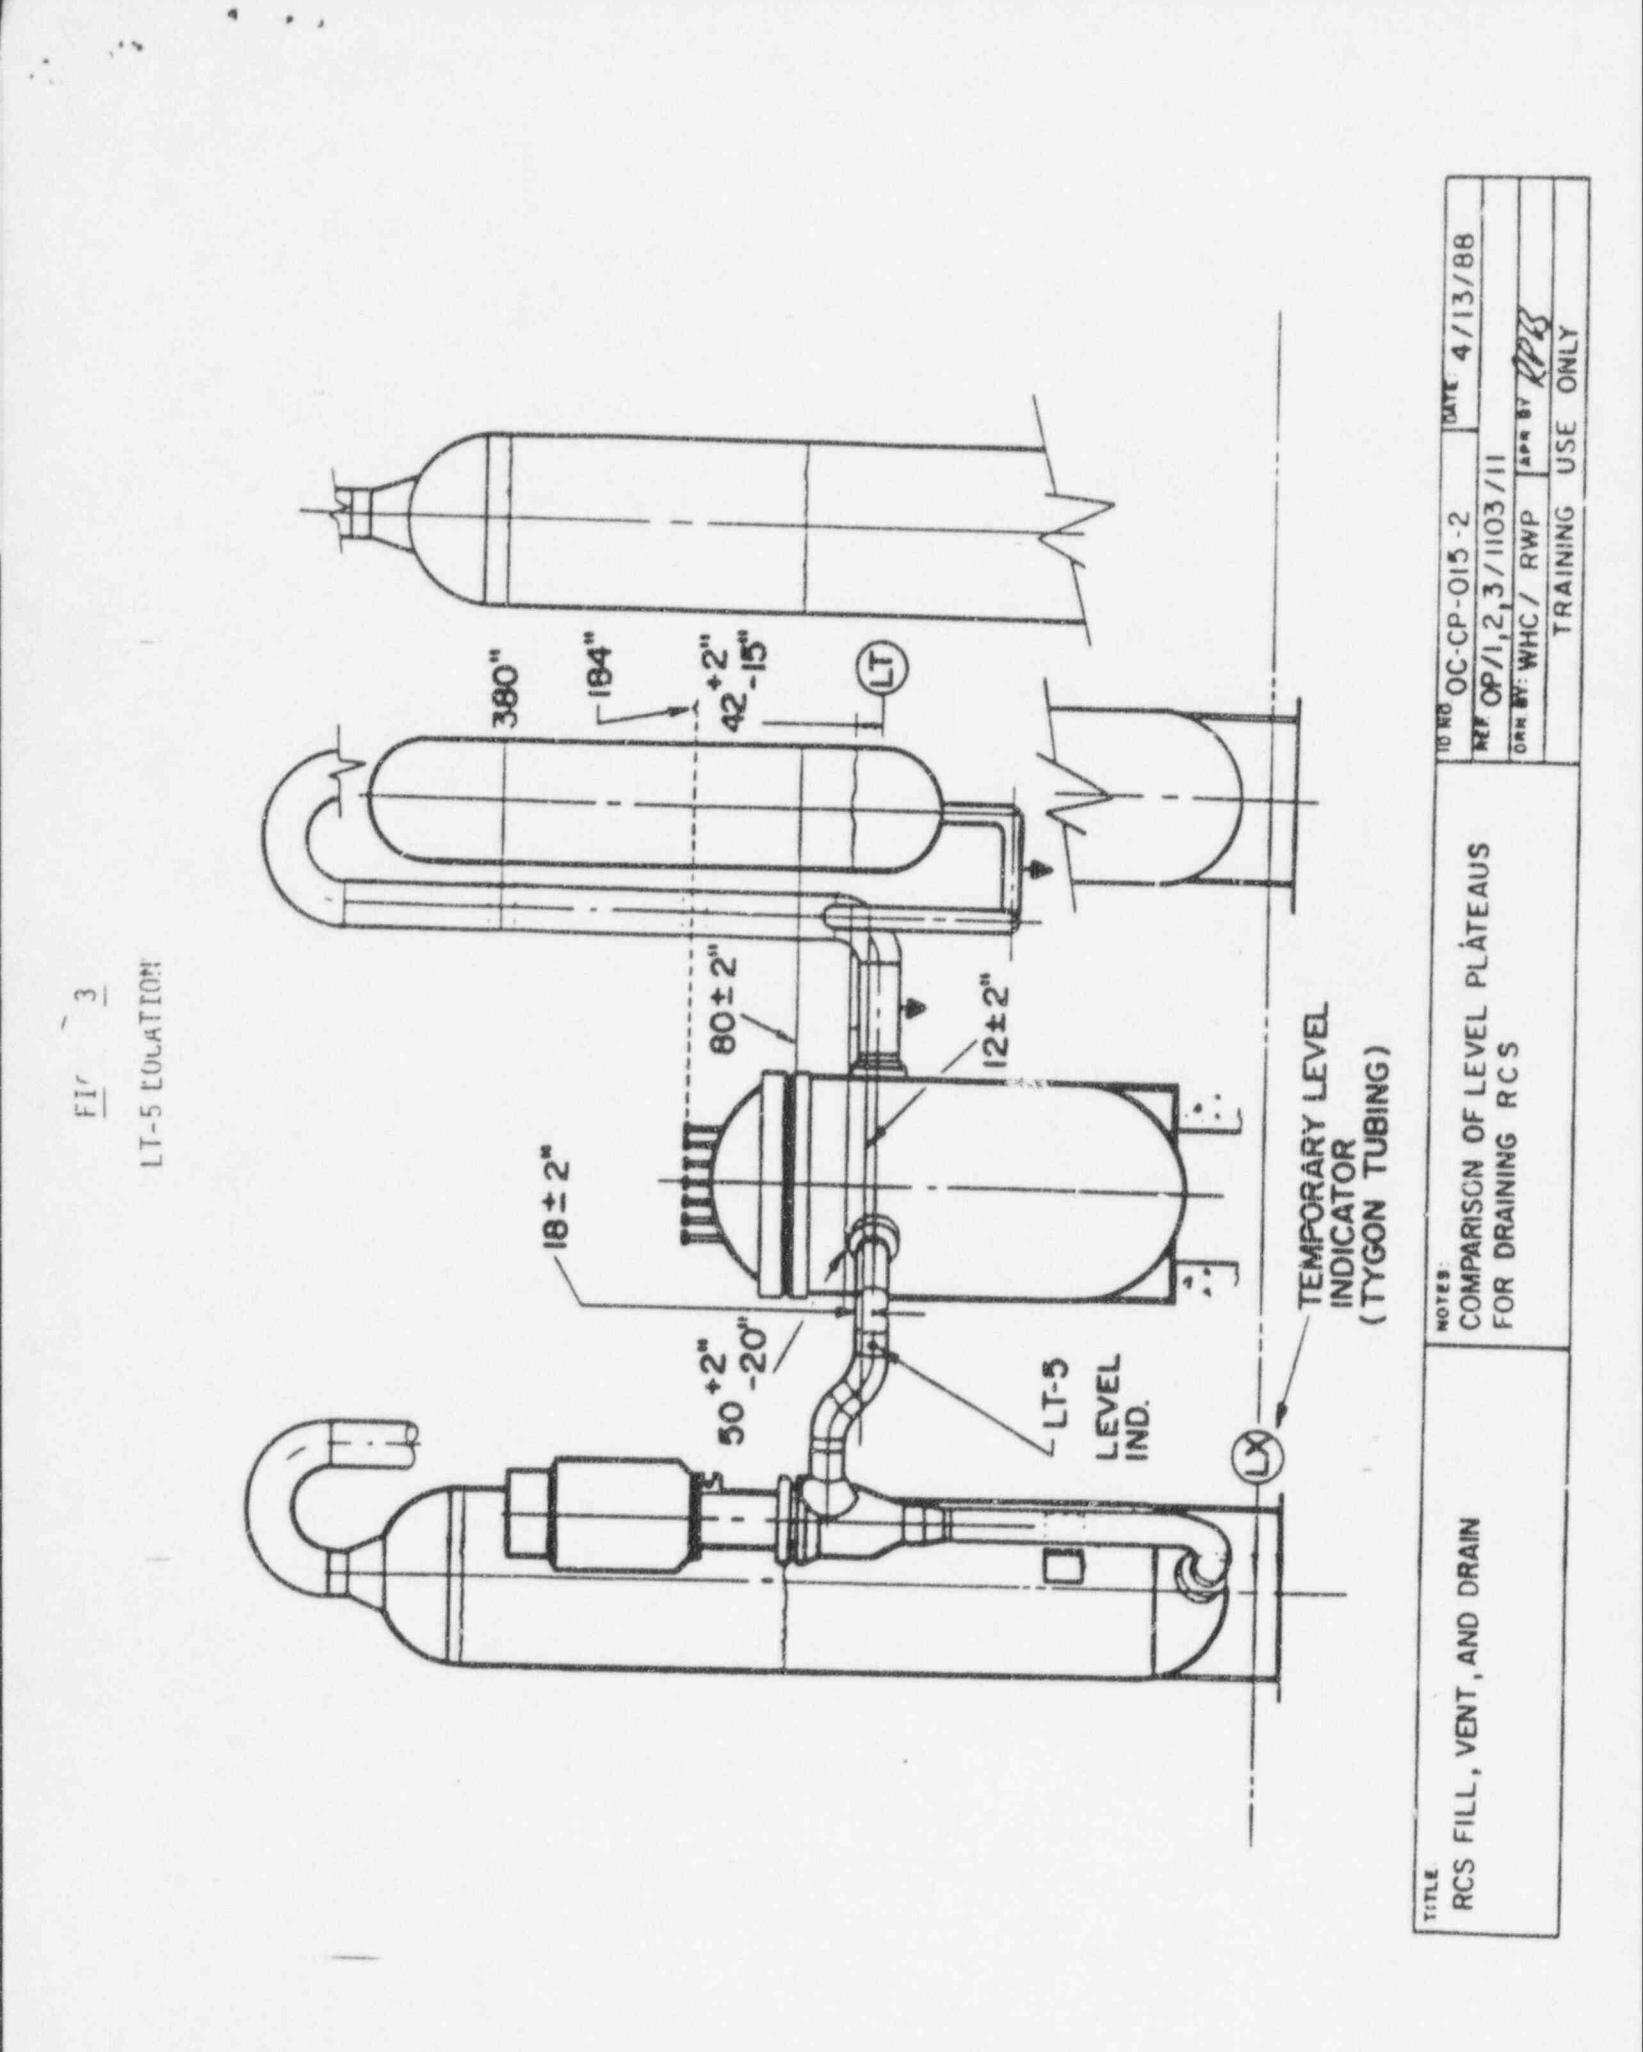
- 08:48 A CRO noticed LT-5 (See Figure 3), reactor vessel level instrument, was at 20 inches and decreasing. This indicated the primary system had an excessive leak or the instrument had failed. The CROs on shift discussed the possible causes of the decreasing level. This instrument had failed in the past.

Operators acknowledged the RBNS "high" level alarm actuation, however, the alarm was expected due to other ongoing outage activities. Operators acknowledged the RB emergency sump high level alarm. Operators observed LT-5 reactor level indication drop from 76 inches.

The operator questioned his supervisor with regard to possible testing on LT-5 since the instrument had failed in the past. They decided that the instrument was correctly indicating a problem.

The level drop was confirmed by the RV ultrasonic level alarm which appeared on the front panel display. The operators observed LT-5 reactor level offscale low. The operators thought that it took only 1 minute for LT-5 to drop to offscale low.

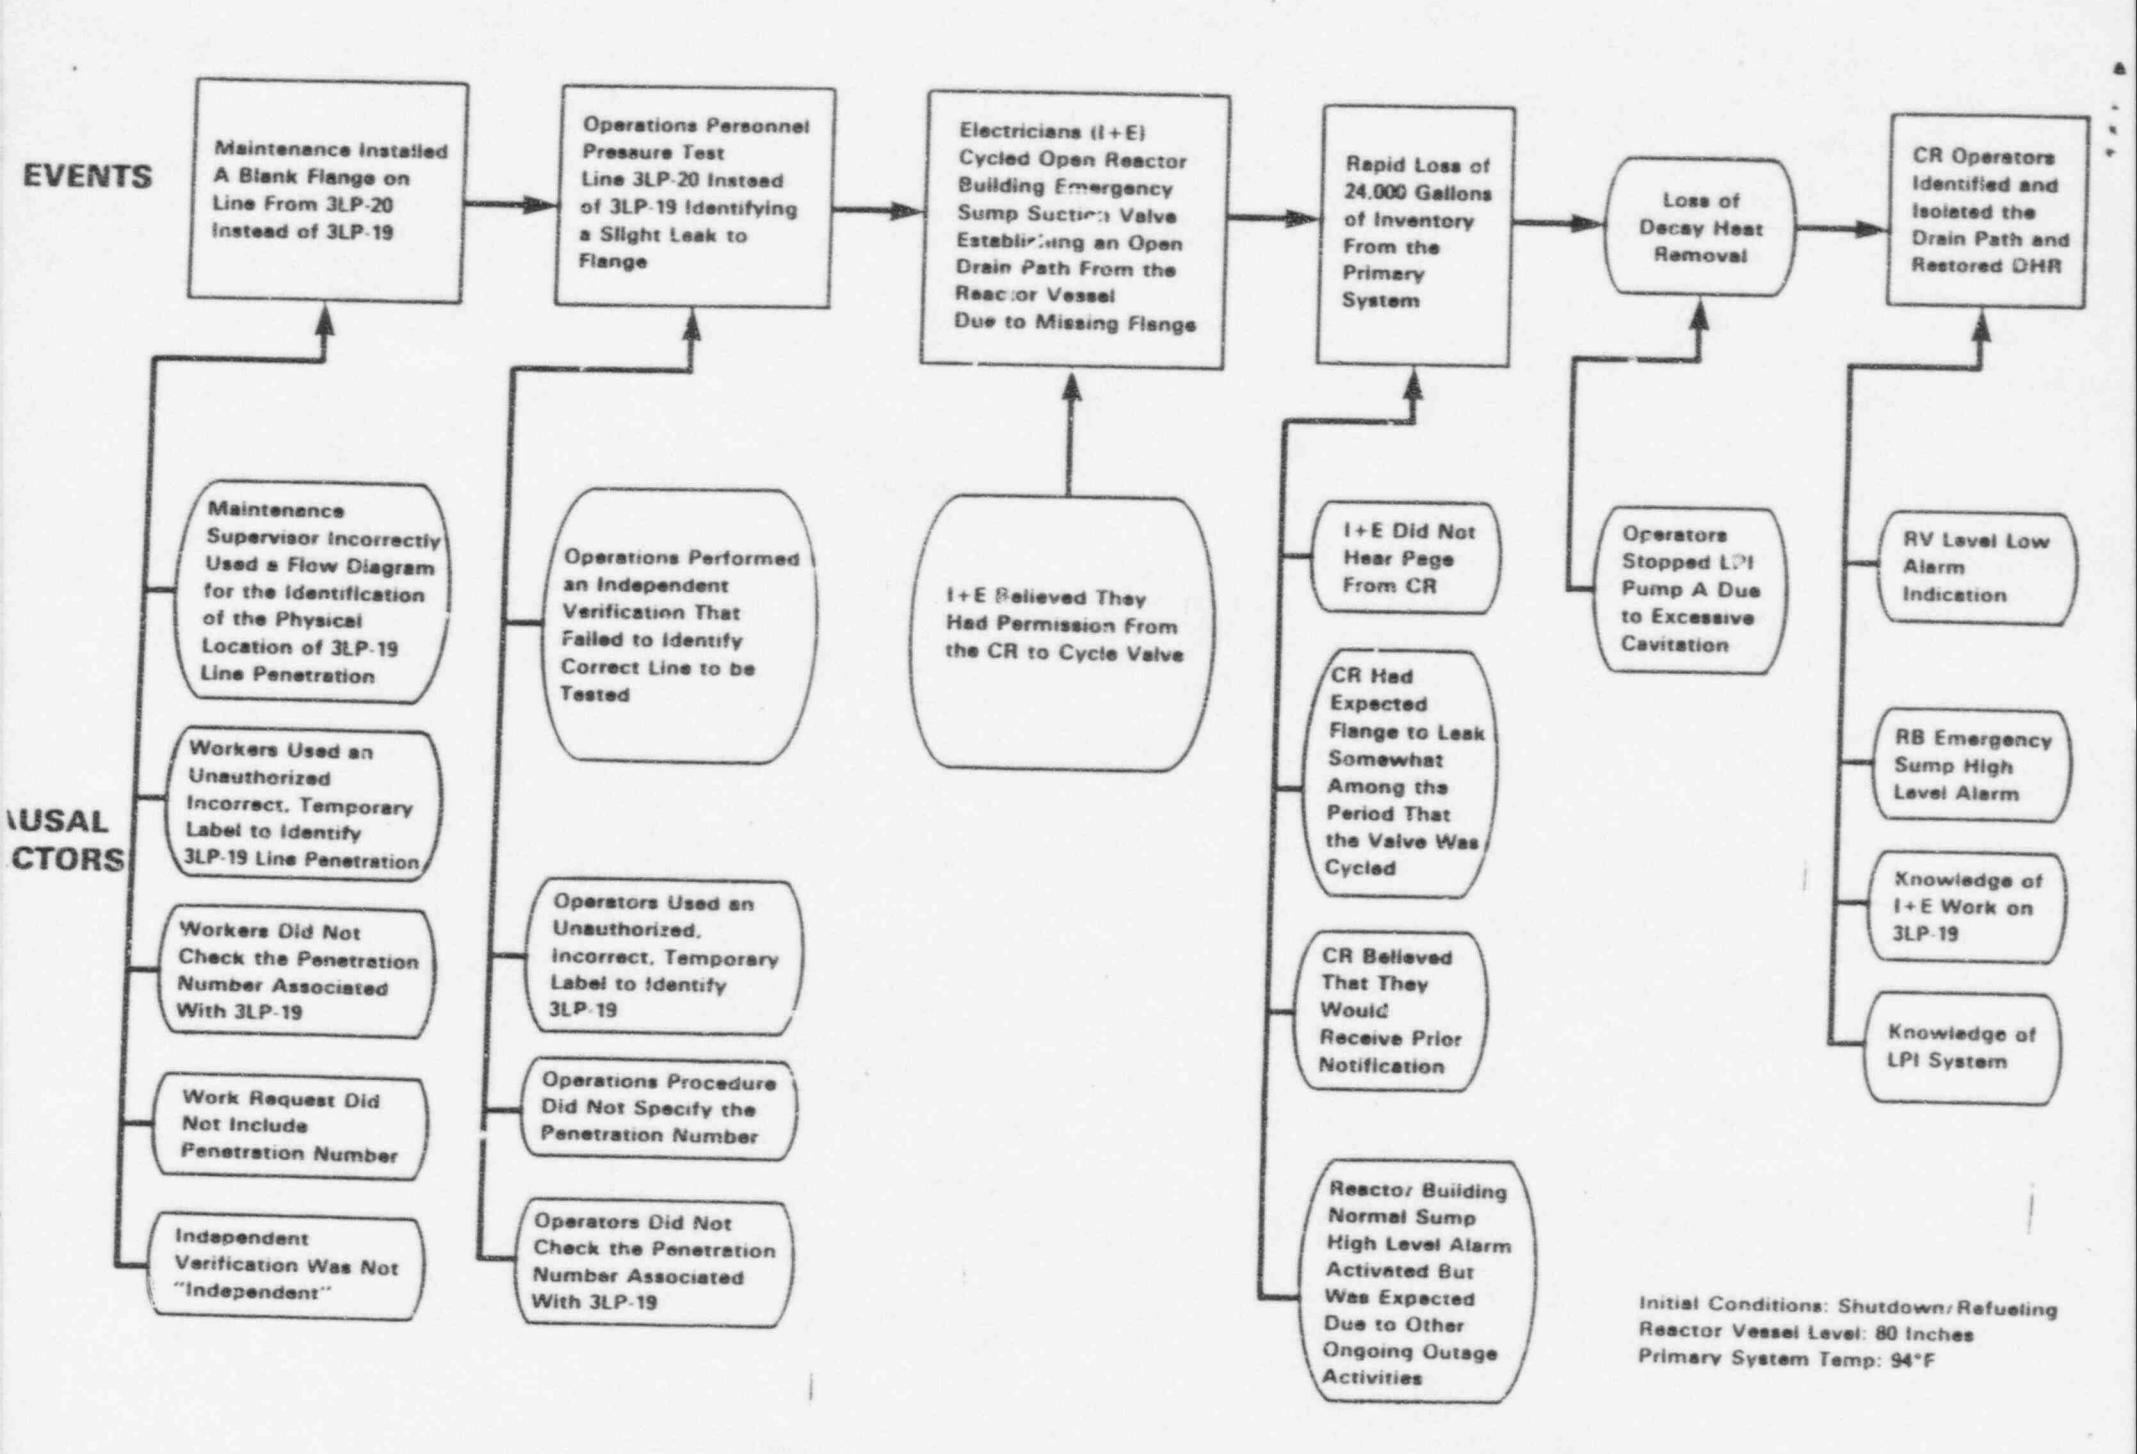
FIGURE :

To aid in understanding of the human performance implications of this event, an EVENTS AND CAUSAL FACTORS CHART was constructed. (See Figure 5). The chart is a visual presentation of the sequence of events and the causal factors for those events. The sequence of events is along the top, from left to right and the causal factors are listed below each event. From the chart it is clear that numerous causal factors are involved in this event; no individual cause stands alone. The human factor implications section of the AIT addresses most of the causal factors identified in the chart.

The failure of plant maintenance personnel to install the flange on the correct emergency sump suction line as part of a LPI system leakage surveillance procedure resulted in the discharge of reactor water to the RB emergency sump. Defense in depth is important to maintaining safe operation of nuclear plants. Contributing causes are factors which reduce the level of protection by reducing the defense in depth. Human errors are seldom the result of a single "root cause." The following discussion of contributing causes ranks these causes in approximate priority of their importance as the AIT judged them.
