ARKANSAS POWER AND LIGHT ARKANSAS NUCLEAR ONE - UNIT 1 CONTROL ROOM DESIGN REVIEW FINAL SUMMARY REPORT HUMAN ENGINEERING DISCREPANCIES VOLUME 2 AUGUST 14, 1985

Category 1 HEDs (42 HEDs)

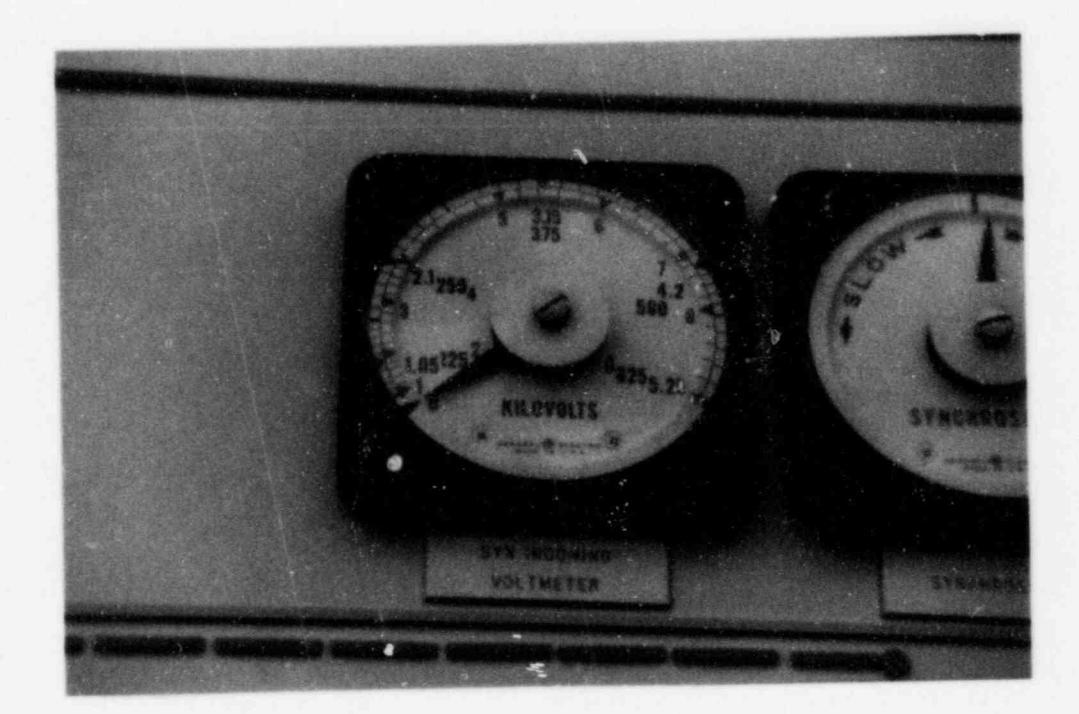
The multiscale indicators are difficult to use and a better display may be justified. Therefore, an evaluation of the available display options to correct this discrepancy is to be performed.

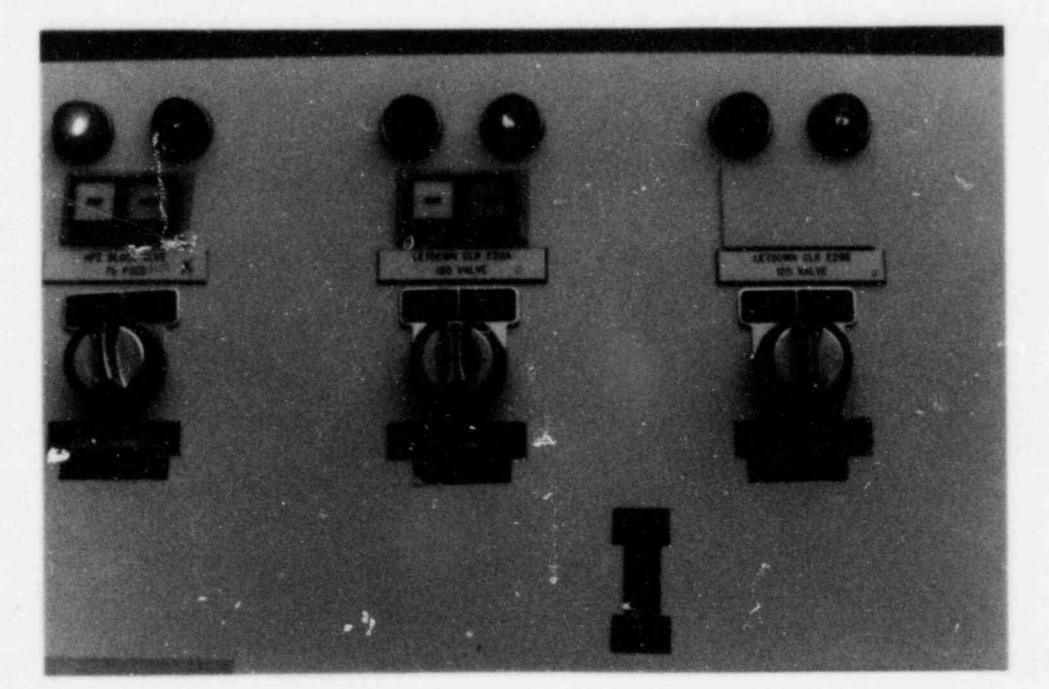
The arrangement of components by ES grouping was the original design for panel C-16 and C-18. However, due to the potential problems created by this arrangement pattern and subsequent design changes which made the original arrangement pattern partially obsolete, an evaluation will be performed to determine if other arrangement schemes would be better.
