UNITED STATES ATOMIC ENERGY COMMISSION DIVISION OF COMPLIANCE. REGION IV 10395 WEST COLFAX. ROOM 200 DENVER. COLORADO 80215

KERR-MCGEE CORPORATION, KERR-MCGEE BUILDING, OKLAHOMA CITY, OKLAHOMA - LICENSE NO. SUB-1010 (Docket No. 40-8027)

COMPLIANCE IN	SPECTION REPORT	Category I Priority II	
1. Name and address of licensee	2. Date of inspection	1	
	April 29 and	30, 1970	
Kerr-McGee Corporation Kerr-McGee Building Oklahoma City, Oklahoma 73102	3. Type of inspection	Announced initial/	
	4. 10 CFR Part(=) =	4. 10 CFR Part(a) applicable	
	20 and 40		
5. License number(s), issue and expiration dates, scope and conditi	ions (including amendments)		
License No. SUB-1010 (Docket No. 40-8027), Is	ssued October 14, 1969		
License Condition No. 8 - For sto	orage only		
Amendment No. 1, Issued November 24,	1969

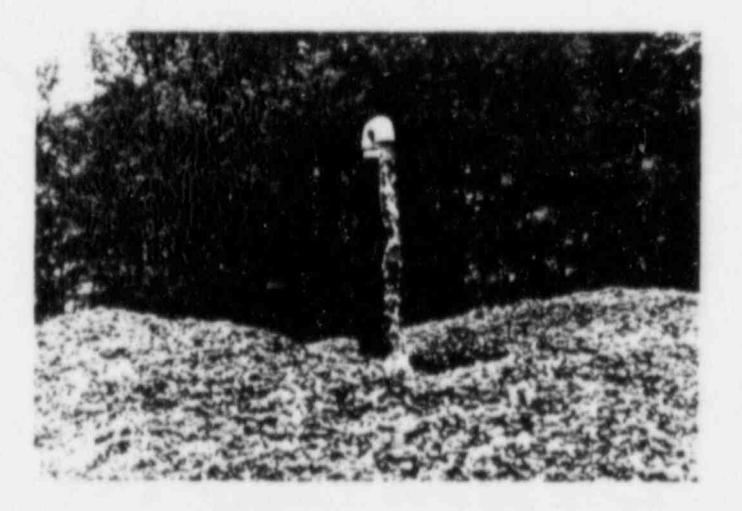
uranium stream by the licensee. The HF gas had not been in contact with \nearrow since no hydrofluorination had been performed to date. The licensee had permission for the above noted discharge from the Oklahoma Water Resources Board (see paragraphs 13 and 43). No limits for airborne HF concentrations have been set by the State of Oklahoma, and the licensee has had no contact with the State concerning this. (See paragraph 17)

Photo 2: Closeup of unneutralized HF scrubber discharge liquid as it enters limestone rock pile.

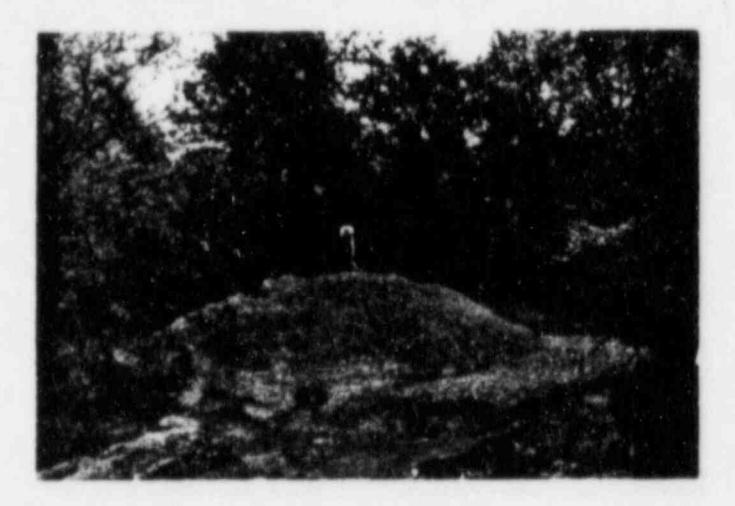
Photo 3: View, looking east, of limestone rock pile showing neutralized discharge flowing westward in foreground.

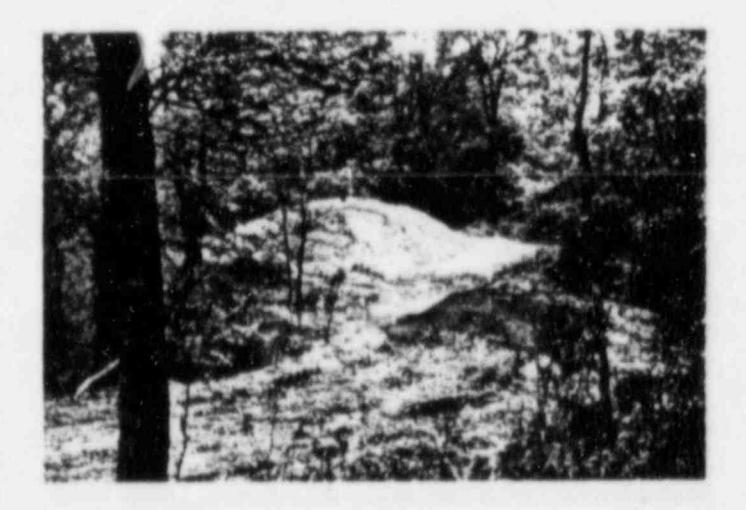
Photo 4: Same view as Photo 3 at distance of approximately 50 feet.

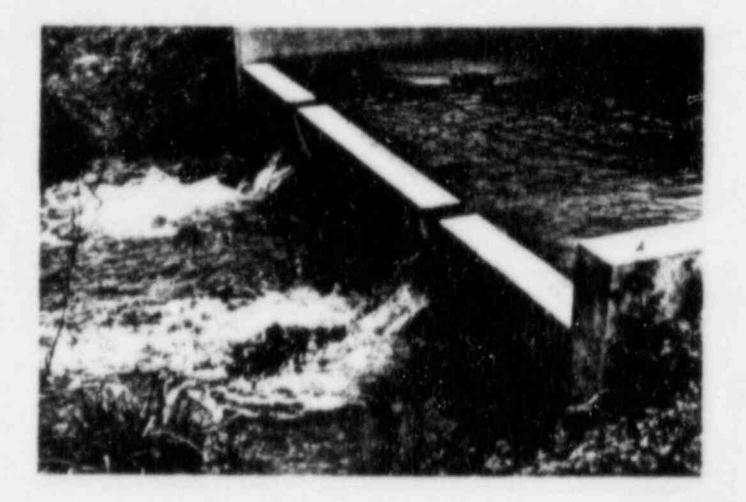
Photo 6: Overflow of excess Lake Tenkiller water which dilutes neutralized stream at location downstream from Photos 2 through 4.

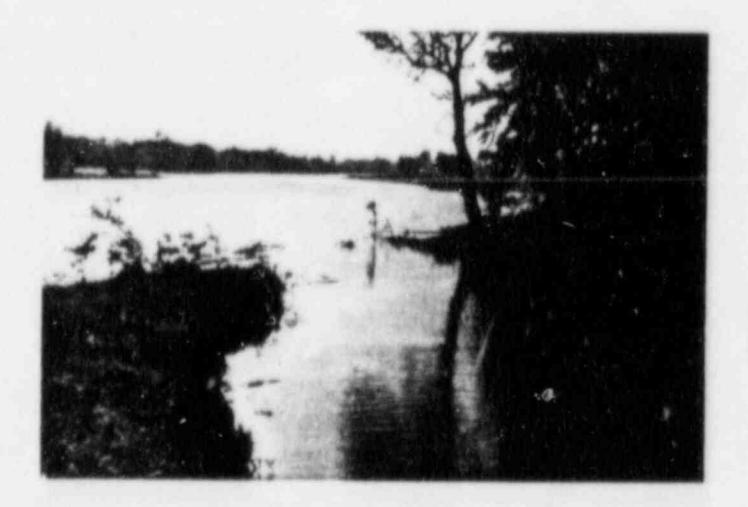
7: Combined outfall (neutralized stream and Lake Tenkiller stream) as it enters Illinois River.
