In the Matter of
LONG ISLAND LIGHTING COMPANY
(Jamesport Nuclear Power Station, Units 1 & 2)
Docket Nos. 50-516 & 50-517

SUBJECT: NRC FIRE PROTECTION RESEARCH TEST

SUBJECT: UL FIRE PROTECTION TESTS

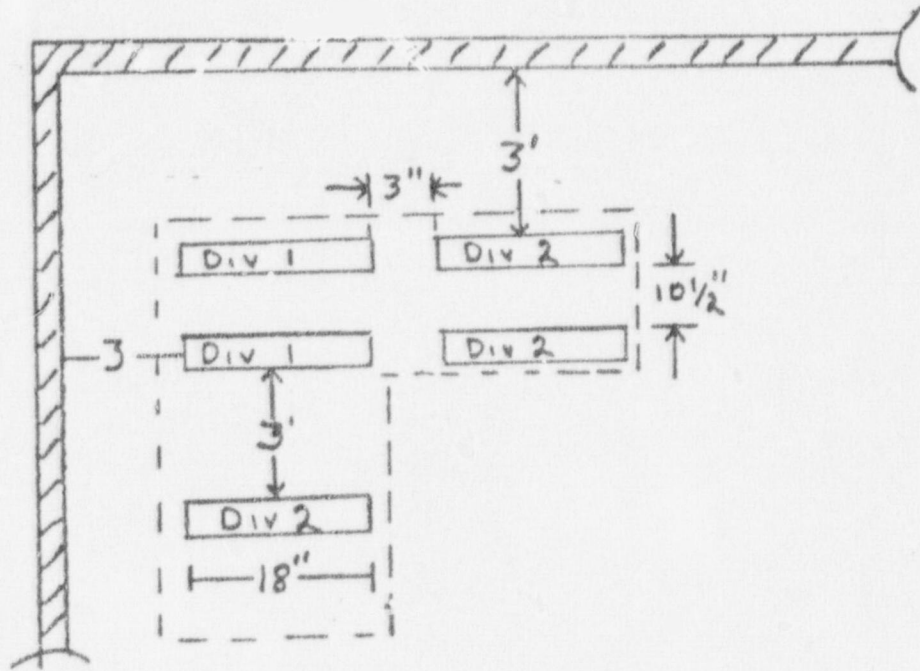
Figure 1

At about 3 minutes there was an indication of a short circuit in cable trays 3, and after 7 minutes indication of a short in tray 1. After 5-7 minutes the height of the flames appeared to subside; however, residual flames continued for about 40 minutes. It was reported that apparently the highest measured temperature inside any cable bundle was less than 150 F; however, damage to the cables indicates that higher temperatures were reached in the trays at the bottom regions, below the location of the thermocouples.

Test results are still being analyzed and no firm conclusions can be drawn at this time. Preliminary information received from RES subsequent to the test indicates that the flammable liquid or flames penetrated an opening in the protective barriers at the bottom of the vertical trays and caused fire damage to the PVC cables in four of the five trays. The electrical short to ground that occurred in cable tray 3 probably was caused by the fire. The second electrical short in tray 1 apparently was caused by a broken instrument connection, and is not considered to be related directly to the fire. On subsequent 500-volt megger tests, it was found that another cable in tray 2 had also experienced some damage.

The most probable cause of the fire damage in certain cable trays appears to be related to the absorption and/or seepage of heptane under the mineral wool blanket at the juncture with the floor. Once the heptane entered the interior regions of the cable tray, then ignition apparently occurred via the small opening at the floor or through a vapor/air path within the joints. It is believed that this type of failure mode could be prevented by using a seal material that would prevent the absorption or the seepage of heptane under the mineral wool blanket. There is some indication that some cable damage was caused by absorption of the inside of the barrier (wicking effect) which heated a cable tray ladder, causing damage to a cable in contact with the ring. The investigation of the results is still underway, and while no definitive findings can be stated, damage did occur to cables in several trays due to the fire. The slow response of the sprinkler system was not predicted. The ingress of the heptane into the mineral wool needs to be further evaluated since this appears to be the most significant failure mode.

----- approximate boundary
of pan for liquid
spill fire

Vertical Tray Corner Test

The test results are still being analyzed and it would be premature to establish firm conclusions at this time; however, the results now available indicate: (a) fire detectors located approximately 15 feet away from the fire promptly (~15 sec) detected the fire; (b) some small fires may not actuate sprinkler heads; and (c) protective barriers should be designed to prevent the entry of flammable liquids.
