In the Matter of
The Detroit Edison Company
(Greenwood Energy Center, Units 2 and 3)
Docket Nos. 50-452, 50-453

SUBJECT: NRC FIRE PROTECTION RESEARCH TEST

SUBJECT: UL FIRE PROTECTION TESTS

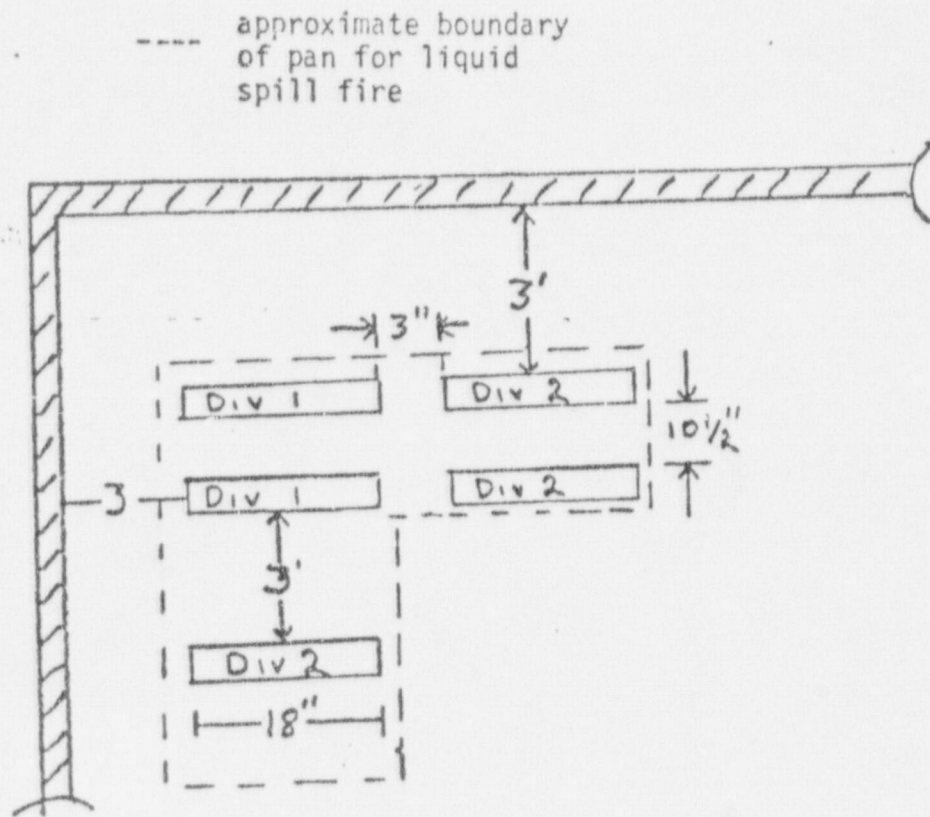
Figure 1

Vertical Tray Corner Test
