In the Matter of
FLORIDA POWER & LIGHT COMPANY
(St. Lucie Nuclear Power Plant, Unit 2)
Docket No. 50-389

SUBJECT: NRC FIRE PROTECTION RESEARCH TEST

SUBJECT: UL FIRE PROTECTION TESTS

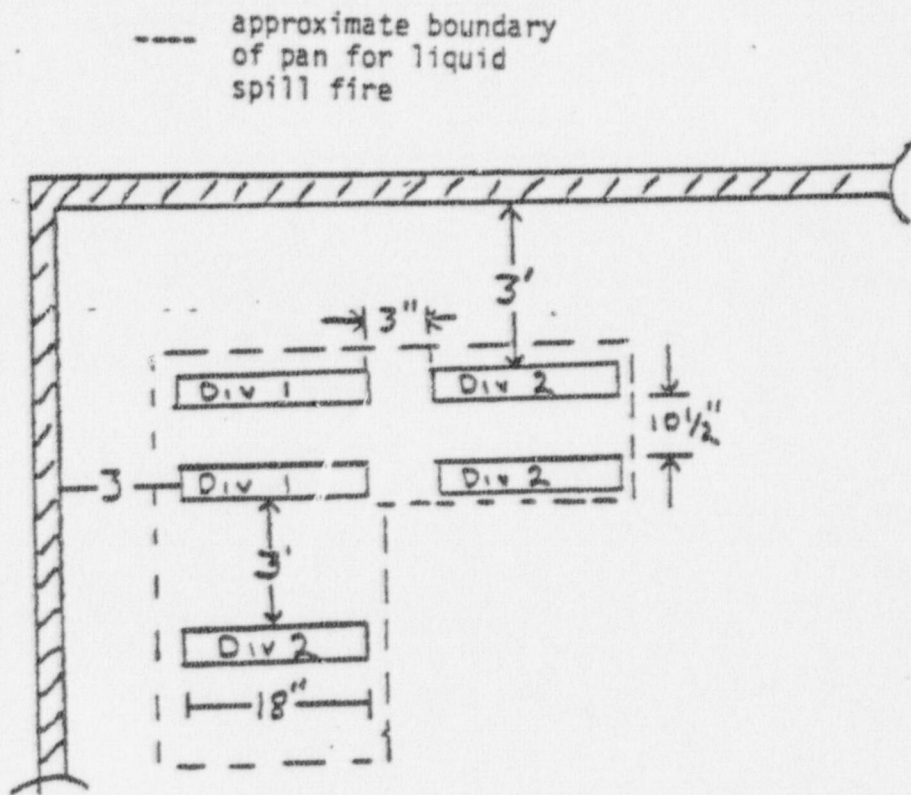
Figure 1

At about 3 minutes there was an indication of a short circuit in cable trays 3, and after 7 minutes indication of a short in tray 1. After 5-7 minutes the height of the flames appeared to subside; however, residual flames continued for about 40 minutes. It was reported that apparently the highest measured temperature inside any cable bundle was less than 150 F; however, damage to the cables indicates that higher temperatures were reached in the trays at the bottom regions, below the location of the thermocouples.

Test results are still being analyzed and no firm conclusions can be drawn at this time. Preliminary information received from RES subsequent to the test indicates that the flammable liquid or flames penetrated an opening in the protective barriers at the bottom of the vertical trays and caused fire damage to the PVC cables in four of the five trays. The electrical short to ground that occurred in cable tray 3 probably was caused by the fire. The second electrical short in tray 1 apparently was caused by a broken instrument connection, and is not considered to be related directly to the fire. On subsequent 500-volt megger tests, it was found that another cable in tray 2 had also experienced some damage.

The most probable cause of the fire damage in certain cable trays appears to be related to the absorption and/or seepage of heptane under the mineral wool blanket at the juncture with the floor. Once the heptane entered the interior regions of the cable tray, then ignition apparently occurred via the small opening at the floor or through a vapor/air path within the joints. It is believed that this type of failure mode could be prevented by using a seal material that would prevent the absorption or the seepage of heptane under the mineral wool blanket. There is some indication that some cable damage was caused by absorption of the inside of the barrier (wicking effect) which heated a cable tray ladder, causing damage to a cable in contact with the ring. The investigation of the results is still underway, and while no definitive findings can be stated, damage did occur to cables in several trays due to the fire. The slow response of the sprinkler system was not predicted. The ingress of the heptane into the mineral wool needs to be further evaluated since this appears to be the most significant failure mode.

Vertical Tray Corner Test

The test results are still being analyzed and it would be premature to establish firm conclusions at this time; however, the results now available indicate: (a) fire detectors located approximately 15 feet away from the fire promptly (~ 15 sec) detected the fire; (b) some small fires may not actuate sprinkler heads; and (c) protective barriers should be designed to prevent the entry of flammable liquids.
