In the Matter of Virginia Electric and Power Company
(North Anna Nuclear Power Station, Units 1 and 2)
Docket Nos. 50-338 OL and 50-339 OL

SUBJECT: NRC FIRE PROTECTION RESEARCH TEST

SUBJECT: UL FIRE PROTECTION TESTS

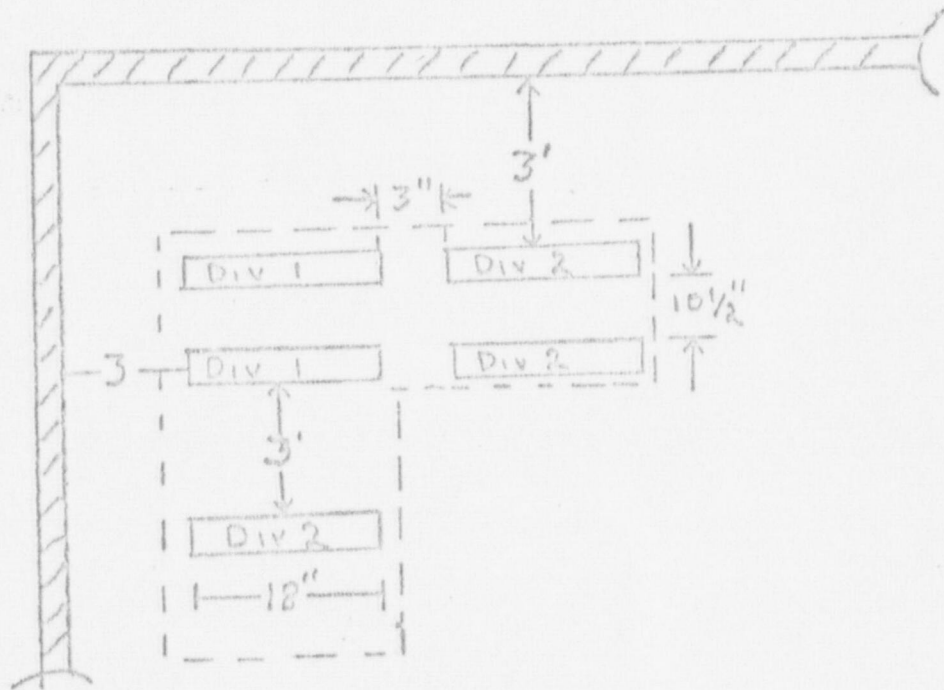
Figure 1

Vertical Tray Corner Test
