In the Matter of
Cincinnati Gas and Electric Company, et al.
(Wm. H. Zimmer Nuclear Power Station, Unit No. 1)
Docket No. 50-358

SUBJECT: NRC FIRE PROTECTION RESEARCH TEST

SUBJECT: UL FIRE PROTECTION TESTS

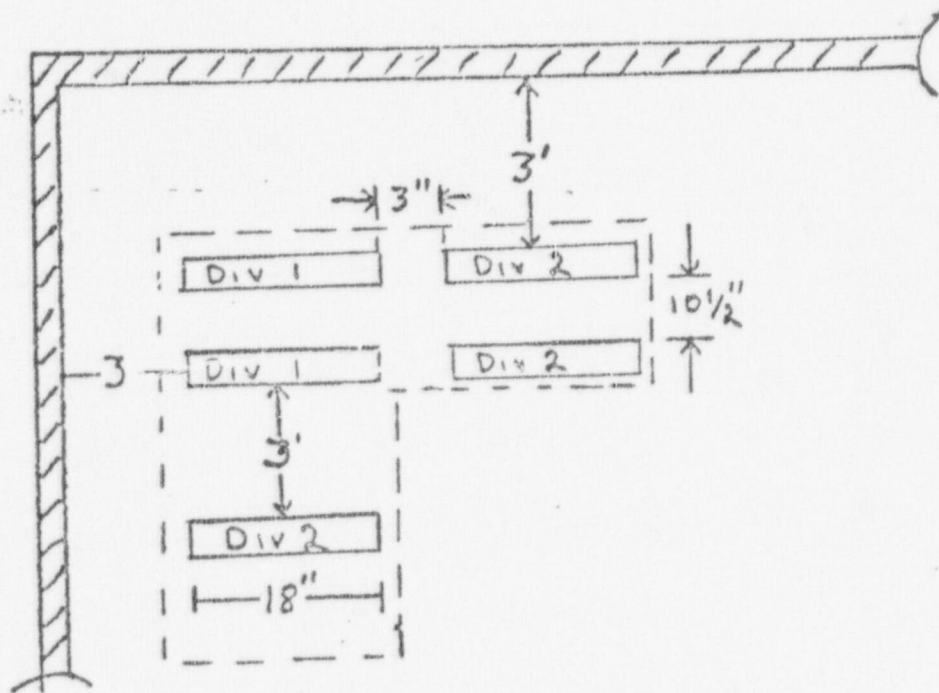
Figure 1

The most probable cause of the fire damage in certain cable trays appears to be related to the absorption and/or seepage of heptane under the mineral wool blanket at the juncture with the floor. Once the heptane entered the interior regions of the cable tray, then ignition apparently occurred via the small opening at the floor or through a vapor/air path within the joints. It is believed that this type of failure mode could be prevented by using a seal material that would prevent the absorption or the seepage of heptane under the mineral wool blanket. There is some indication that some cable damage was caused by absorption of the inside of the barrier (wicking effect) which heated a cable tray ladder, causing damage to a cable in contact with the ring. The investigation of the results is still underway, and while no definitive findings can be stated, damage did occur to cables in several trays due to the fire. The slow response of the sprinkler system was not predicted. The ingress of the heptane into the mineral wool needs to be further evaluated since this appears to be the most significant failure mode.

----- approximate boundary
of pan for liquid
spill fire

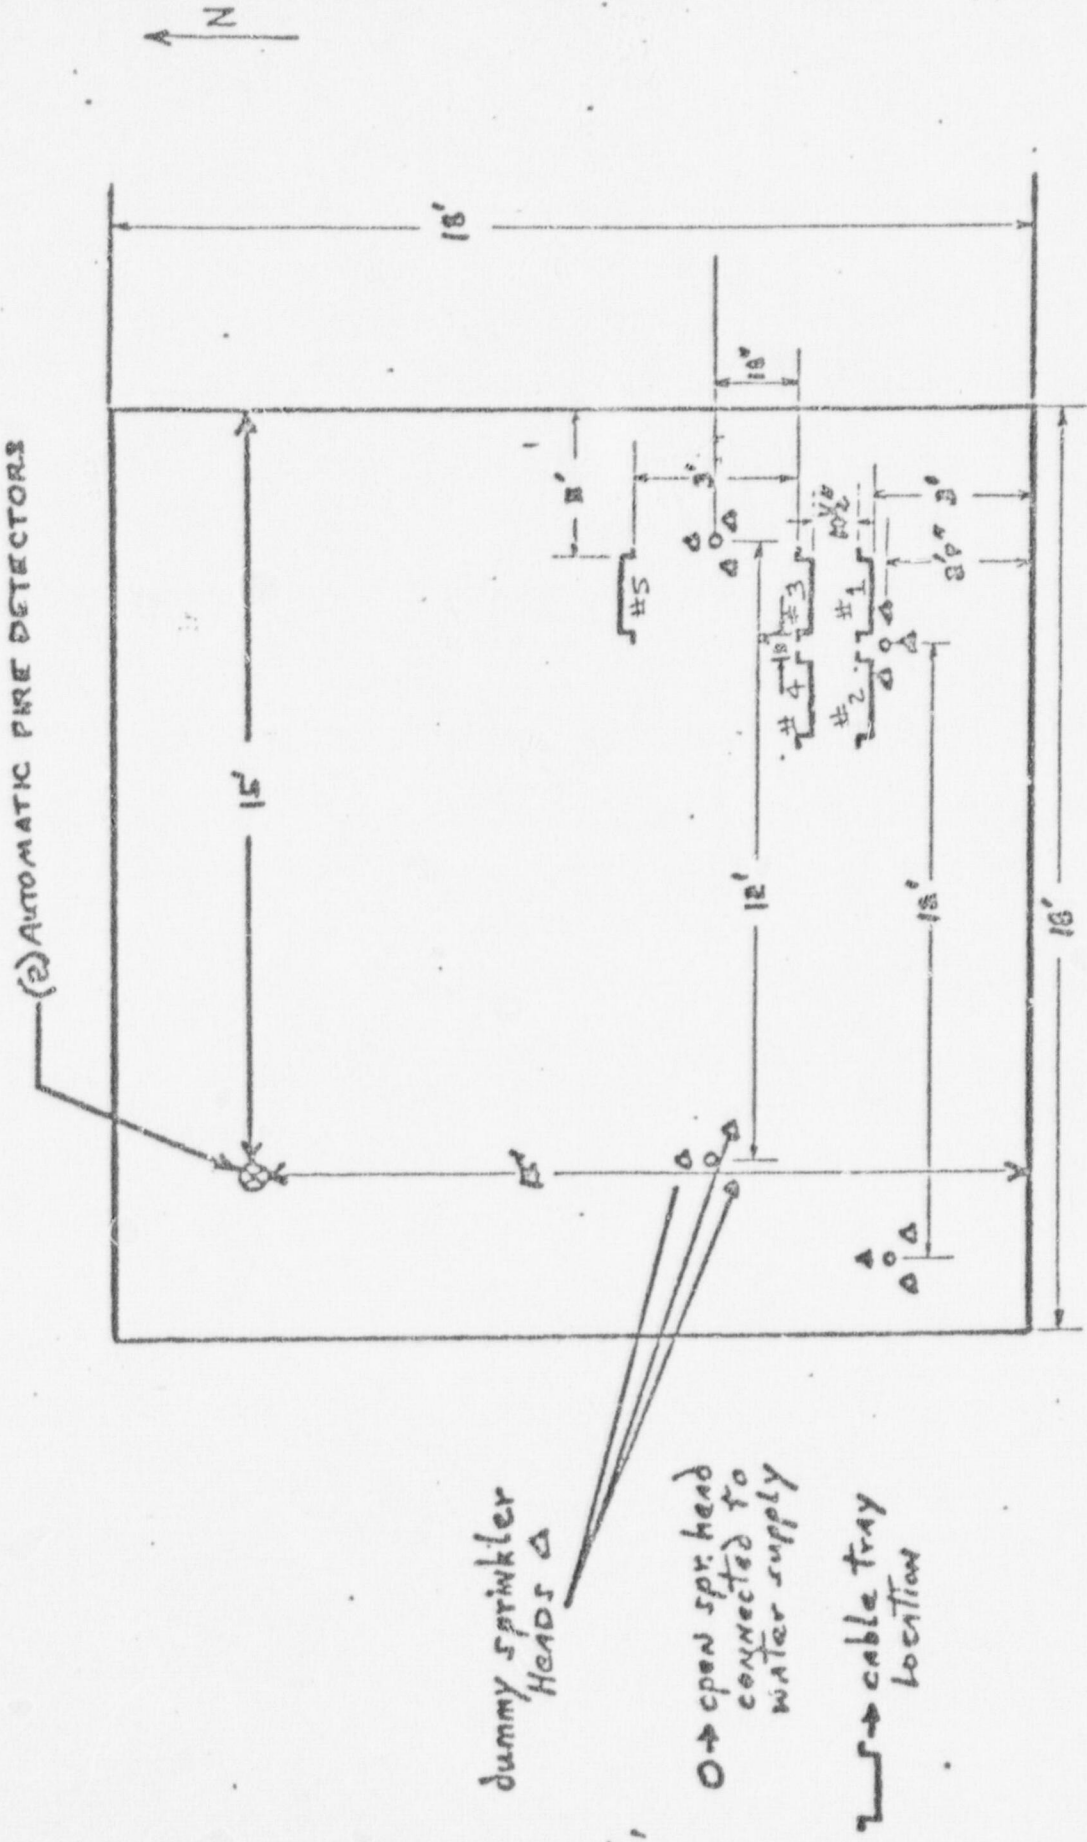
FIGURE 2
TOP VIEW GENERAL

Vertical Tray Corner Test
