In the Matter of
TENNESSEE VALLEY AUTHORITY
(Hartsville Nuclear Plants Units 1A, 2A, 1B, and 2B)
Docket Nos. STN 50-518, STN 50-519, STN 50-520 and STN 50-521

SUBJECT: NRC FIRE PROTECTION RESEARCH TEST

SUBJECT: UL FIRE PROTECTION TESTS

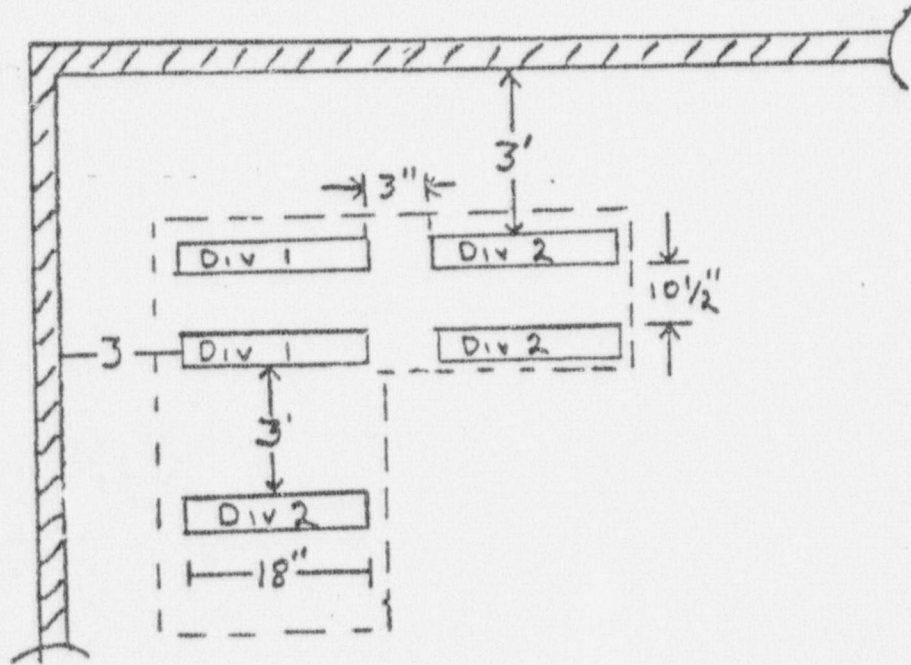
Figure 1

At about 3 minutes there was an indication of a short circuit in cable trays 3, and after 7 minutes indication of a short in tray 1. After 5-7 minutes the height of the flames appeared to subside; however, residual flames continued for about 40 minutes. It was reported that apparently the highest measured temperature inside any cable bundle was less than 150 F; however, damage to the cables indicates that higher temperatures were reached in the trays at the bottom regions, below the location of the thermocouples.

Test results are still being analyzed and no firm conclusions can be drawn at this time. Preliminary information received from RES subsequent to the test indicates that the flammable liquid or flames penetrated an opening in the protective barriers at the bottom of the vertical trays and caused fire damage to the PVC cables in four of the five trays. The electrical short to ground that occurred in cable tray 3 probably was caused by the fire. The second electrical short in tray 1 apparently was caused by a broken instrument connection, and is not considered to be related directly to the fire. On subsequent 500-volt megger tests, it was found that another cable in tray 2 had also experienced some damage.

The most probable cause of the fire damage in certain cable trays appears to be related to the absorption and/or seepage of heptane under the mineral wool blanket at the juncture with the floor. Once the heptane entered the interior regions of the cable tray, then ignition apparently occurred via the small opening at the floor or through a vapor/air path within the joints. It is believed that this type of failure mode could be prevented by using a seal material that would prevent the absorption or the seepage of heptane under the mineral wool blanket. There is some indication that some cable damage was caused by absorption of the inside of the barrier (wicking effect) which heated a cable tray ladder, causing damage to a cable in contact with the ring. The investigation of the results is still underway, and while no definitive findings can be stated, damage did occur to cables in several trays due to the fire. The slow response of the sprinkler system was not predicted. The ingress of the heptane into the mineral wool needs to be further evaluated since this appears to be the most significant failure mode.

Vertical Tray Corner Test

The test results are still being analyzed and it would be premature to establish firm conclusions at this time; however, the results now available indicate: (a) fire detectors located approximately 15 feet away from the fire promptly (~15 sec) detected the fire; (b) some small fires may not actuate sprinkler heads; and (c) protective barriers should be designed to prevent the entry of flammable liquids.
