AEOD ENGINEERING EVALUATION REPORT*

UNIT: Calvert Cliffs Units 1 & 2 DOCKET NO.: 50-317 & 318 LICENSEE: Baltimore Gas & Electric Co. NSSS/AE: Combustion Engineering, Inc./Bechtel Corp.

EE REPORT NO. <u>AEOD/E3</u>04 DATE: March II, 1983 EVALUATOR/CONTACT: Theodore C. Cintula Corp.

SUBJECT: INVESTIGATION OF BACKFLOW PROTECTION IN COMMON EQUIPMENT AND FLOOR DRAIN SYSTEMS TO PREVENT FLOODING OF VITAL EQUIPMENT IN SAFETY-RELATED COMPARTMENTS

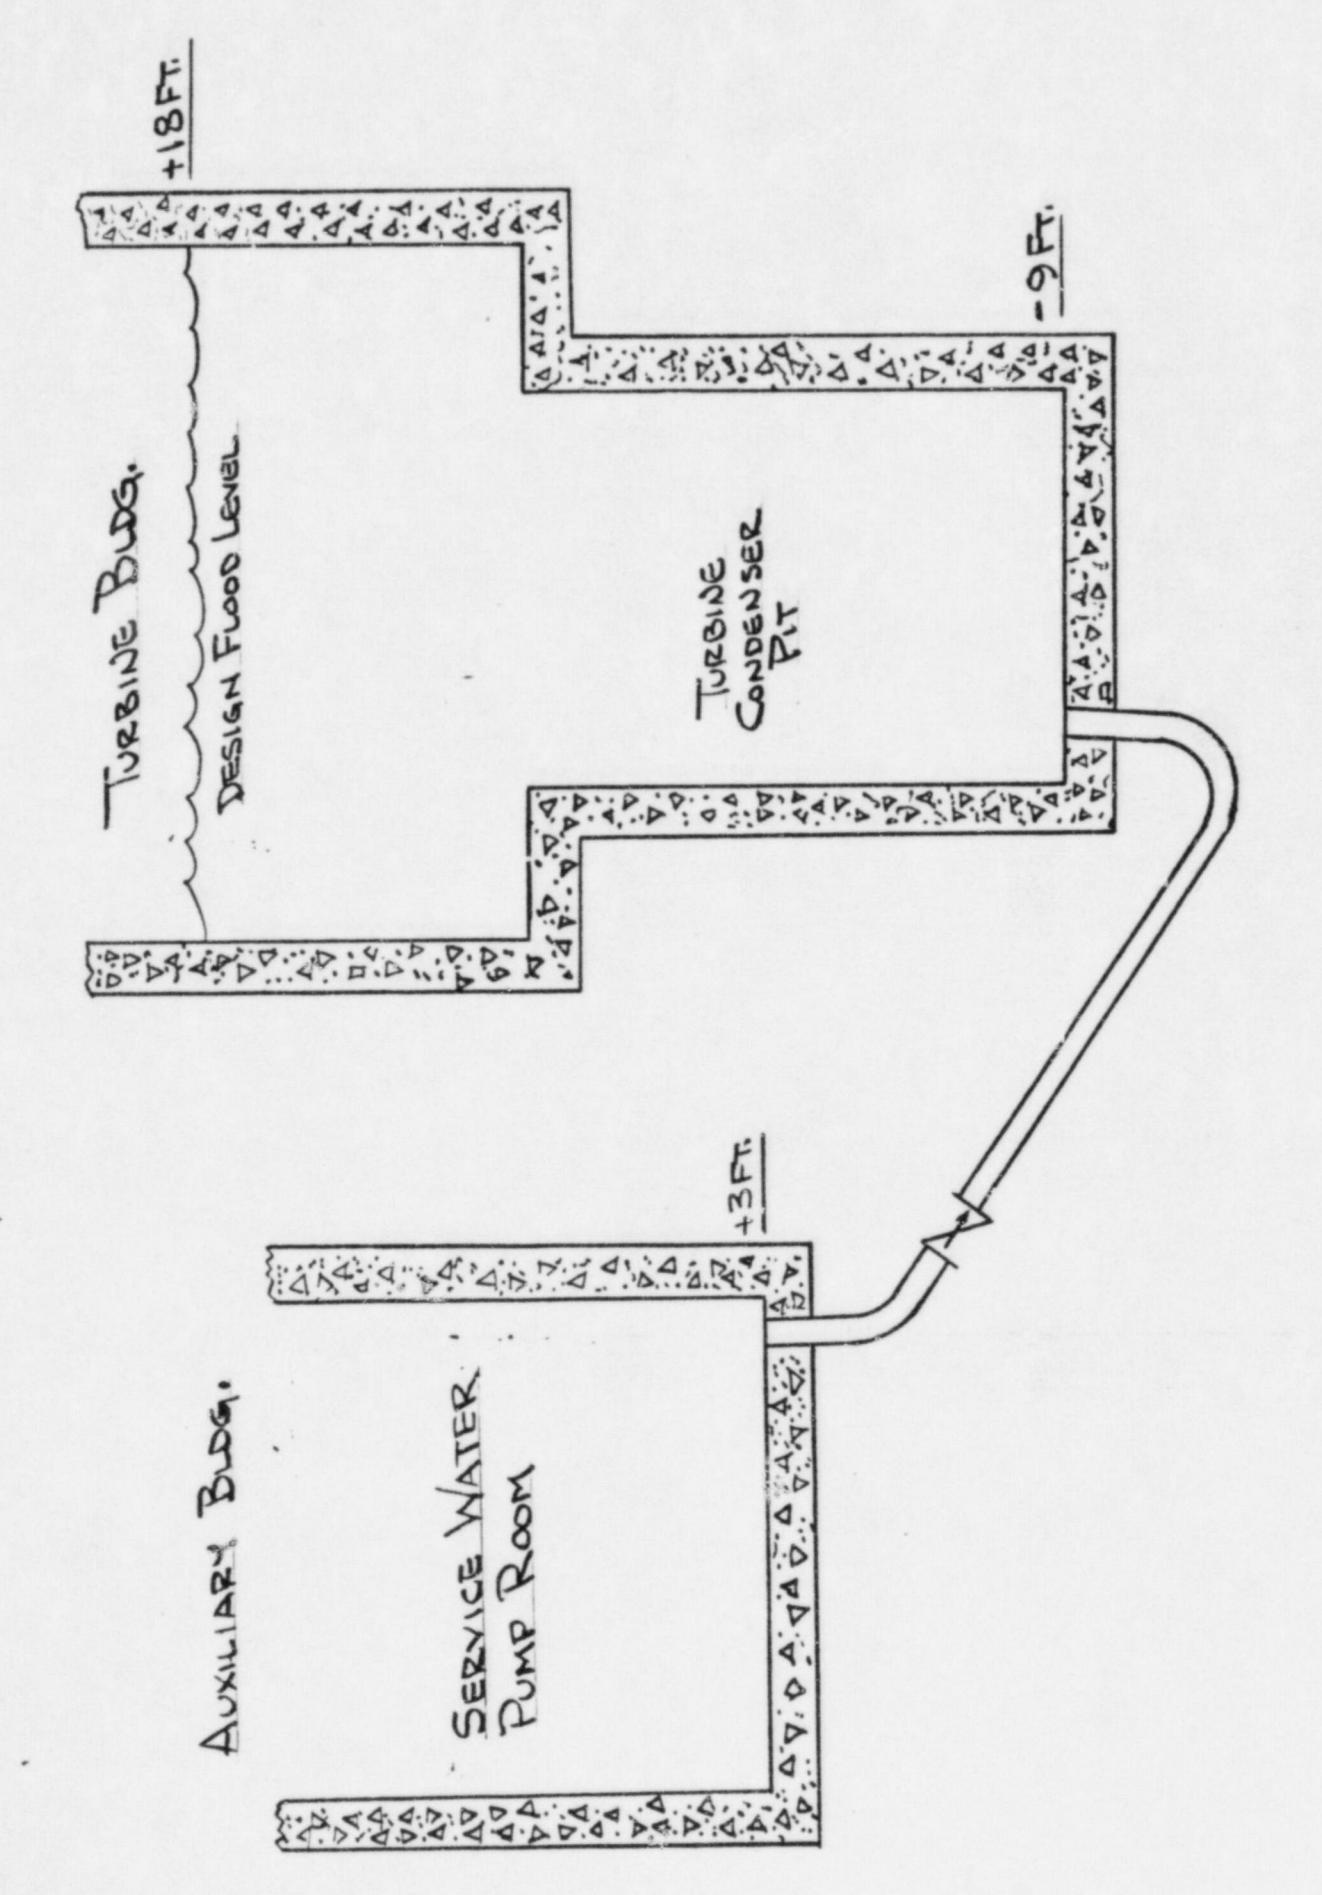
ELEVATIONS IN TURBINE BLOG. AND SERVICE WATER PUMP ROOM FIGURE 1.

Although the elevation of the service water pump room floor is twelve feet above the turbine condenser pit floor, the water level in the turbine building following the breaking of a circulating water conduit would have resulted in backflow through the floor drains and simultaneous flooding of the service water pump rooms in both Units 1 & 2 to a depth of 15 feet. Although the increase in water level would have been detected and annunciated by nonsafety grade instrumentation in the turbine pit and safety grade instrumentation in the service water pump room, there would not have been any way to stop the inflow of water into the service water pump room following a design basis flood. As a temporary corrective measure to resume power operation, the utility sealed some of the floor drains with inflatable plugs (which are still in place) and the remaining drain lines were modified by installing check valves to prevent potential backflow into the safety-related rooms. A review of other drain lines within the plants did not reveal a similar situation.

The design flood level of the turbine building is +18 feet. The finished grade of the plant site is +45 feet, high enough so outside flooding interactions with the turbine building were not considered in the Final Safety Analysis Reports (FSAR). The service water pump room floor is at an elevation of +3 feet (with the service water pump platform at +6 feet). Therefore, the design flood could have resulted in 15 feet of water in the service water pump rooms. There are redundant high level switches in each service water pump room; these switches are waterproof, testable, seismic class 1, and actuate an alarm in the control room.

On November 5, 1981, Bechtel Corporation, the architect-engineer, notified the licensee for Calvert Cliffs Unit 1 and 2 that the watertight integrity of the service water pump rooms at both units could be impaired because check valves had not been installed in the floor drain system which drains by gravity to the turbine condenser pit in the turbine building. Without these check valves, the operability of the service water pumps for both units could not be assured in the event of a circulating water conduit break in the turbine building (a nonsafety area). As a temporary corrective measure, the licensee sealed some of the floor drains with inflatable plugs and modified the remaining drain lines by installing check valves to prevent potential backflow.
