_							LICENSE	E EVENT	REPOR	T (LER)					
Facilii	y Name	e (1)	LaSal	le Ci	ounty Stat	ion U	nit 2				Docket Nu	mber (2	2) Page (3) 3  7  4 1 of 0 6		
Title	(4)		Chable	0.0			1.0	Suitch	Our t	o Looka	Across Di	anheam			
Even	Date	(5)	Static	150	P Number (	6)	I Pressure	Reno	rt Dat	e (7)	Other	Facilit	ties Involved (8)		
fonth	Day	Year	Year	1/1/1	Sequentia	1/1/1	Revision	Month	Day	Year	Facility	Names	Docket Number(s)		
			1	///	Number	1	Munber						0 5 0 0 0 0

LICENSEE EVENT REPORT (LER) TEX	XT CONT	INUATI	ON					1.1.22
FACILITY NAME (1)	DOCKET NUMBER (2)	LER	NUMBER	(6)			P	age	(3)
		Year	111	Sequential Number	11/1	Revision Number			
LaSalle County Station Unit 2	0 5 0 0 0 3 7 4	8   7	-	0   1   9	-	0   1	0  2	OF	016

CONFIGURATION OF TEST EQUIPMENT FOR LEAKAGE INTEGRITY CHECK

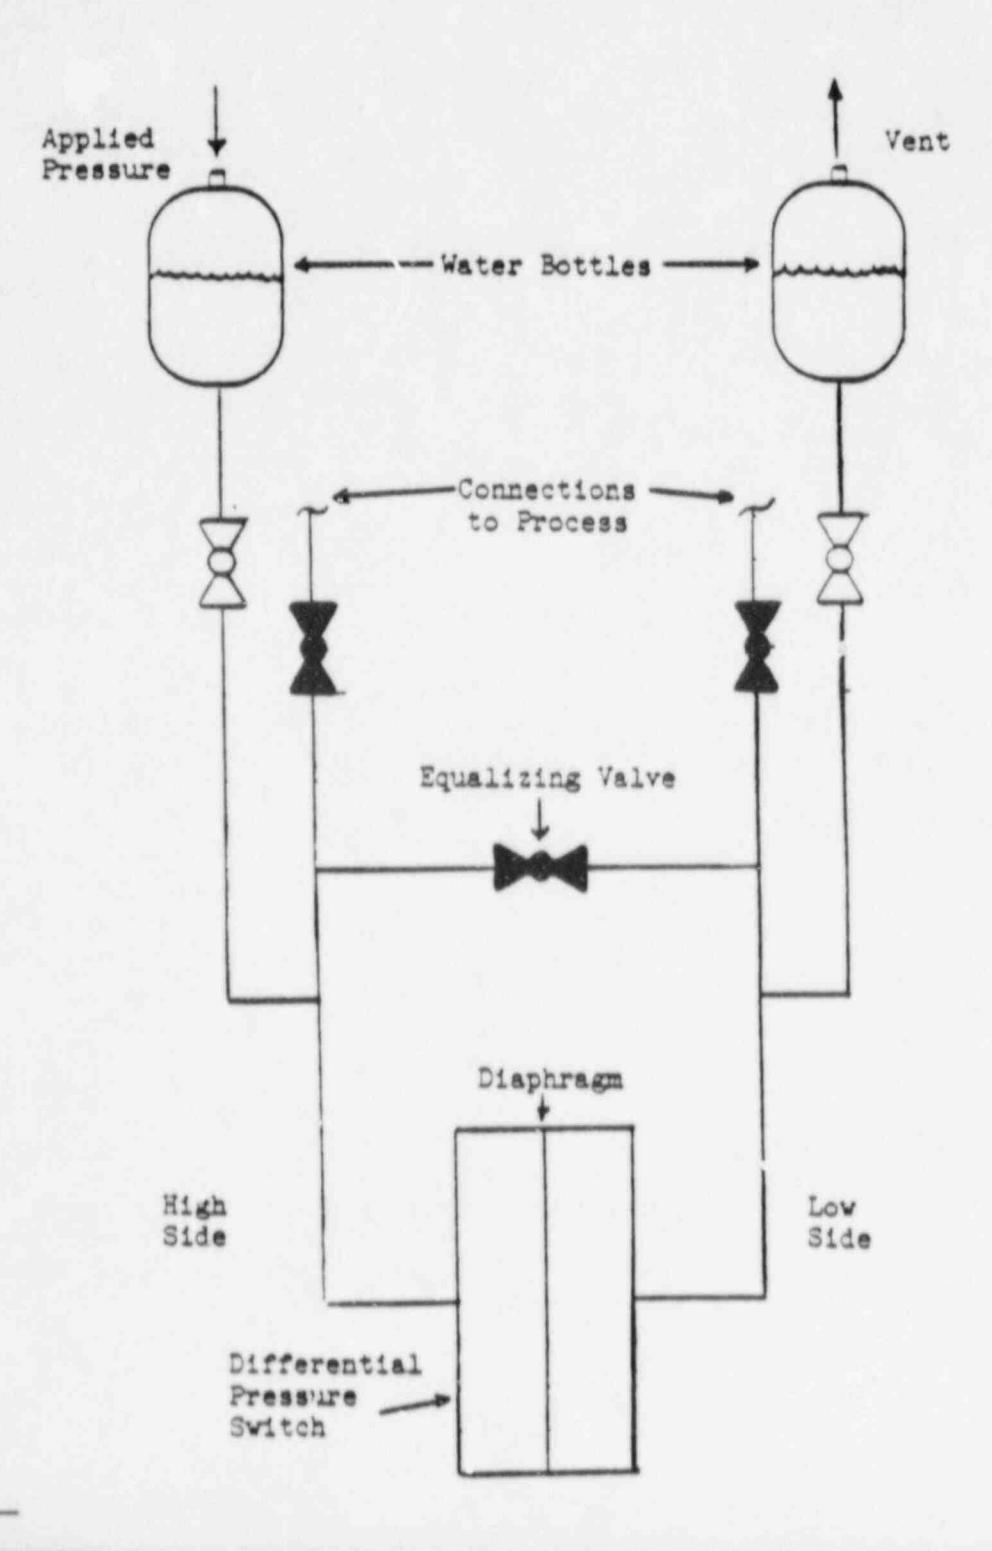
FIGURE 1

Step F.30 of LIS-RI-201 was in progress at the time of this event. This step determines the "As Found" setpoint of PDS-2E31-NO13AA, and verifies the integrity of the diaphragm. The test equipment configuration is shown on Figure 1. A test pressure is applied to the high side water bottle while the low side bottle is vented to determine the differential pressure at which the switch would trip. The diaphragm integrity test is done by holding the setpoint pressure on the high side bottle for approximately two minutes and monitoring the levels in the water bottles. Upon application of the test pressure, water began flowing from the high side bottle.

Troubleshooting was performed to rule out the equalizing valve as the source of the leak and to qualify the nature of the leak. The water bottles were connected directly to the pressure ports of the flow switch and leakage was still observed, eliminating the equalizing valve as the source of the leak. Water flowed to the low side water bottle only when pressure was applied to the high side water bottle; raising the high side bottle so that the elevation of its water level was higher than the low side bottle was insufficient to cause water to flow through the switch. This indicates that the leak is small and that it was probably discovered at an early point in its development. This flow switch was successfully functionally tested (which includes a diaphragm integrity test) on September 23, 1987, so it is believed that the leak developed subsequent to that date.
