Enclosed are responses to questions forwarded with your March 8, 1988 letter to Thomas E. Murley, who testified for the Nuclear Regulatory Commission at the Senate Labor and Human Resources Committee hearing on the proposed restart of the Pilgrim plant.

## SPENT RESIN CONTAMINATION LEVELS

FIGURE 2  
SPENT RESIN CONTAMINATION/RELEASE  
PATHWAY

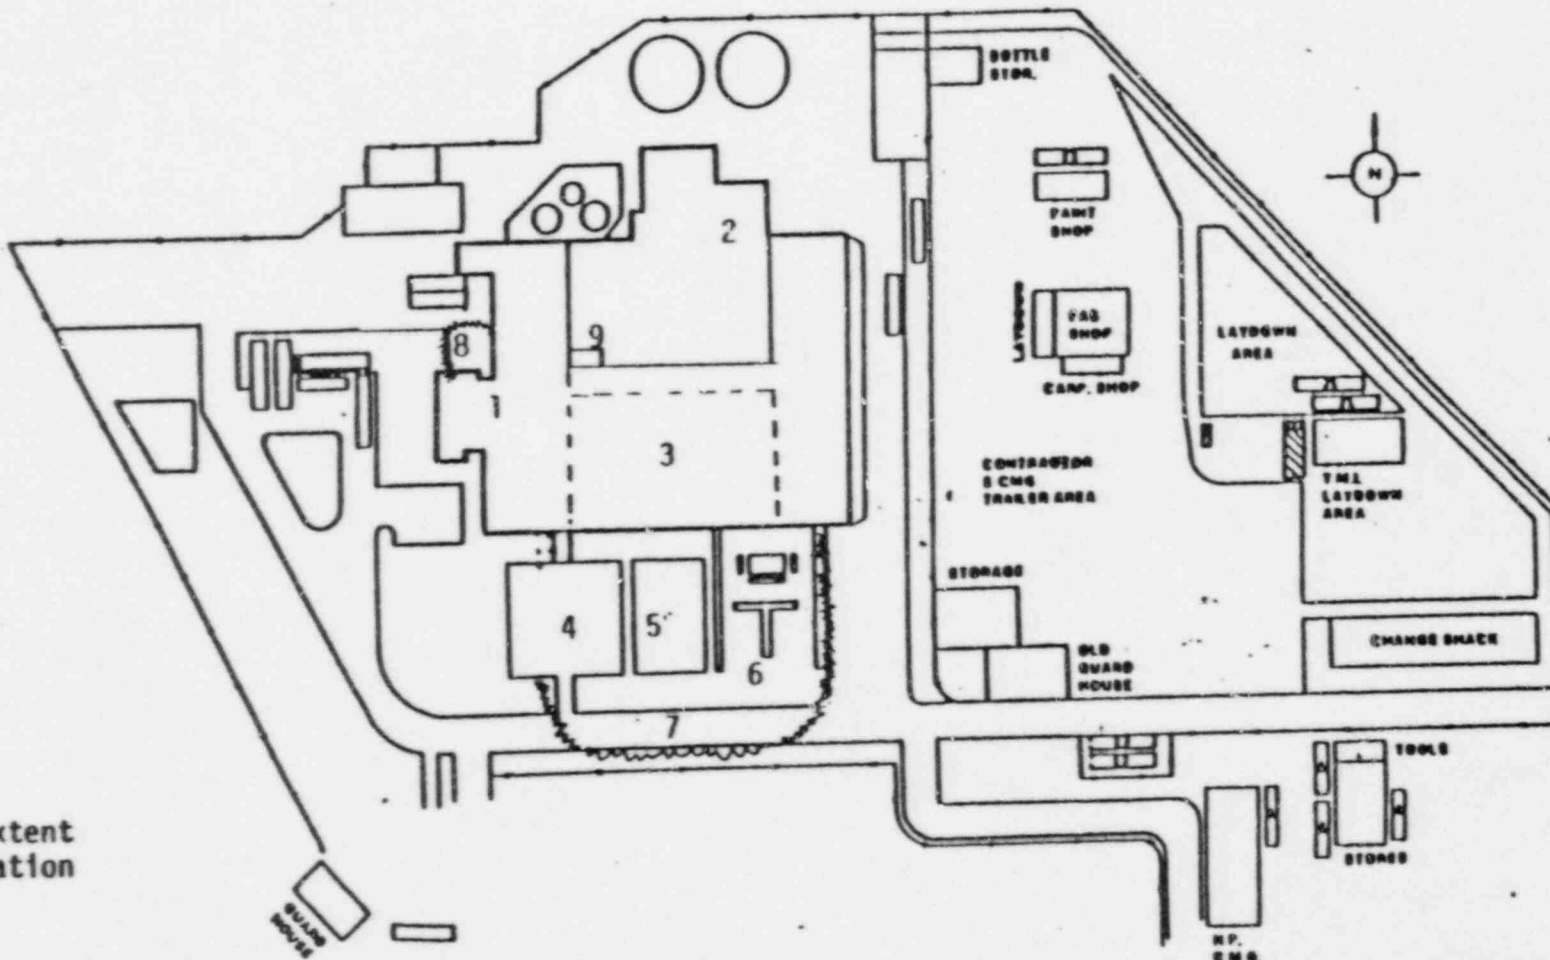
FIGURE 1

Enclosures 1 and 3 provide the most detail concerning the event itself. Figure 1 of Enclosure 1 indicates the extent of the contamination by the resin found on June 11, 1982. All contamination found was within the site boundary. Figure 1 of Enclosure 1 provides a detailed map, but basically contamination was found as follows:

JUNE 11, 1982

Indicates extent of contamination

- 1. Administration Building Roof - pockets, 100K - 200K dpm
- 2. Reactor Building Roof - clean
- 3. Turbine Building Roof - pockets, 100K dpm
- 4. AOG Building - pockets, 200K dpm
- 5. Retube Building - pockets, 200K dpm
- 6. Main Transformer Area - 1K - 25K dpm (small areas)

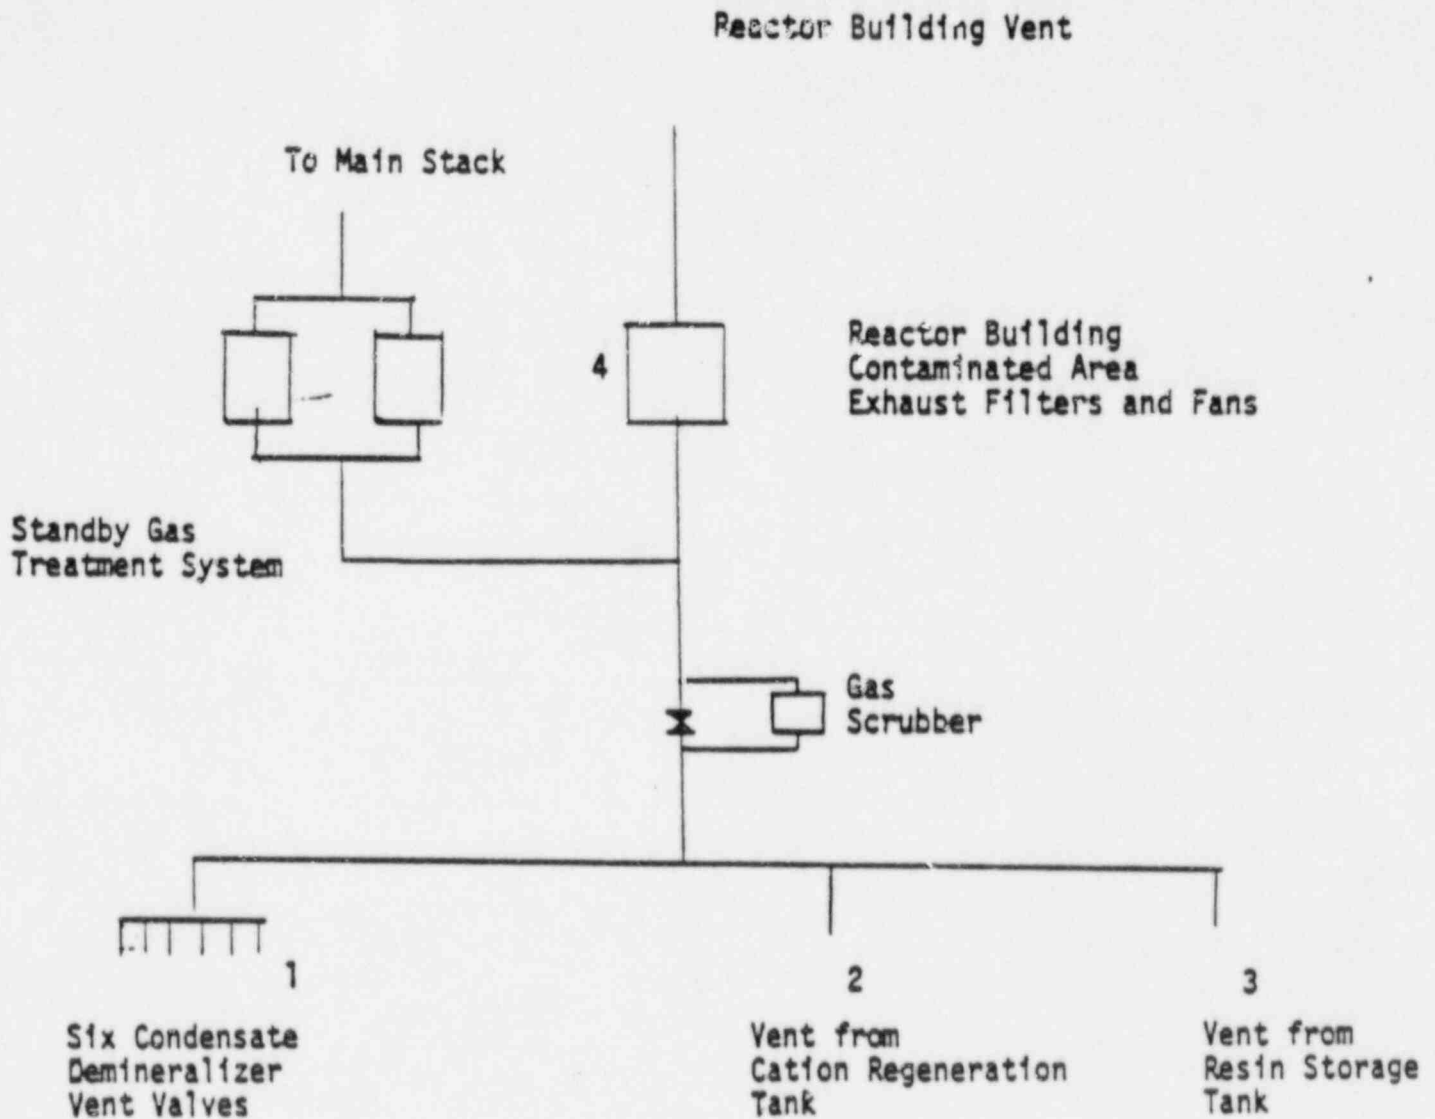
1. Possible source prior to repair.
2. Apparent source during backwashing.
3. Possible source during resin transfer
4. Filters found to be by-passing about September 1981.

The licensee believes the resin entered the ventilation ducts from the condensate demineralizer system during resin backwashing via the Cation Regeneration Tank Vent. In addition, resin from defective condensate demineralizer vent valves may have also been released prior to their repair during the September 1981 - March 1982 refueling outage. The resin appears to have been released from the Reactor Building Ventilation Exhaust System vents above the reactor building roof, prior to the repair of defective filters in this system in September 1981.
