This forwards a copy of a letter from Promatec, dated February 17, 1986, for your information. This letter was a 10 CFR Part 21 report concerning defective material used in fire stops and may be applicable to the installations in your facility.

February 17, 1986

Reference: 10 CFR Part 21 - Notification of Defects

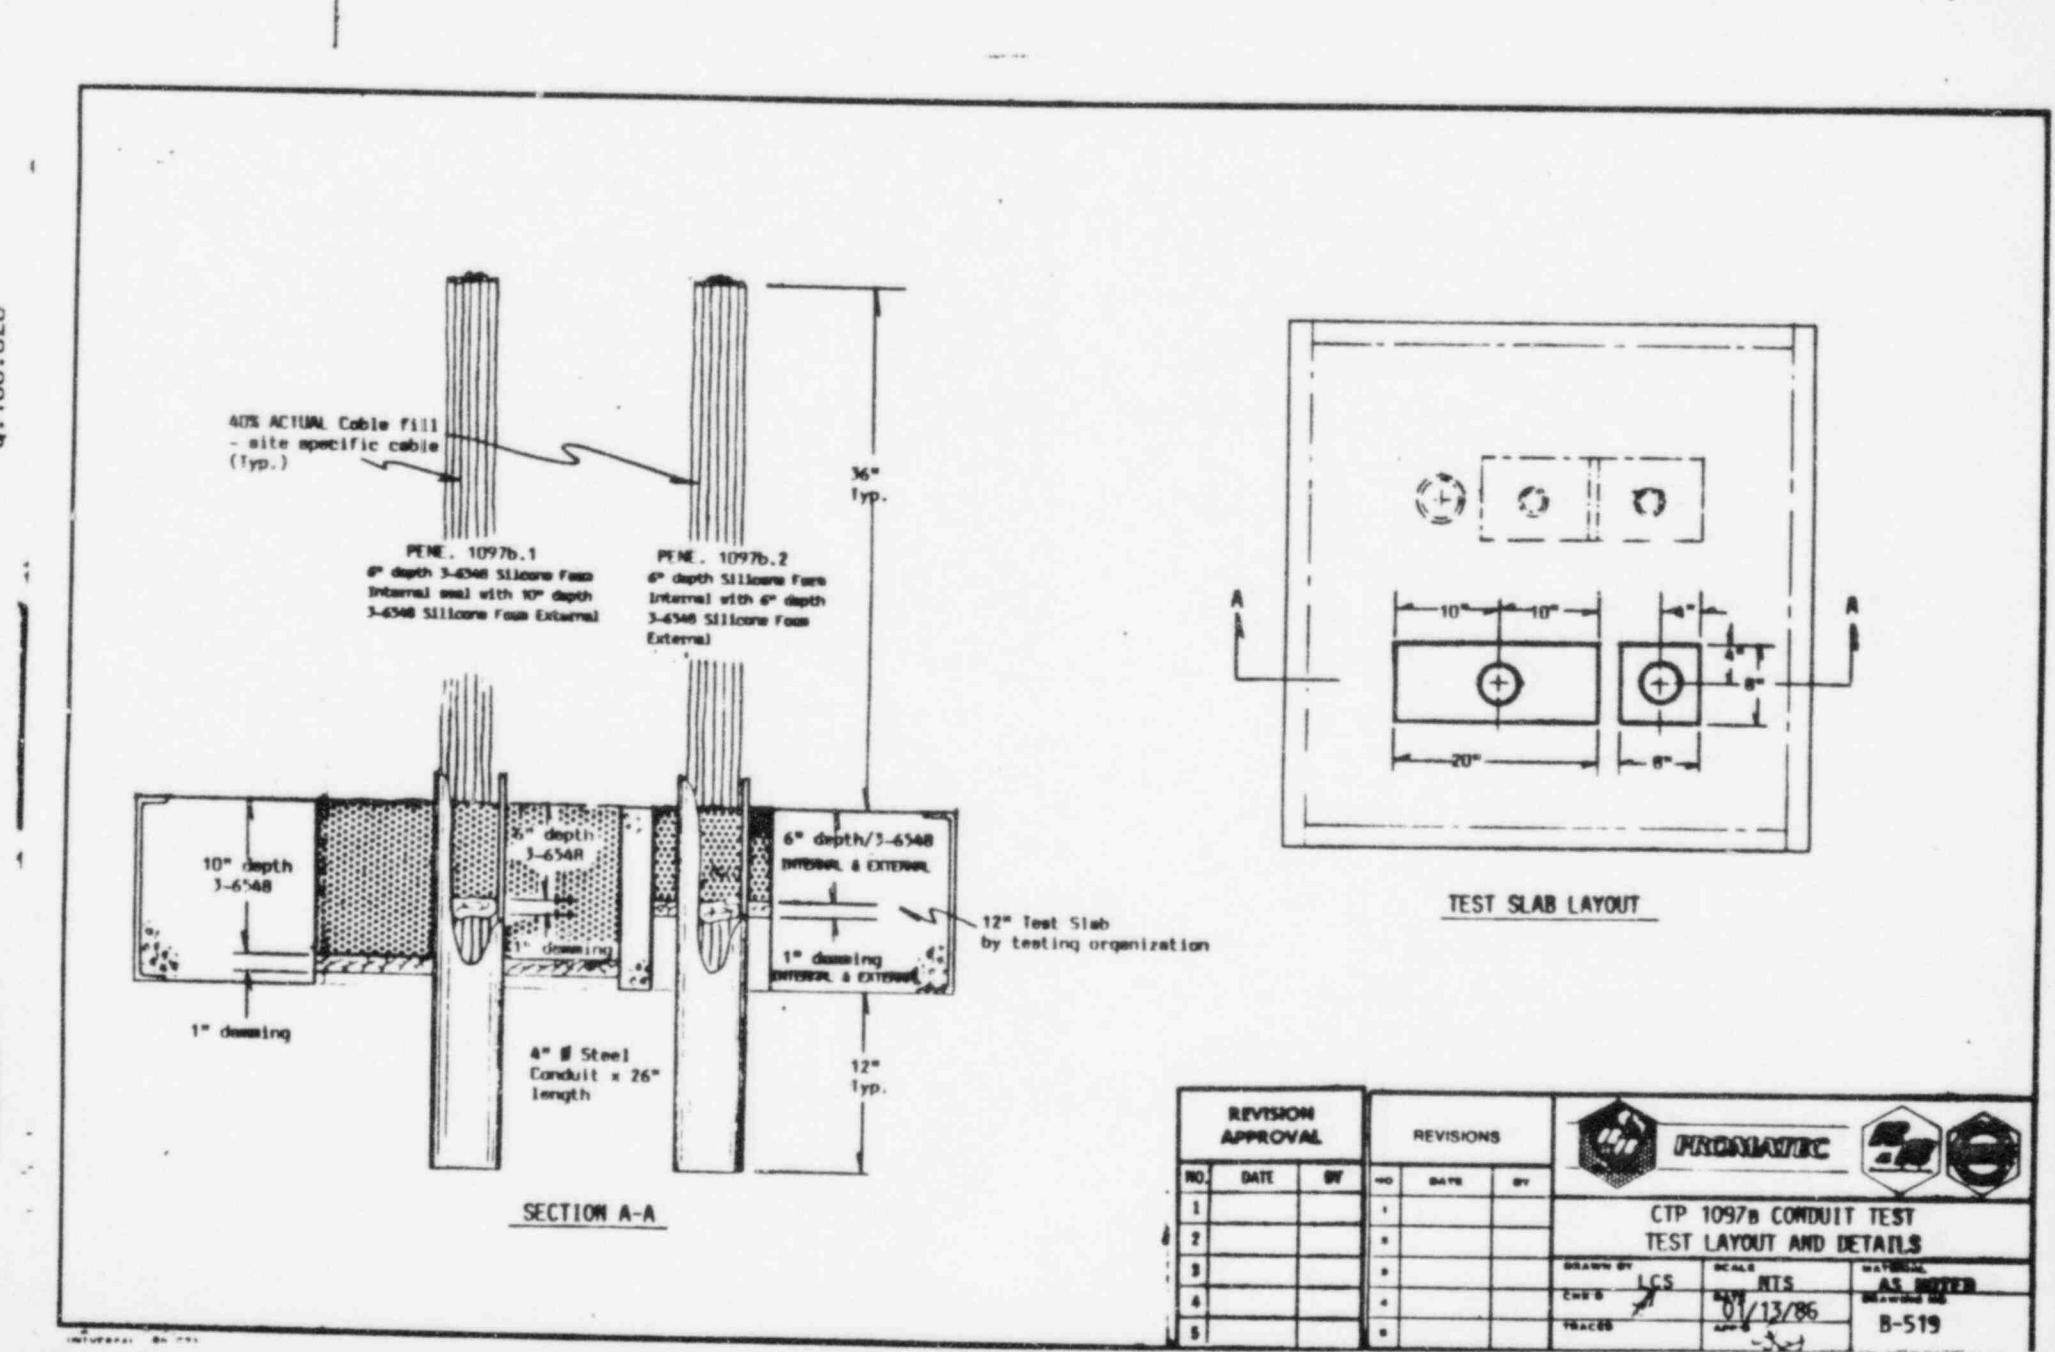
Attachment 1

One 8" x 8" blockout and one 8" x 20" blockout in a 12" thick concrete slab with two (2) conduit penetrators as described below and detailed on drawing no. B-519 (attachment 1).

- 2.1.1 Damming and cable separation Alumina Silica Fiberous Material (Bulk and Board).
- 2.1.2 Penetration and conduit seal Dow Corning 3-6548 Silicone RTV Foam
- 2.2 Penetration and conduit seal configurations were as follows:
 - 2.2.1 Configuration 1097b.1 Conduit seal with a minimum depth of 6" plus 1" damming as measured from the top of the slab; penetration seal with a minimum depth of 10" plus 1" damming as measured from the top of the slab.
 - 2.2.2 Configuration 1097b.2 Conduit seal with a minimum depth of 6" plus 1" of damming as measured from the top of the slab; penetration seal with a 6" depth plus 1" of damming as measured from the top of the slab.

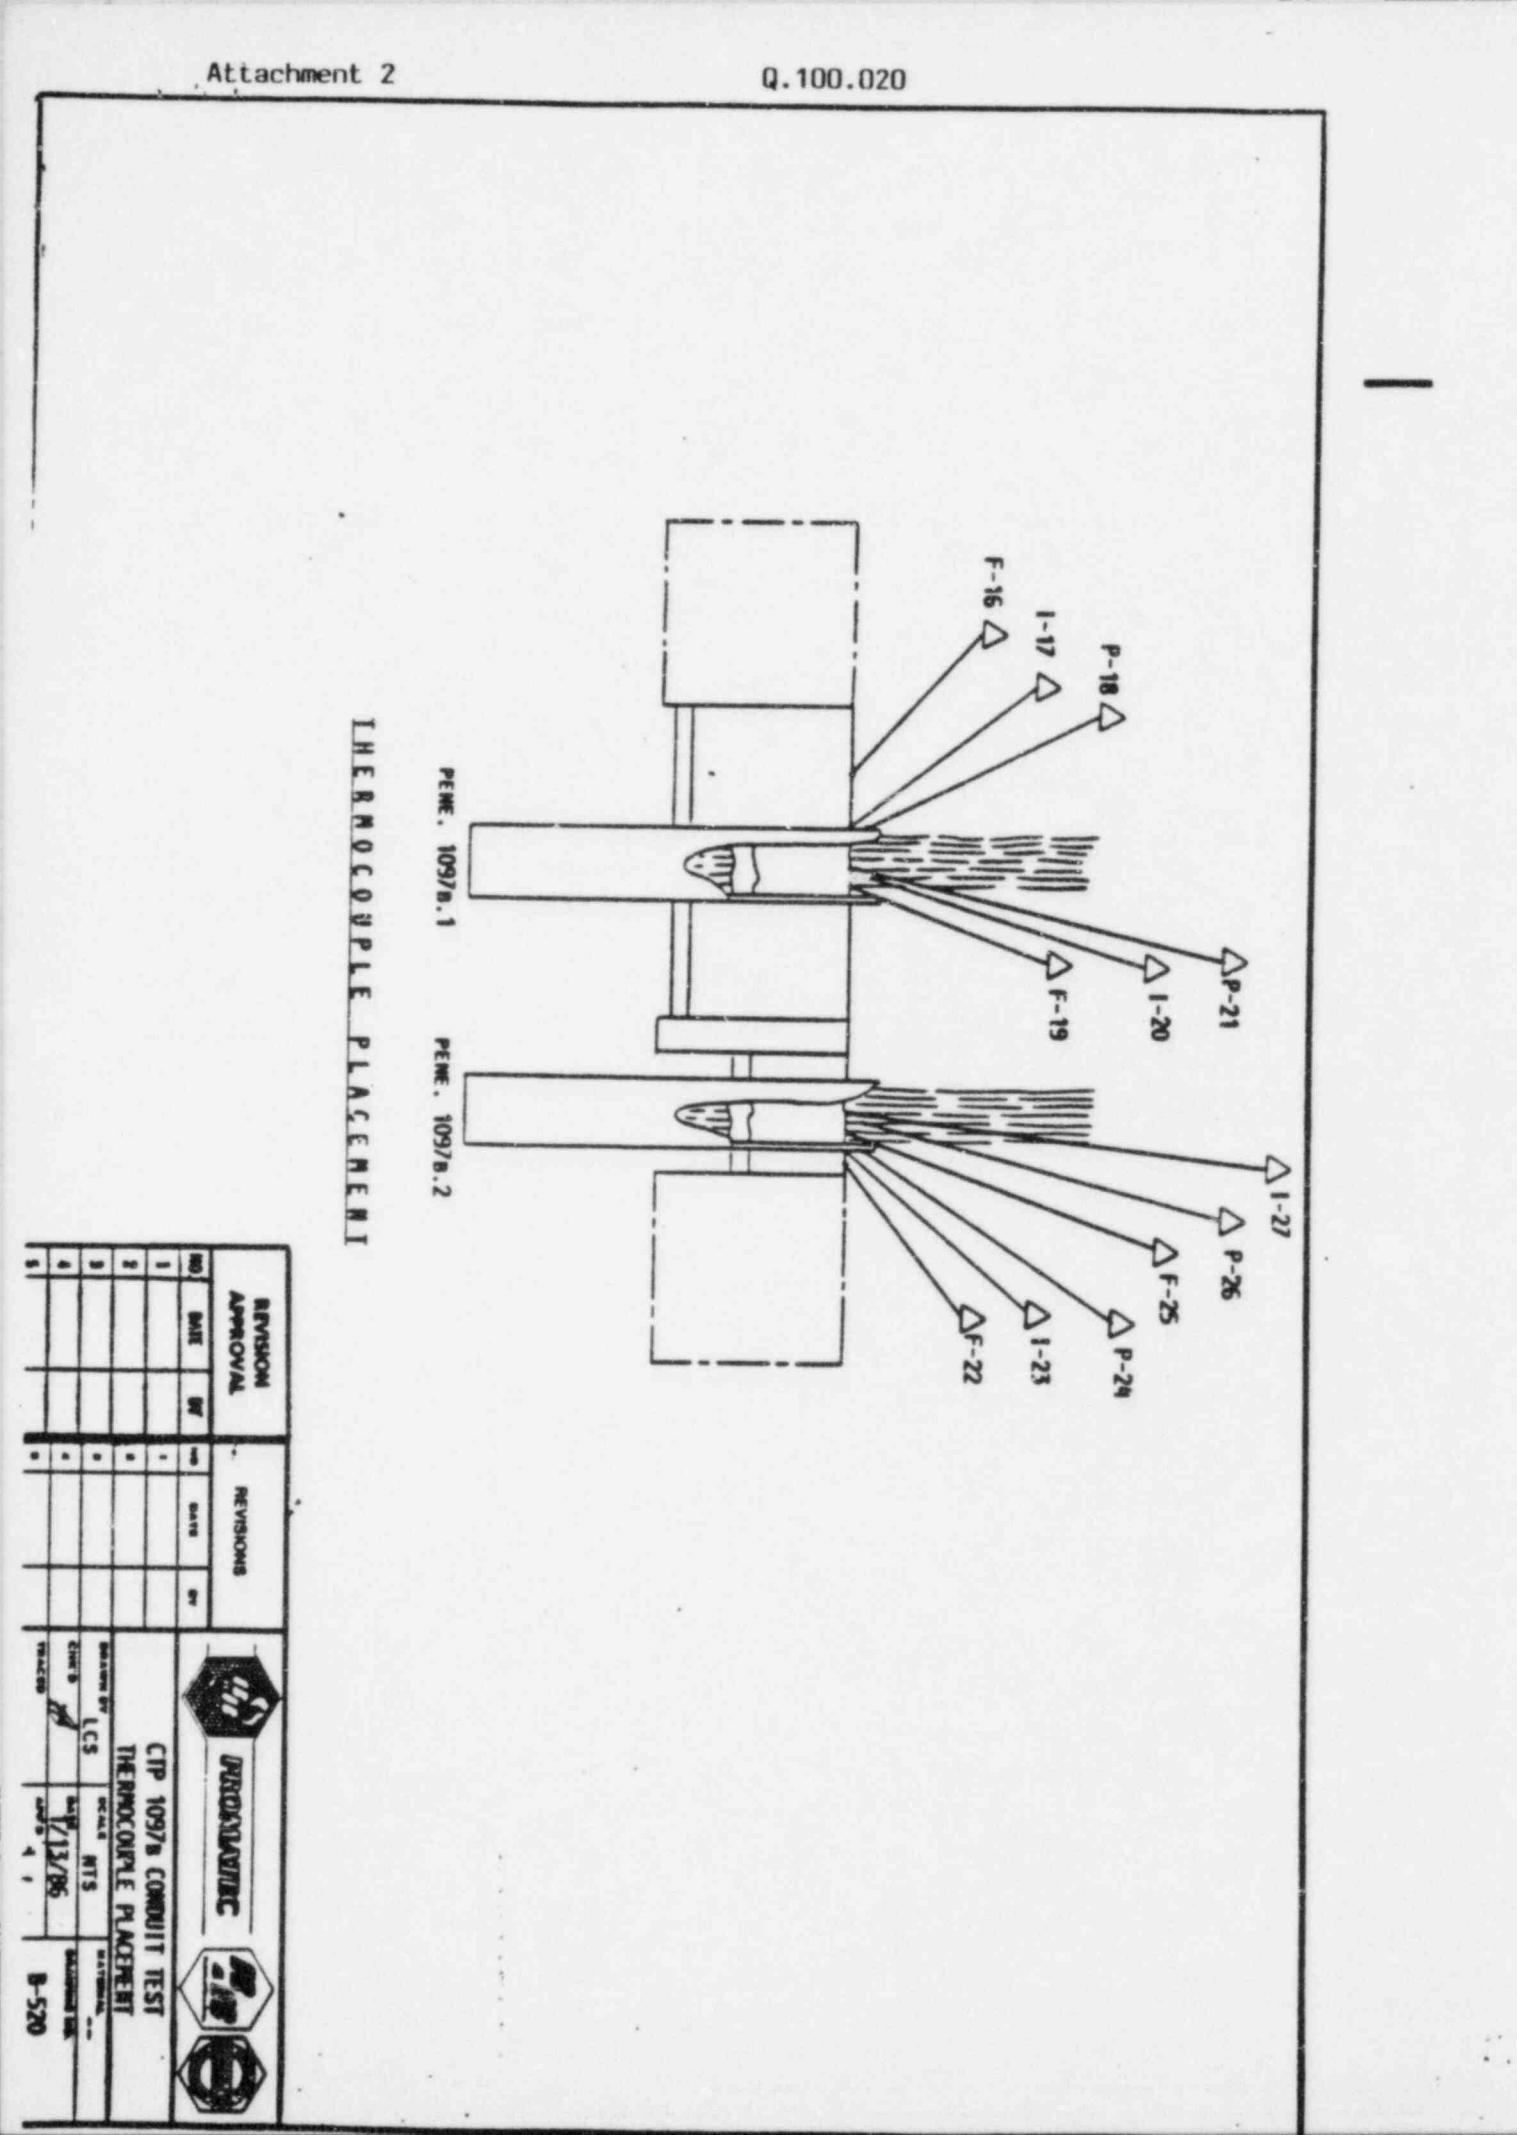
- 3.1 Thermocouples were located in accordance with the requirements of IEEE 634 and ASIM E119 as shown on drawing no. B-520 (attachment 2).
- 3.2 The prepared test slab assembly was exposed to the standard time temperature curve established by ASTM E119 for a period of three (3) hours with the following results:

- 3.2.1 Configuration 1097b.2 Thermocouple F-19 exceeded the maximum allowable with a temperature of 401° F at 1 hour, 23 minutes and a three (3) hour reading of 659° F.

- 3.2.2 Configuration 1097b.1 Thermocouple F-25 exceeded the maximum allowable with a temperature of 401° F at 2 hours, 14 minutes and a three (3) hour reading of 446° F.

- 3.3 While no flame through was noted on the unexposed side and hose stream tests did not cause openings, heat transmission as indicated by the field thermocouples exceeded the maximum temperature requirement of 325° F above ambient. An autopsy was performed and resulted in the discovery that both conduit seals were reduced to ash.
