NSIC Accession Number: 130111

Date: September 28, 1977

Title: Blackout Condition Occurs After Reactor Trip at Cook 1

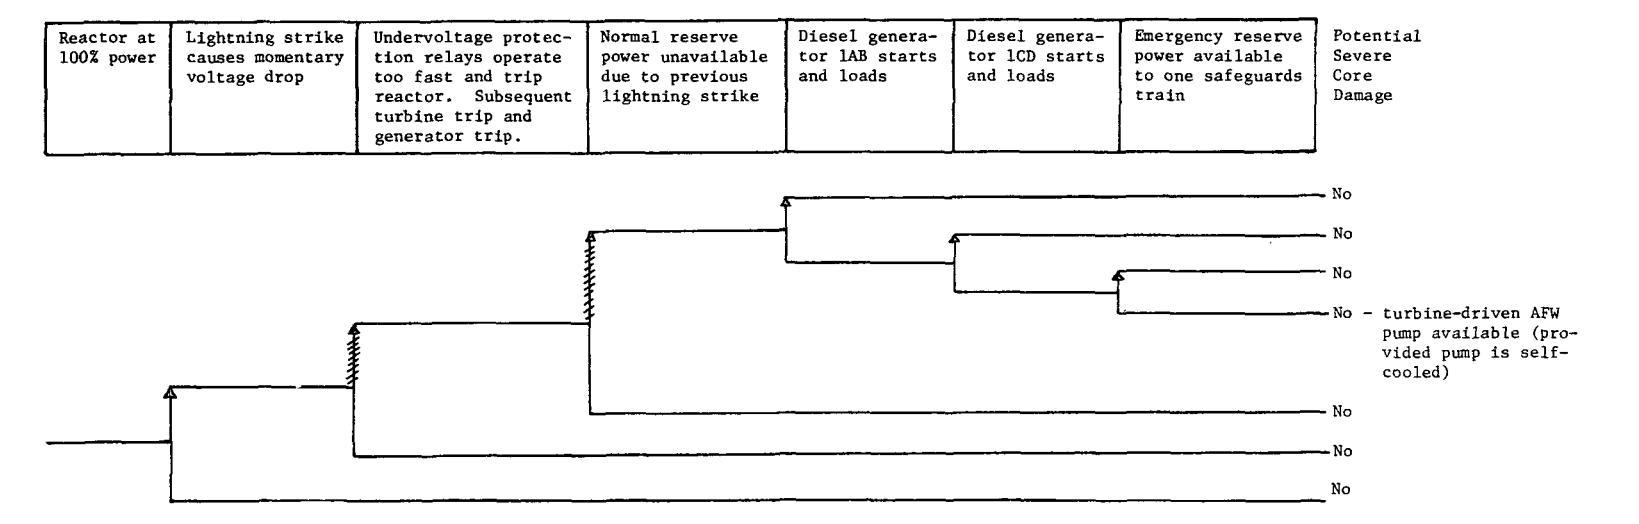
NSIC 130111 - Actual Occurrence for "Blackout" Condition Occurs After Reactor Trip at Cook 1

The failure sequence was:

- 1. With the reactor at 100% power and during an extreme thunderstorm, a lightning strike on a transmission circuit resulted in the opening of transformer breakers and the de-energization of the "normal reserve" transformer.

- 2. A subsequent lightning strike resulted in a momentary 36% voltage dip that was sensed by the reactor coolant pump bus undervoltage relays, which prematurely initiated a reactor trip and subsequent turbine and generator trips. This resulted in a loss of station electric power.

- 3. The two diesel generators started and provided power to essential loads.
- 4. One hour and 13 minutes after reactor trip, the decision was made to transfer the emergency buses to the "emergency reserve" offsite source (which had been available throughout the incident). Three of the four buses successfully transferred, the fourth bus did not transfer (reason unspecified) and was supplied power from its diesel generators.

- 1. The reactor coolant pump bus undervoltage relays were reset to their correct delay times.
- The reason for the failure of one emergency bus to transfer to the "emergency reserve" source was not specified.

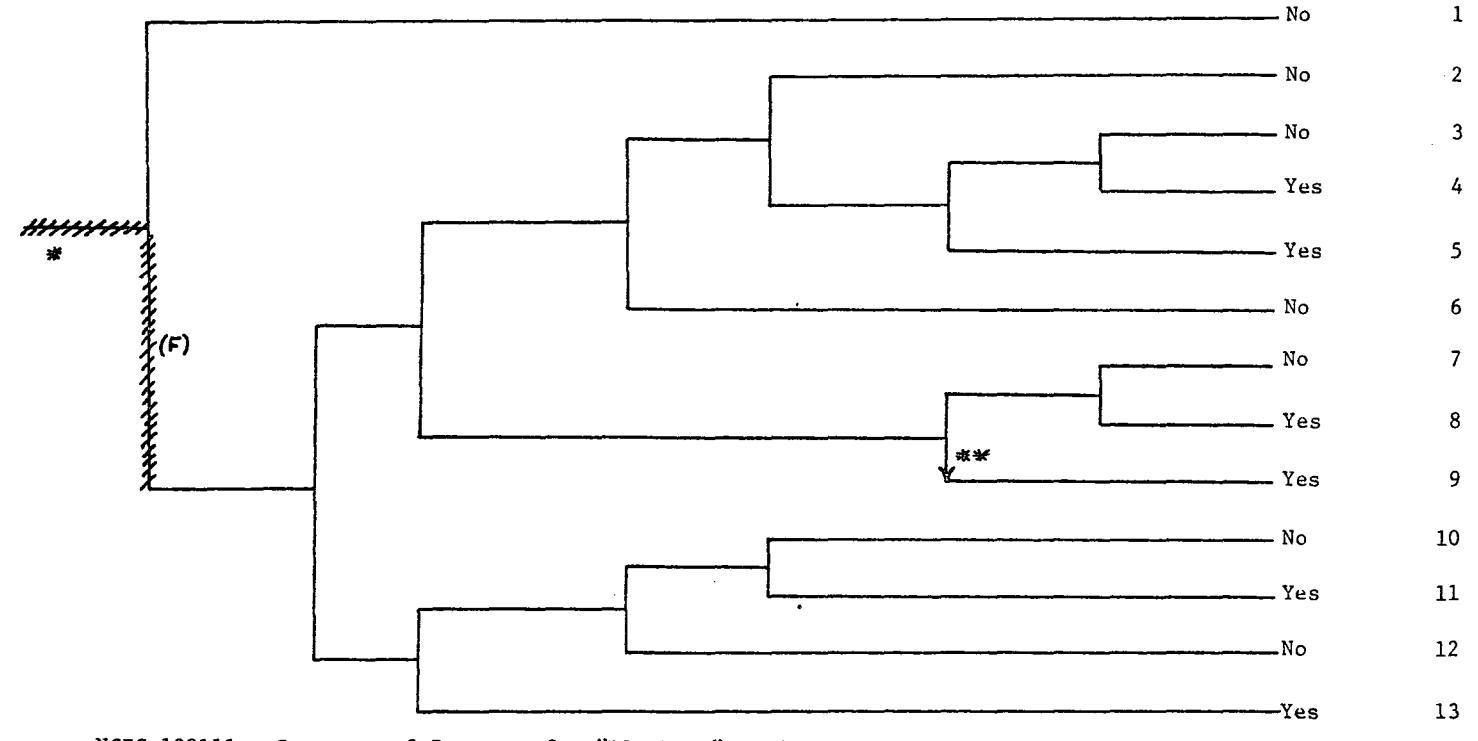
NSIC 130111 - Sequence of Interest for "Blackout" Condition Occurs After Reactor Trip at Cook 1 \* success requires manual transfer to an emergency reserve power source.

\*\*
not included in mitigation procedures.
