PRECURSOR DESCRIPTION AND DATA

NSIC Accession Number: 153333

Title: Flowpath from AFW Pump to Two Steam Generators Made Inoperable at Cook 1

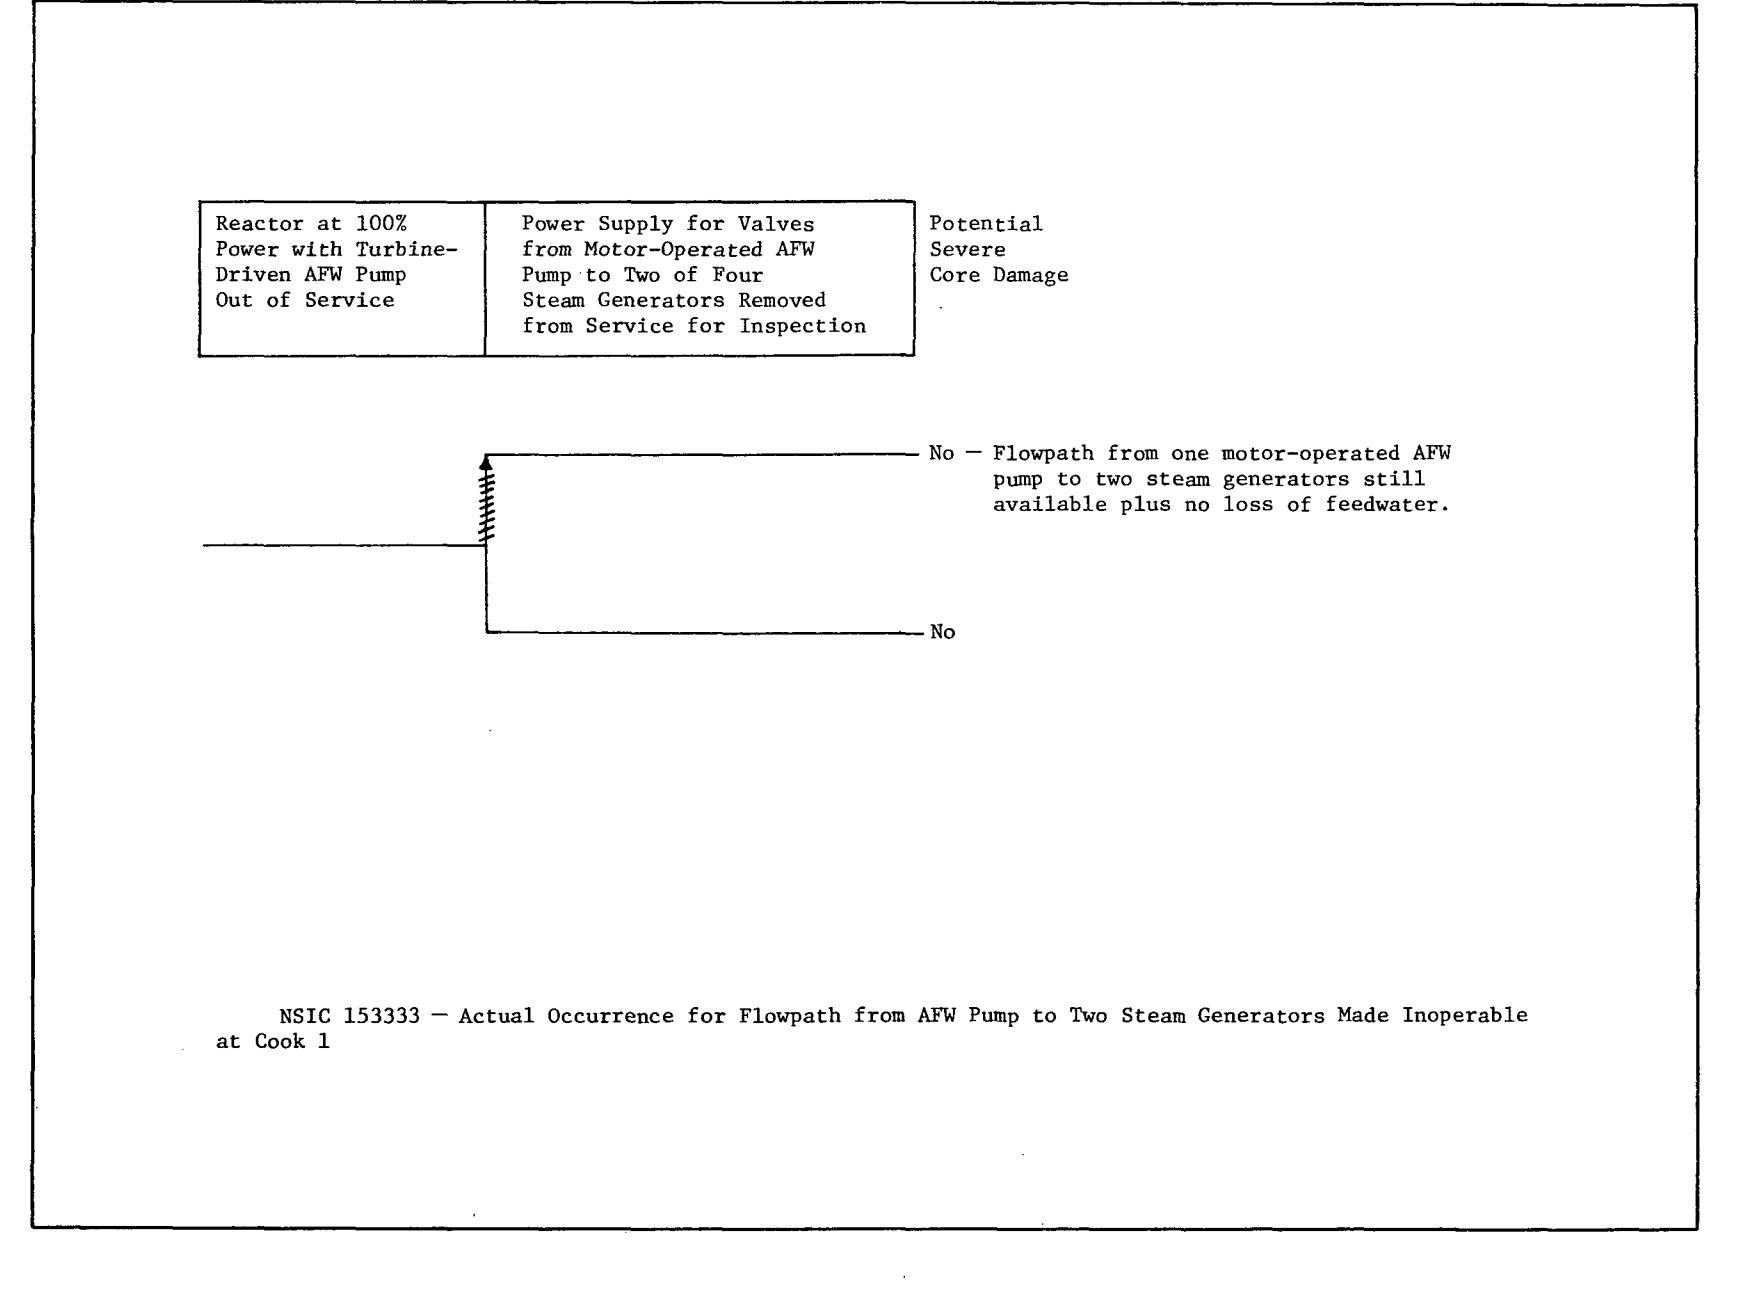
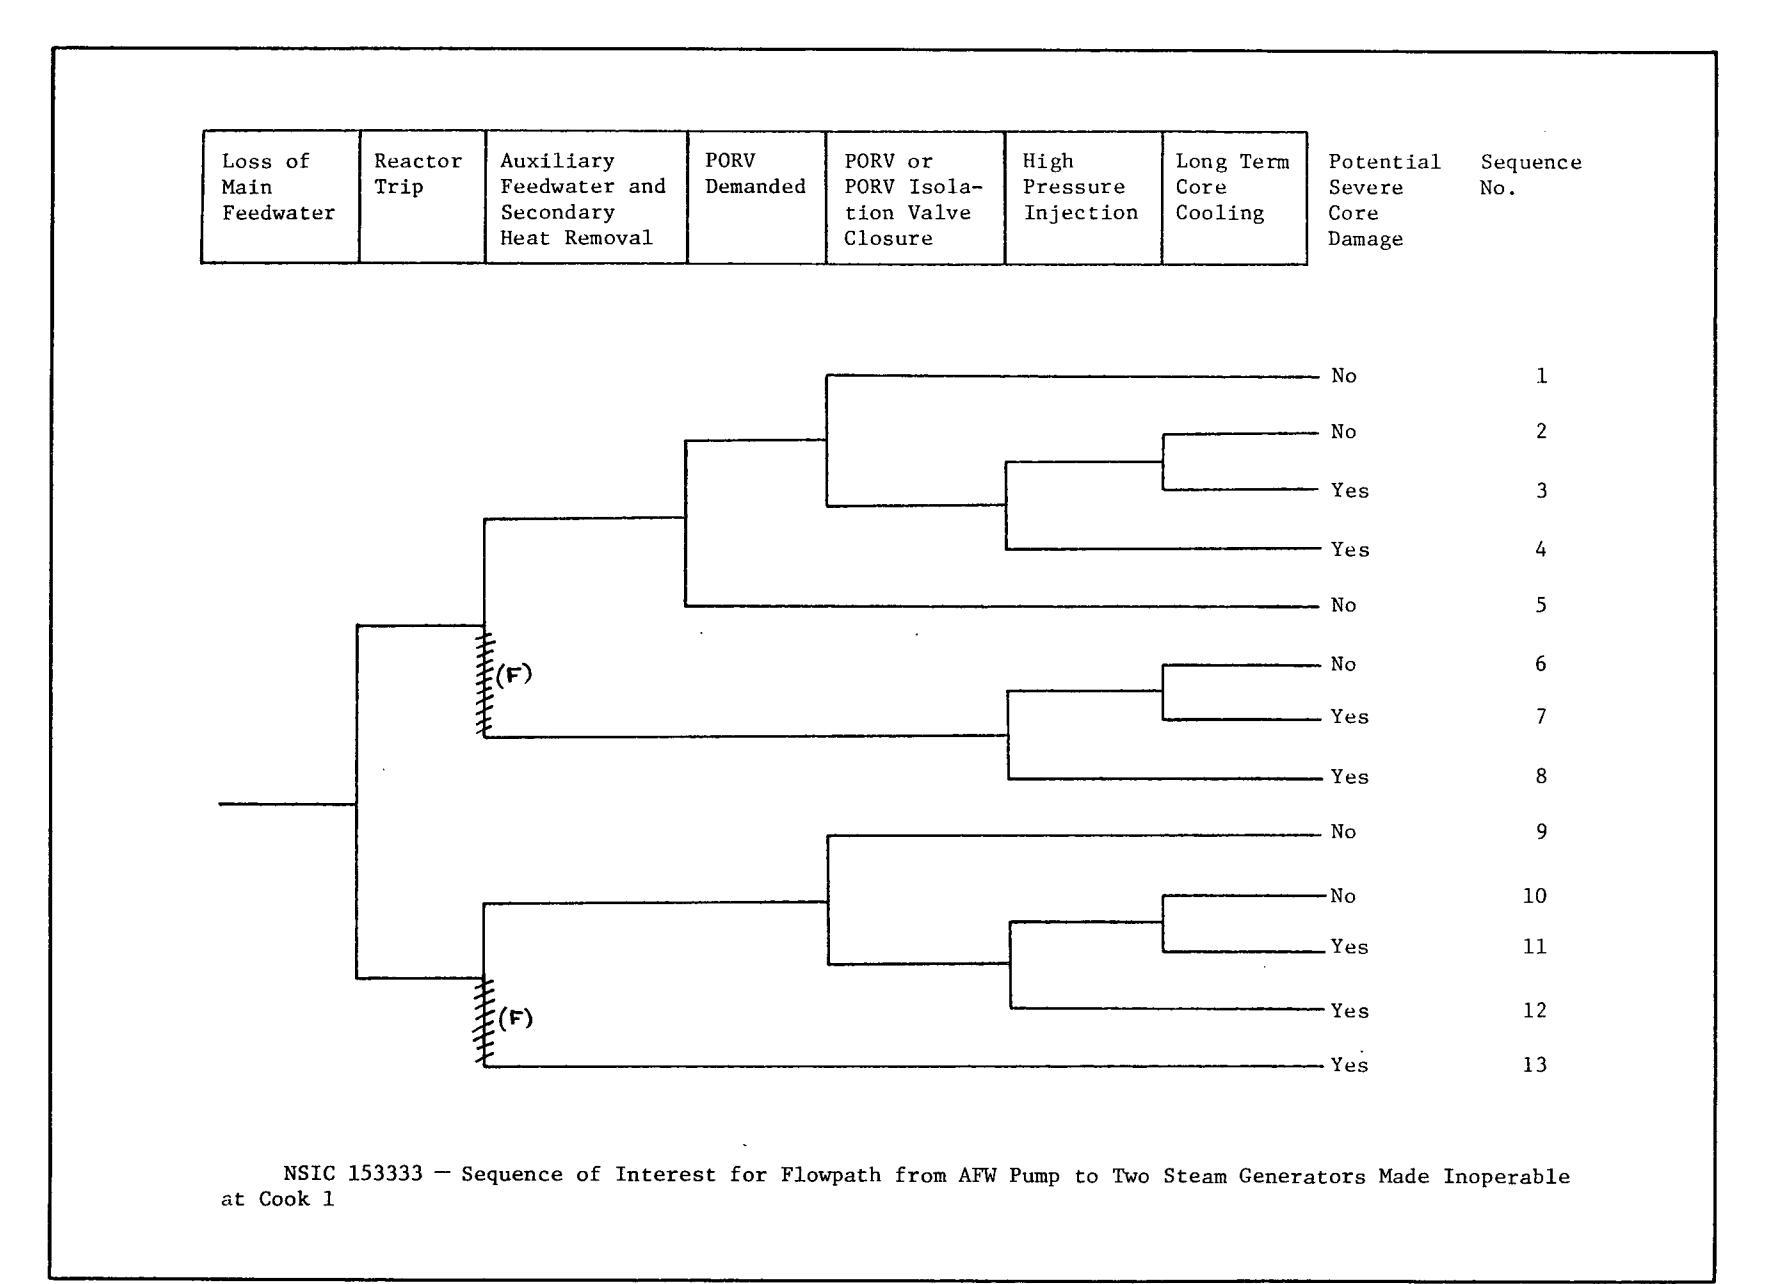
With the reactor at 100% power and the turbine driven AFW pump out of service for repair, the motor control center which provides power for valves which direct flow from one motor-driven AFW pump to two of the four steam generators was removed from service for inspection.

The motor control center provides power to the two motor operated valves associated with the AFW flow path from the motor-driven AFW pumps to two of the four steam generators.

CATEGORIZATION OF ACCIDENT SEQUENCE PRECURSORS NSIC ACCESSION NUMBER: 153333 DATE OF LER: November 29, 1979 DATE OF EVENT: November 15, 1979 SYSTEM INVOLVED: Auxiliary Feedwater COMPONENT INVOLVED: Motor Operated Valves CAUSE: Motor Control Center removed from service for inspection while the turbinedriven AFW pump was out of service for repair, human error SEQUENCE OF INTEREST: loss of of feedwater ACTUAL OCCURRENCE: unavailability of two AFW system valves plus the turbine driven AFW pump REACTOR NAME: Cook 1 DOCKET NUMBER: 50-315 REACTOR TYPE: PWR DESIGN ELECTRICAL RATING: 1054 MWe 4.8 yr REACTOR AGE: VENDOR: Westinghouse ARCHITECT-ENGINEERS: American Electric Power Corp. OPERATORS: Indiana and Michigan Electric Co. LOCATION: 11 miles south of Benton Harbor, Michigan DURATION: 4 hours PLANT OPERATING CONDITION: 100% power SAFETY FEATURE TYPE OF FAILURE: (a) inadequate performance; (b) failed to start; (c))made inoperable; (d) DISCOVERY METHOD: operator observation COMMENT: The Cook 1 FSAR states the LOFW analysis for Cook 1 assumes flow to all four steam generators. The failure reported herein resulted in flow to only two steam generators.

The motor control center was returned to service.
