SUBJECT: INTERNATIONAL ISOTOPES, INC. - NRC INSPECTION REPORT 030-35486/2020-001

NRC INSPECTION REPORT 030-35486/2020-001 - DATED June 22, 2020

NRC Inspection Report 030-35486/2020-001

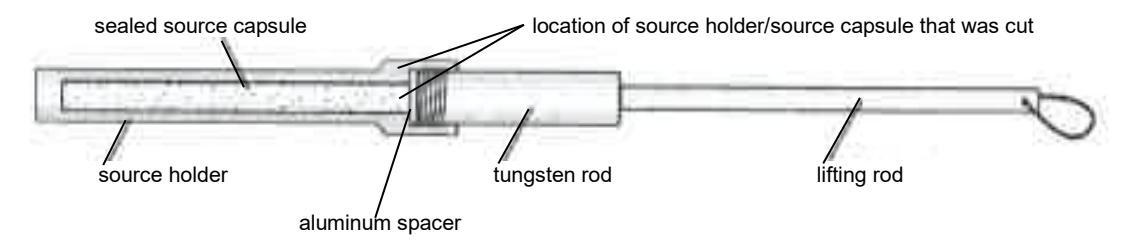
On May 2, 2019, INIS personnel began operations on-site at the University to remove the sealed source capsule from the source holder by using a high-speed cut-off saw, with attached grinding wheel, while the source holder was within the mobile hot cell. The original plan was to grind down the ends of a roll pin (a small rod inserted perpendicular through the source holder and the tungsten rod in the area of their threaded interface) sufficiently to allow the tungsten rod to be unthreaded from the source holder, thereby allowing the source holder to be opened and sealed source capsule removed. International Isotopes, Inc., considered it necessary to remove the sealed source capsule from the source holder because the source holder was too long to fit into the NPI transportation cask which they had previously used for shorter source holders, and the external dose rates were too high to use the 10-160B transportation cask.

International Isotopes, Inc., personnel proceeded to make several circumferential cuts into the source holder in an area that they believed to contain the threaded portion of the tungsten rod/source holder interface (INIS was apparently unsure of the critical dimensions of the source holder/source capsule, and where the active portion of the source capsule was located). Some of the circumferential cuts into the source holder penetrated the source capsule at various lengths and depths, which resulted in the release of cesium-137. Since this work was performed within the mobile hot cell, it would be assumed that a radioactive release would have been contained; however, this mobile hot cell was not designed to contain unsealed radioactive material, so the contamination subsequently spread outside of the workers within the room, and eventually spread throughout the University's Harborview Medical Center.
