## SSER

- 1. <u>Allegation Group</u>: Mechanical and Piping Category 43 Poor welding conditions for spent fuel storage pool liner
- 2. Allegation Number: AM-11, AW-40, AW-42, AQW-80, AW-81, and AW-82

- Allegation Group: Mechanical and Piping Category No. 43, Poor Welding Conditions for Spent Fuel Storage Pool Liner
- 2. Allegation Number: AM-11, AW-40, AW-42, AQW-80, AW-81, and AW-82

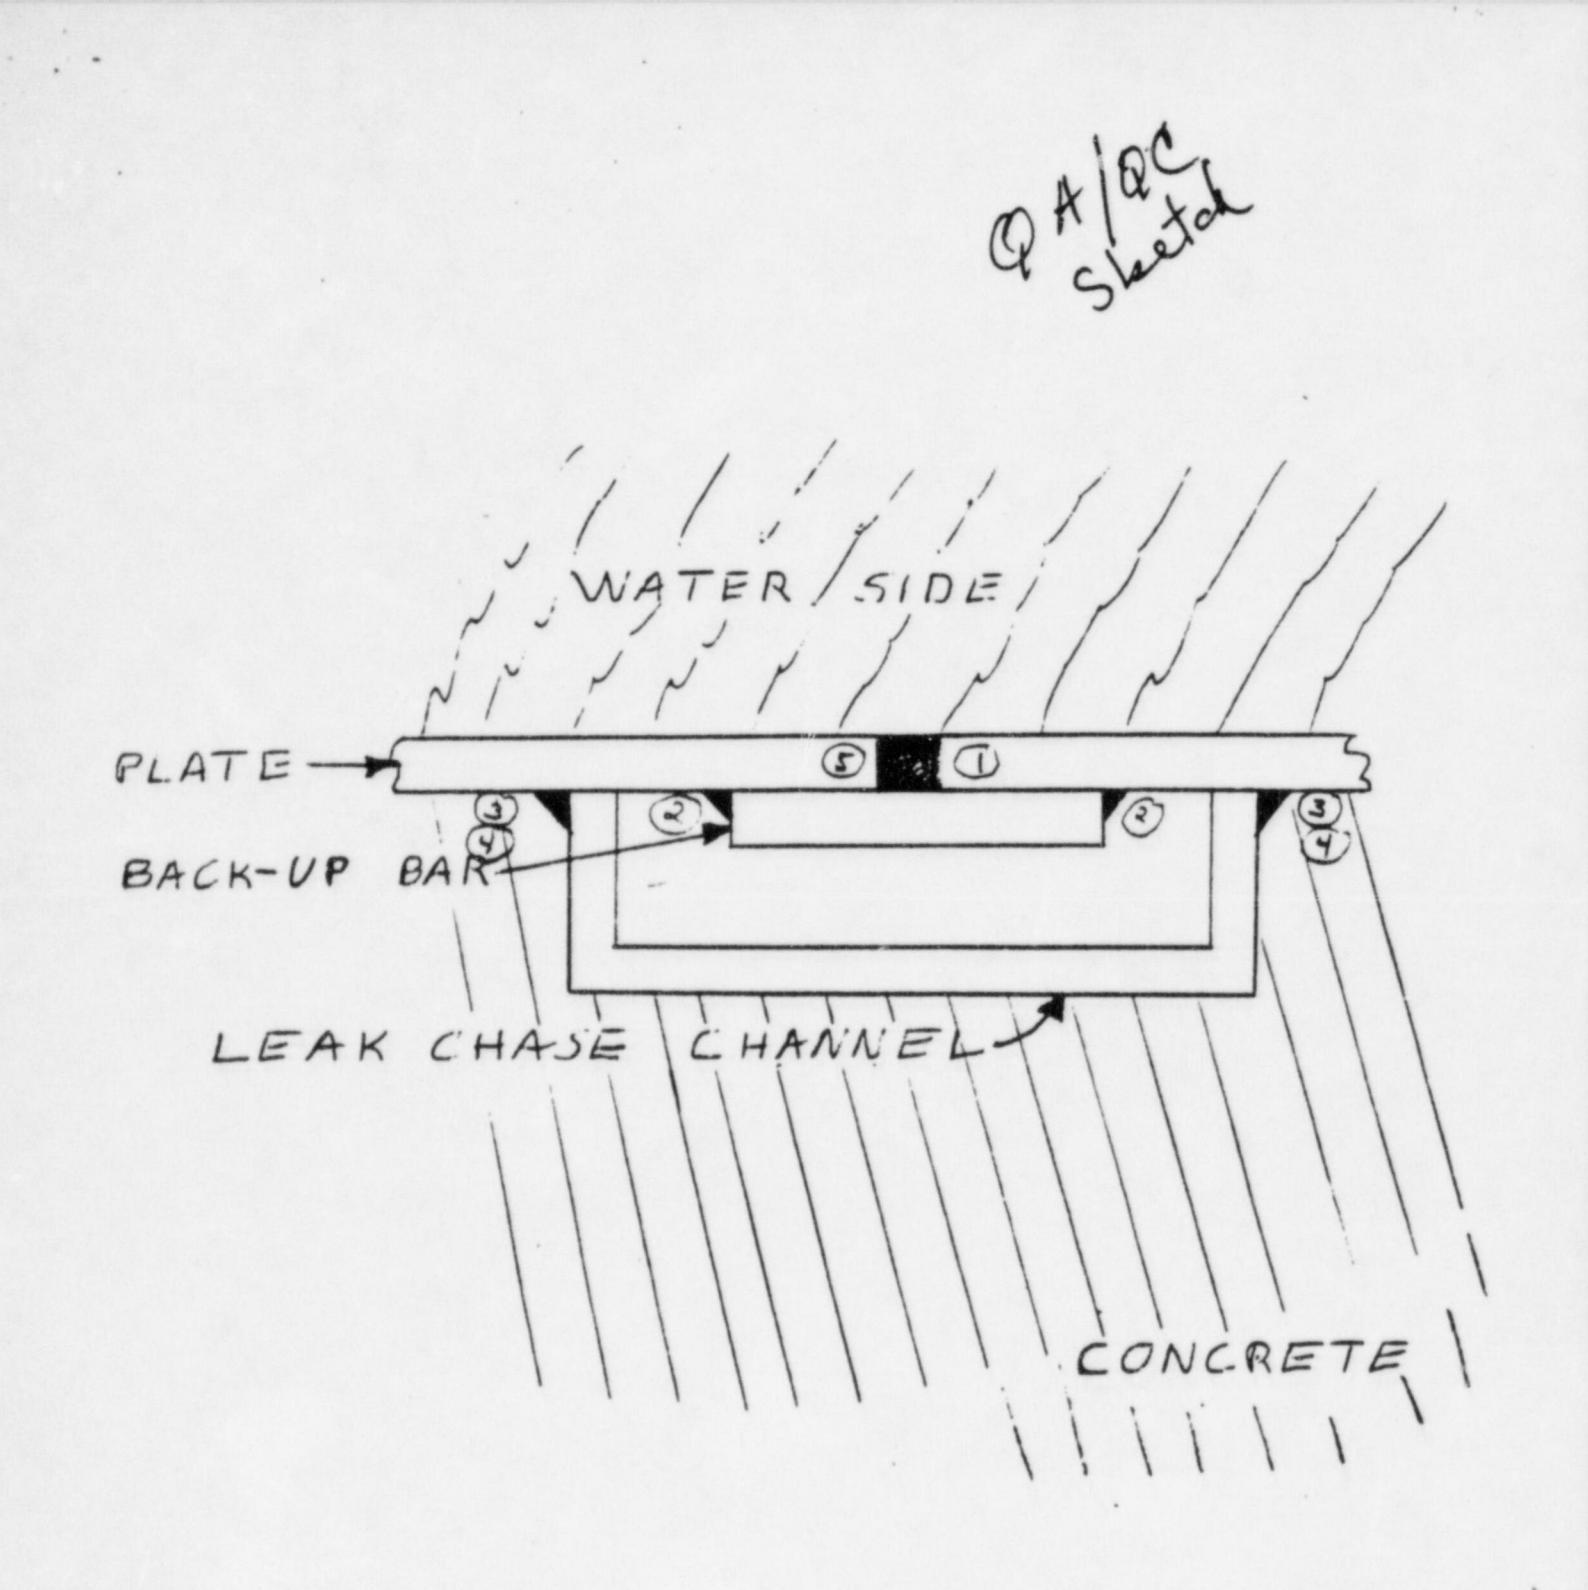
# LINER PLATE-TO-PLATE WELD

backing strip in place to accomplish the wall liner plate-toplate fitup, and the attachment of the leak chase charmels which are fillet welded and form the enclosure around the backing strip. The purpose of the leak channels does not include the intent to be a secondary seal to the plate-to-plate seal weld. Therefore, there are no regulatory requirements for documentation of visual examinations for cleanliness of attachment locations to the back surface of the liners. The requirements which are established in accordance with the pertinent portions of Appendix B to the 10 CFR 50, and defined in B&R's Quality Instruction QA-QAP-11.1-4, apply only to the plate to plate "seal" weld. Normally these requirements include visual examinations for cleanliness, fitup, and the completed weld; a liquid penetrant examination of the completed weld and a liquid film vacuum box "bubble" test for leakage. All of these examinations are performed at the front (exposed) surface. The fact that the backing strip is no longer visible from the back side is of no Over and above any regulatory requirement the consequence. crawings specified certain areas to be radiographed. TUSI letter TUQ-041 dated September 4, 1975 to B&R permitted the substitution of magnetic particle inspection in lieu of radiography for vertical containment liner welds in the -reactor (The TRT notes that magnetic particle inspection is not applicable to the liner material, which is type 304L austenitic stainless steel. It is probable that liquid penetrant inspection was actually used. There were other areas that were examined by the Mass Spectrometer Leak Testing method. As mentioned earlier in this
