SUBJECT: REQUEST FOR COMMENTS/CONCURRENCE ON VOLUME II OF NUREG-1179, "RUPTURE OF MODEL 48Y UF₆ CYLINDER AND RELEASE OF URANIUM HEXAFLUORIDE"

Rupture of Model 48Y UF6 Cylinder and Release of Uranium Hexafluoride

Cylinder Overfill, March 12-13, 1986 Investigation of a Failed UF₆ Shipping Container

NUREG-1179 Vol. 2

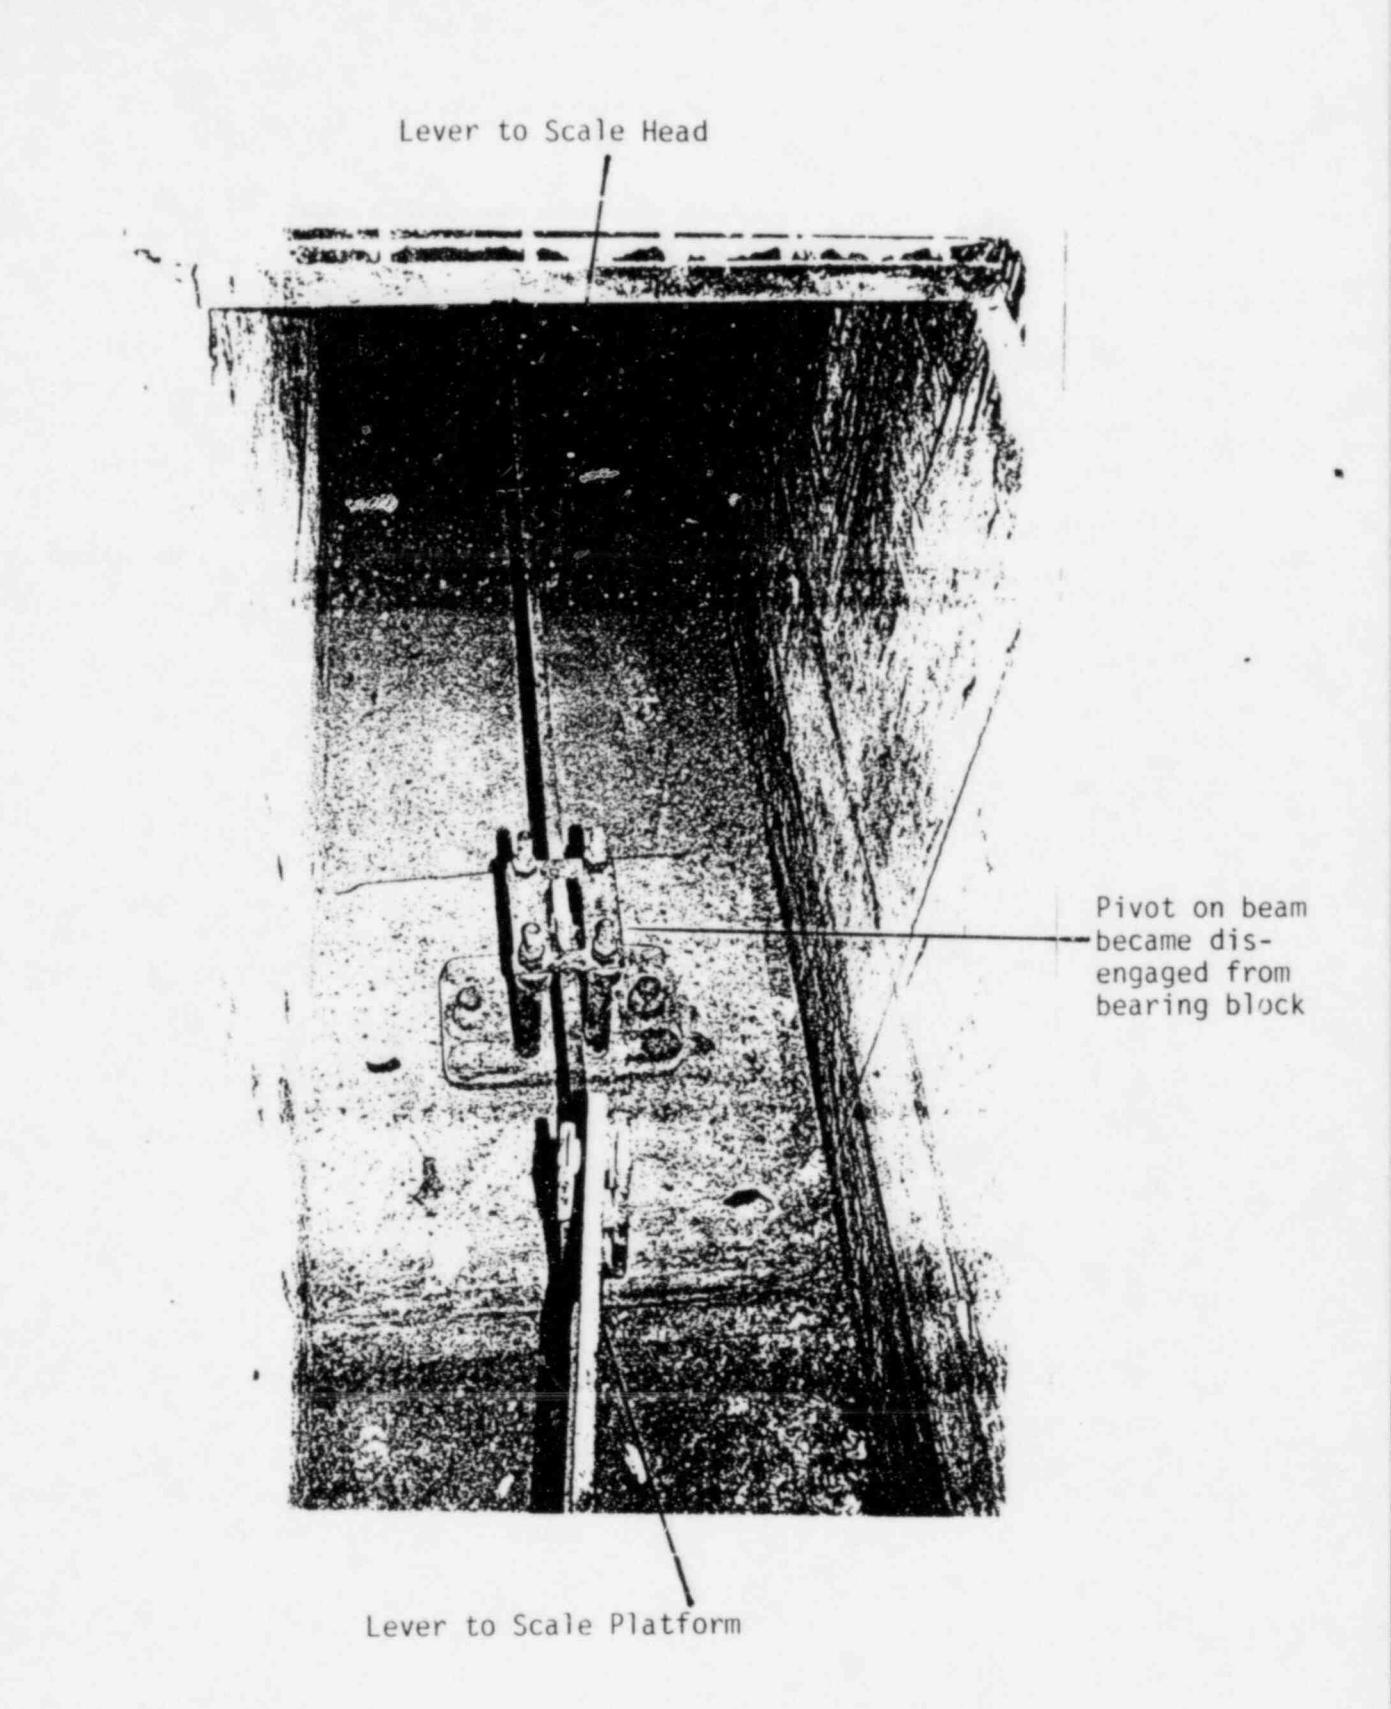
Figure 3.1 Beam and Pivot Assembly

After the scale malfunctioned during the filling of the cylinder on March 12-13, 1986, a scale technician was summoned to the site to examine the north drain station scale on the morning of March 14. The invoice for this service stated that the main lever to the nose iron had been moved out of place. This caused the pivot, which is mounted on the lever, to be out of the bearing block, which is supported in the bottom of the scale pit (see Figure 3.1). The invoice further stated that the lever had been realigned, the scale calibration had been checked, and the scale was found to be in good working order.

The AIT interviewed the scale technician during the morning of March 17, 1986, and the technician accompanied the team members to the north drain station scale. The floor grating was removed to gain access to the scale pit midway between the catwalk located near the fill header and the scale platform. The technician then demonstrated the condition in which he had found the scale on the previous Friday when he entered the scale pit. He then dislodged the lever to demonstrate how it could have been done and replaced it to its normal position. A member of the AIT then entered the pit and repeated these actions. The scale technician rechecked the positioning of the lever. The dislodgement of the lever was noted to take minimal effort. Thus, the lever could have been unnoticeably and unintentionally jarred out of position by decontamination workers working in the pit.

- (1) The scale used for weighing the cylinder being filled was malfunctioning. It was determined that a beam linking the scale platform with the readout dial had become dislodged. With its pivot point displaced, the scale gave erroneously low indications of weight

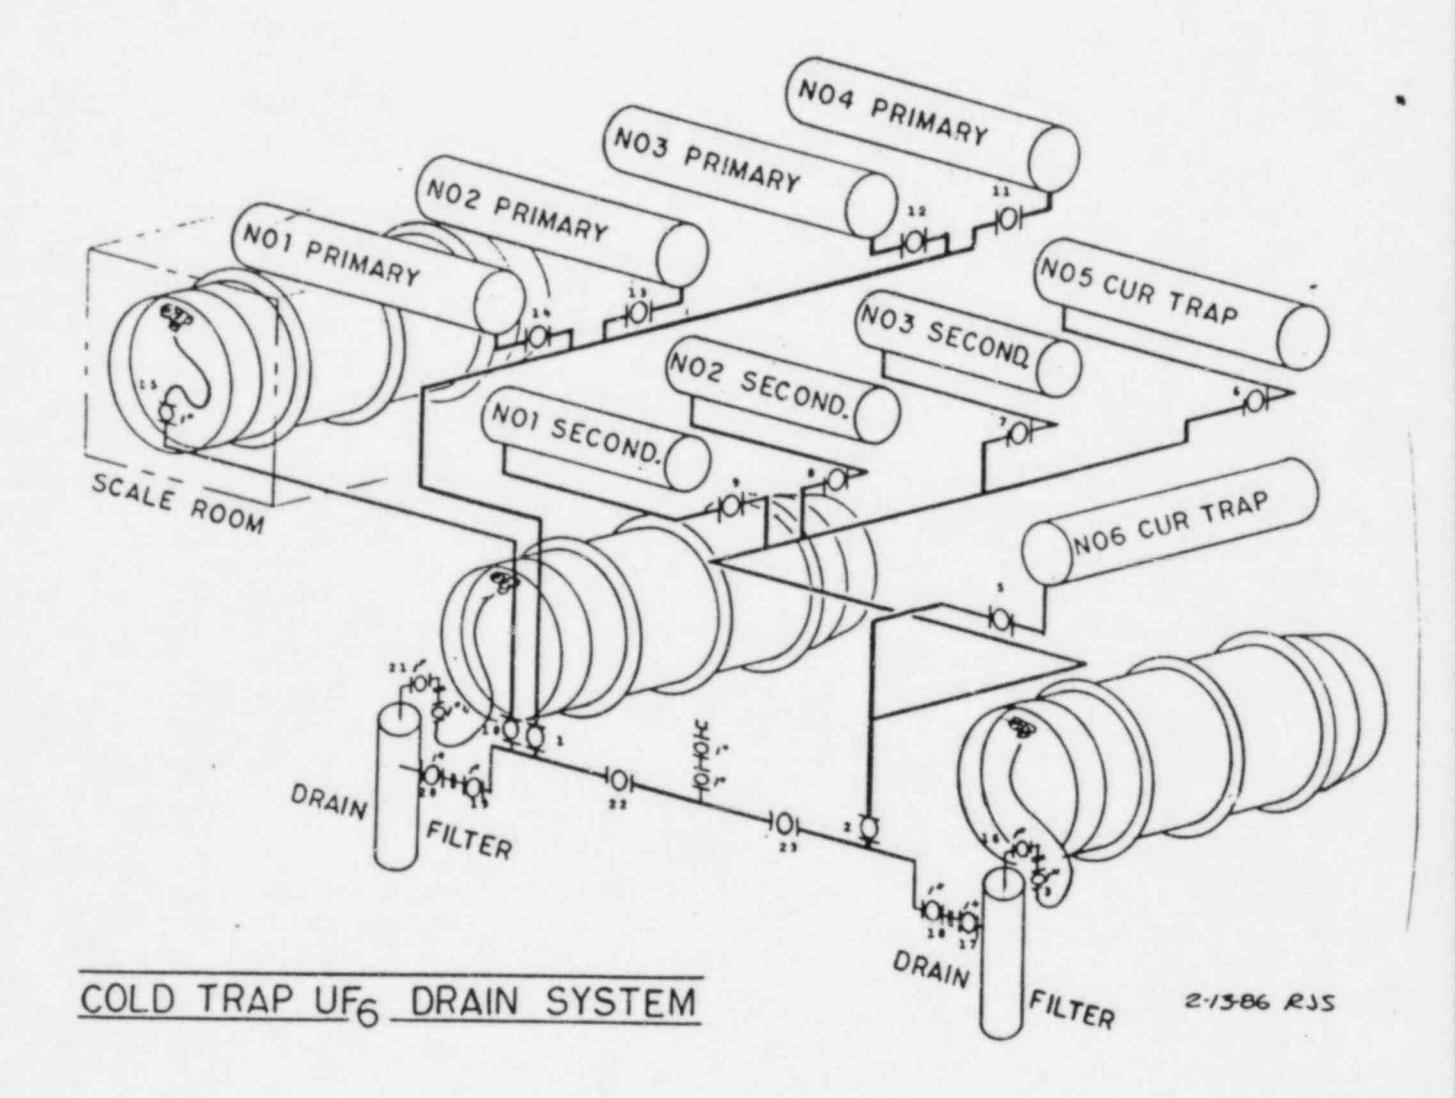
Figure 3.2 Cold Trap UF₆ Drain System

A simplified flow diagram illustrating the draindown equipment is shown in Figure 3.2.
