ROCHESTER GAS AND ELECTRIC CORPORATION . 89 EAST AVENUE, ROCHESTER, N.Y. 14649-0001

March 6, 1987

Subject: Inspection 87-03 - Environmental Qualification of Electrical Equipment 10CFR50.49 R.E. Ginna Nuclear Power Plant Docket No. 50-244

VICTOREEN HIGH-RANGE RADIATION MONITOR (PACKAGE #36)

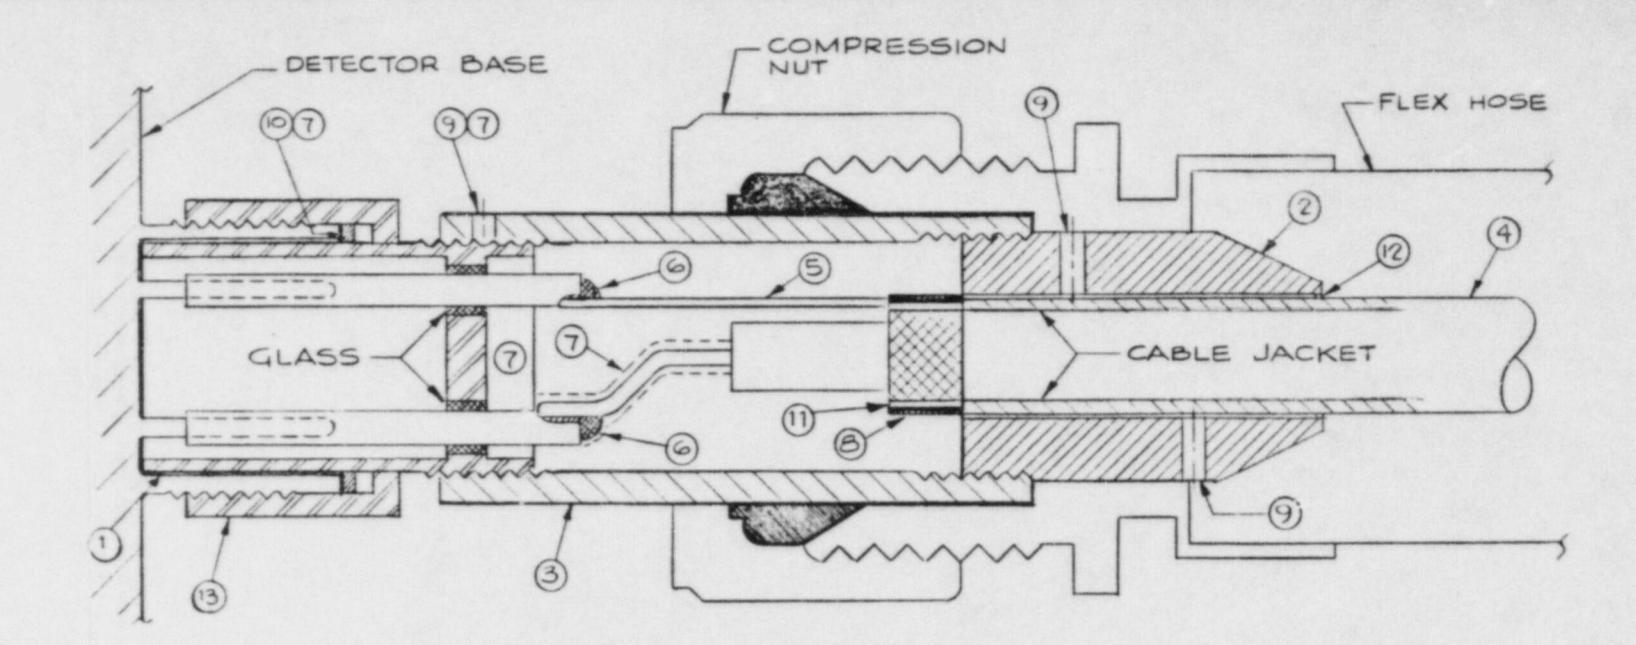
ATTACHMENT 4 FIGURE 1

Victoreen Test Report 950.301, Section V, pages 60 and 61 (Attachment 3) lists the failure mechanisms which occurred during the unsuccessful attempts at qualification. Attachment 4 is a set of 3 drawings which show a) a detailed representation of the detector-connector cable assembly (this is an enhanced version of Figure 2, Section VI, page 51 of Victoreen Test Report 950.301), b) a representation of the failure leakage paths described in Attachment 3, and c) a comparative representation of RG&E's installed configuration. There were no failures attributed to the connection at the base of the detector.

CABLE TERMINATION ASSEMBLY

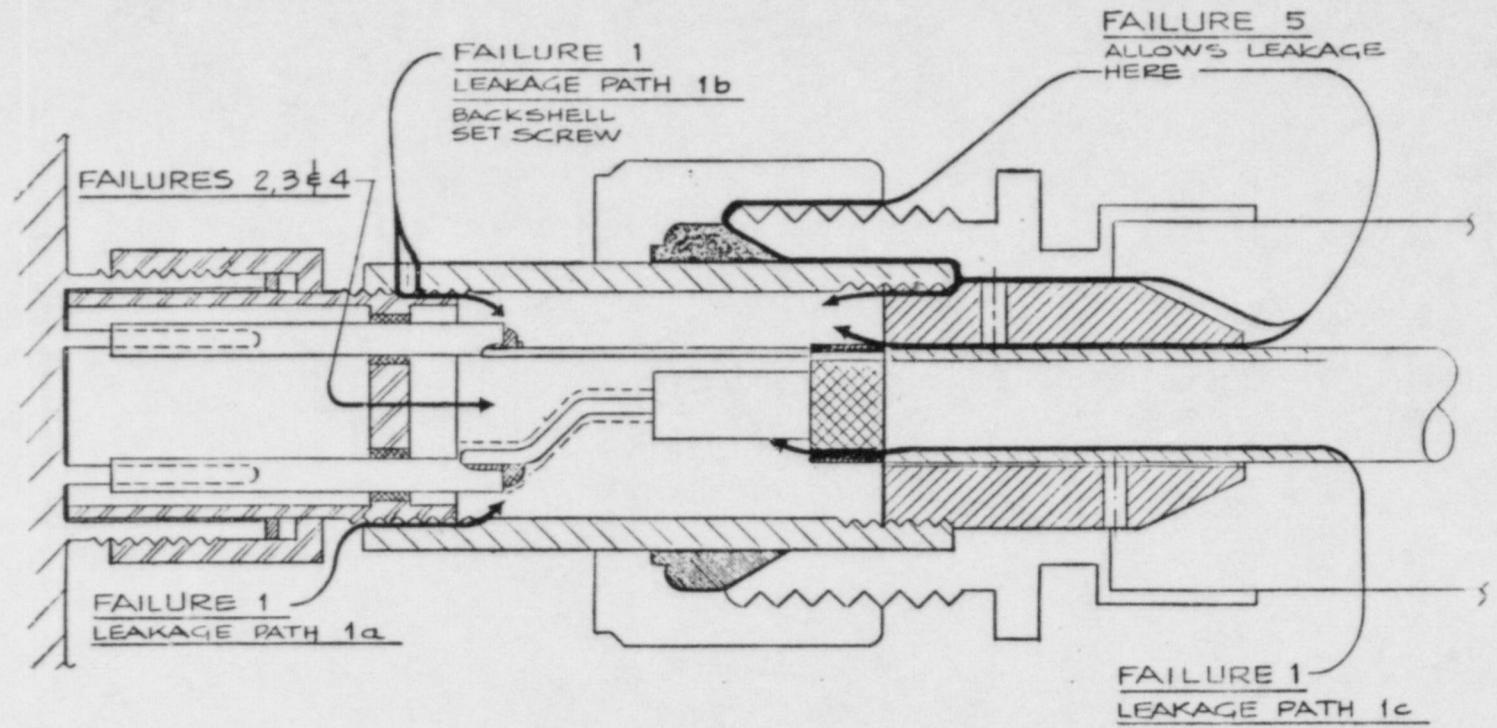
ATTACHMENT 4 FIGURE 2

Failure mechanisms la and 1b allowed leakage at the connection of the back shell to the connector. Victoreen Termination Procedure 910077 (Attachment 5, which is Section VI of the test report 950.301) states these locations shall be potted while making up the cable termination. The cable ends come connected to the cable when shipped from Victoreen and have the required potting performed during make-up to the cable. The connector also comes with the nickel seal which seals the joint between the cable connector and the detector. This nickel seal was used in all qualification tests with no failures due to leakage past this seal reported in the test report. The final configuration Victoreen tested used no additional method of sealing the leakage path for failure mechanisms la and lb (see Attachment 10 photograph). In addition to this sealing by Victoreen, RG&E has covered this area with a qualified Raychem sleeve.

Failure mechanism lc allowed leakage through the cable jacket to the termination points between the cable and connector. Cable damage was probably caused by stress induced in the jacket by the connector. Whatever the cause, the Raychem sleeve installed by RG&E not only covers the connector but the cable jacket for 3 to 4 inches from the connector to the conduit and overlaps several inches on the conduit. The cable is located within conduit from the detector to the penetration area. This failure mechanism is thus corrected by RG&E's installation.

Failure mechanisms 2, 3 and 4 deal with failures occurring inside the backshell due to leads shorting or breaking. The shorting of leads would be enhanced by moisture intrusion (failure mechanisms la, b, c or 5). At RG&E, this is prevented by the use of Raychem sleeves sealing the paths which could allow leakage into this area. The breaking of the connectors was considered to be caused by the process used for making the connections. In Section VI, page 74 of the test report (Attachment 5), the breaking of the conductors is attributed to the thermal expansion of the material used in the attempt to seal the wire termination points. As stated earlier, the connectors come proattached to the cables from Victoreen. Thus the internals of the connector are identical to those which successfully passed gualification. Therefore, the failure mechanism due to wire breakage is not applicable to RG&E since the modifications performed by Victoreen to prevent this failure have not been altered by RG&E.

Failure mechanism 5 was leakage of the welds or compression fitting which would allow moisture intrusion between the outer jacket of the cable and the stress relief fitting. The installation method RG&E used does not utilize the compression fittings, flexible steel tubing, or the junction box which has its cover welded on. RG&E utilizes a multi-layer Raychem sleeve arrangement to seal the connection of the cable to the connector (see Attachments 1 and 4). RG&E considers the Raychem sleeve application to be as good as or better than the steel tubing for sealing the connector to cable since the sleeve covers the entire backshell assembly. Thus, the Raychem sleeve not only seals the point where the cable meets the backshell and stress relief fitting, but also provides additional protection for failure mechanisms la and lb.

THROUGH CABLE JACKET (FLEX STEEL TUBING NOT INSTALLED)

FAILURE MECHANISMS IDENTIFIED

IN VICTOREEN TEST REPORT NO. 950.301

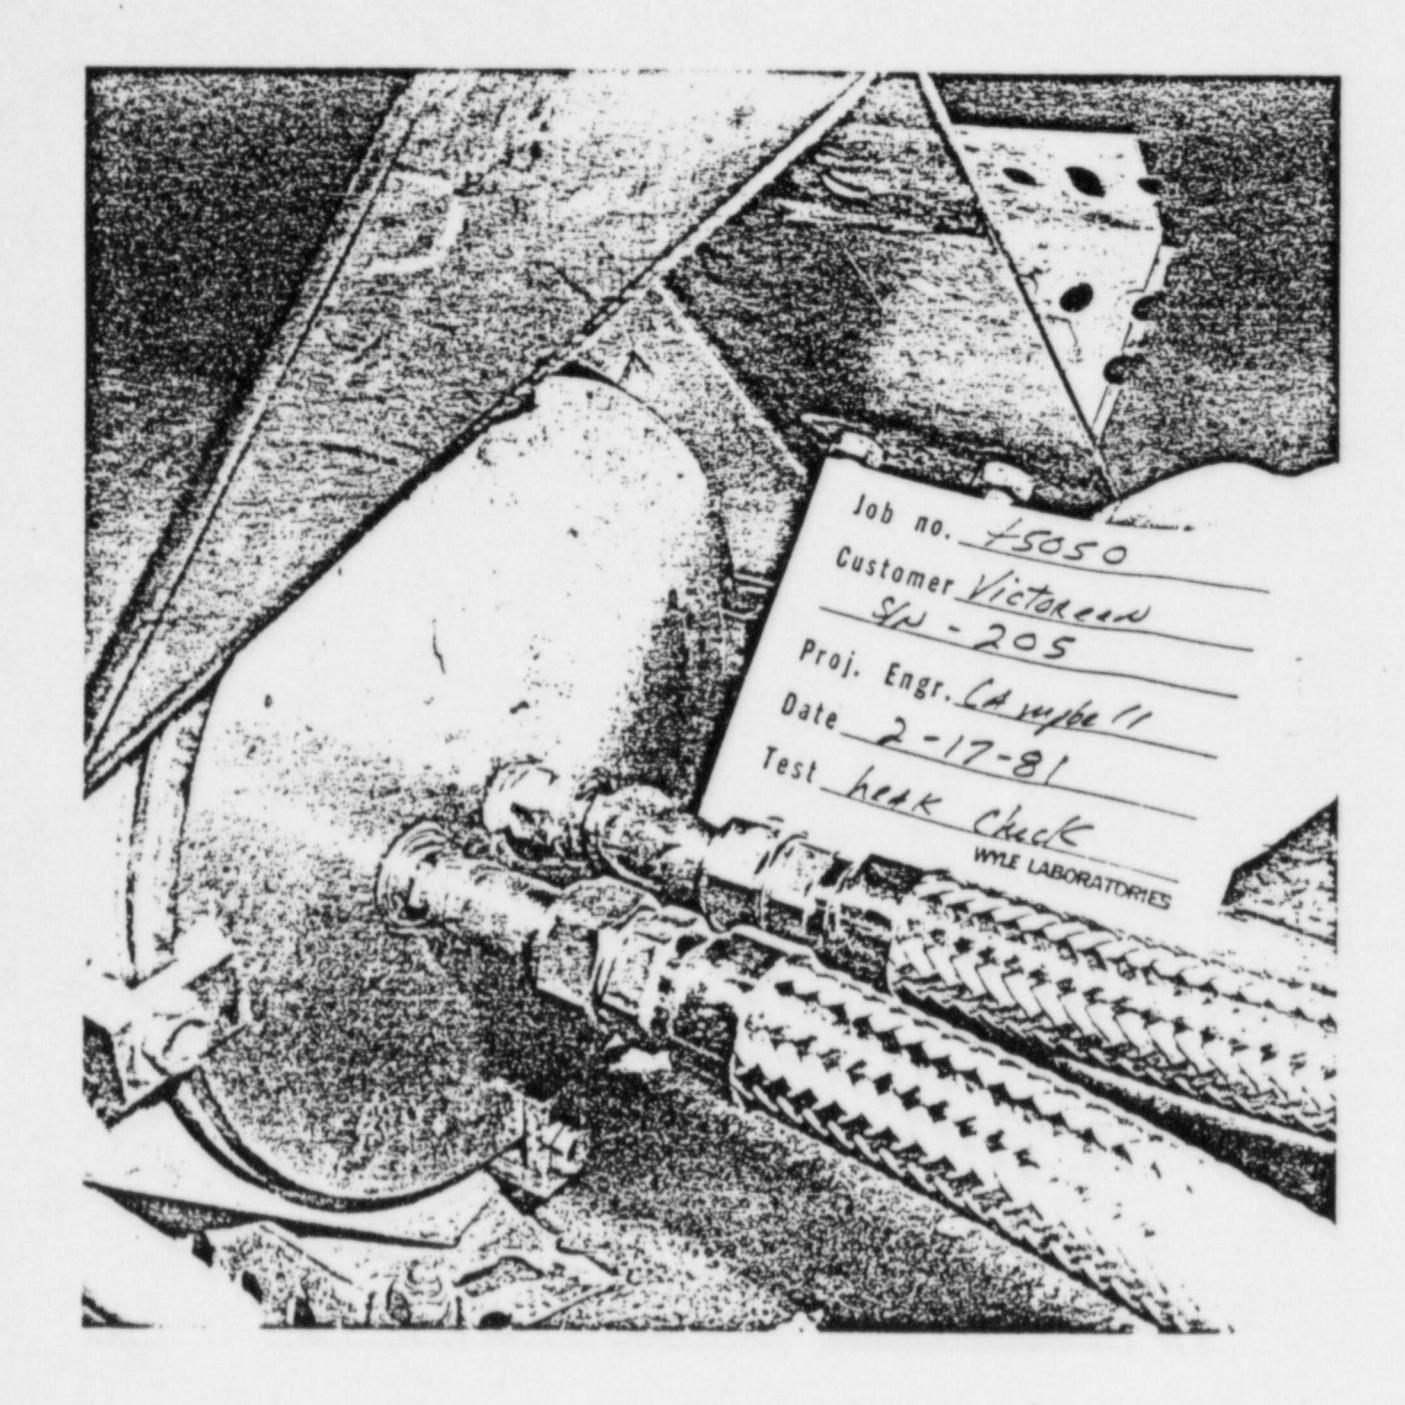
PHOTOGRAPH VI-24

LEAK-CHECKING SPECIMENS PRE-LOCA #9

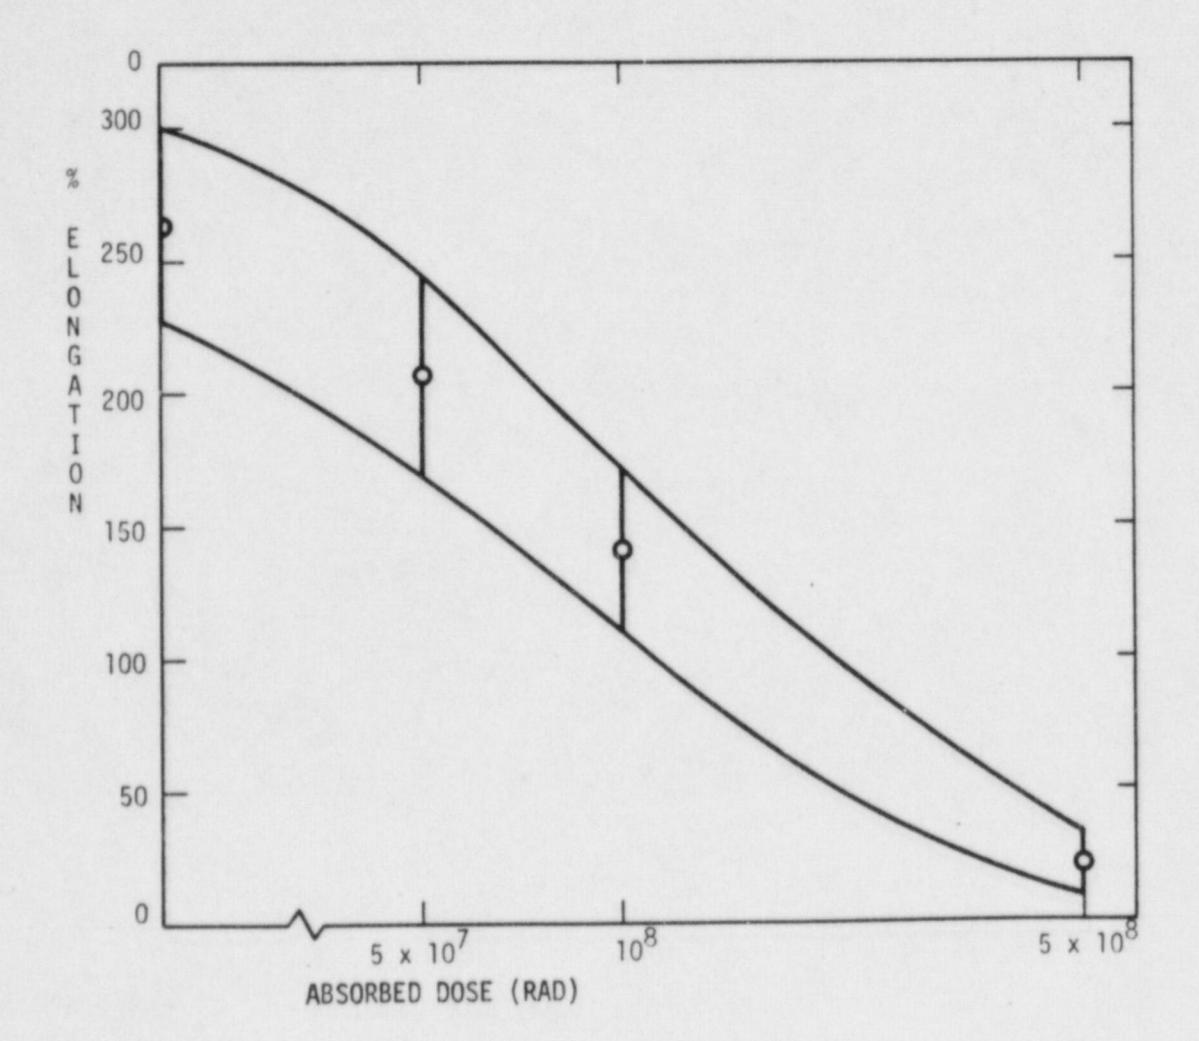
Figure 3-1

"SIMILAR" PVC CABLES IRRADIATED AT 20-40°C

Data for cables from 38 manufacturers (From Reference 50)
