NRC Form 366 (9-83)				LIC	ENSEE	EVE	NT RE	PORT	(LER)	U.S. NU	CLEAR REGUL APPROVED ON EXP:RES: 8/31/	ATORY COMMIS AB NO. 3150-0104 88	SION
FACILITY NAME (1)								D	OCKET NUMBER	(2)	PAGE	(3)
Palo	Verd	ie Un	it 2						0	0 5 0 0	015121	9 1 OF	016
TITLE (4)	1 4 4 1	27	ing Daint	Feult	in Co	no De		i an I	al aulatar	Courses	Depatam	main	
Inva	Invalid Floating Foint Fault in core Protection Calculator Cause						· Causes	s Reactor Trip					
MONTH DAY	YEAR	YEAR	SEQUENTIAL	REVISION	MONTH	DAY	YEAR		FACILITY NAM	ES	DOCKET NUM	BER(S)	
			NUMBER	NUMBER				N/A			0 5 0	01011	1
0 7 2 5	86	8 6	047	- 0 0	0 8	2 2	8 6	N/A			0 15 10 1	0 1 0 1 1	1
OPERATING MODE (8)	1	THIS REP	ORT IS SUBMITTE	D PURSUANT 1	TO THE RE	QUIREME	NTS OF 10	CFR S: 1	Check one or more of	t the following) (1	1)		
POWER		20.4	02(b) 05(a)(1)(i)	-	20.405(c))		X	50.73(a)(2)(iv)		73.71(b)		833
	5,0	20.4	05(a)(1)(ii)		50.38(c)((2)		-	50.73(a)(2)(vii)		OTHER	Specify in Abstra	act

Subject: Palo Verde Nuclear Generating Station (PVNGS) Unit 2 Docket No. STN 50-529 Licensee Event Report-86-047-00 File: 86-020-404

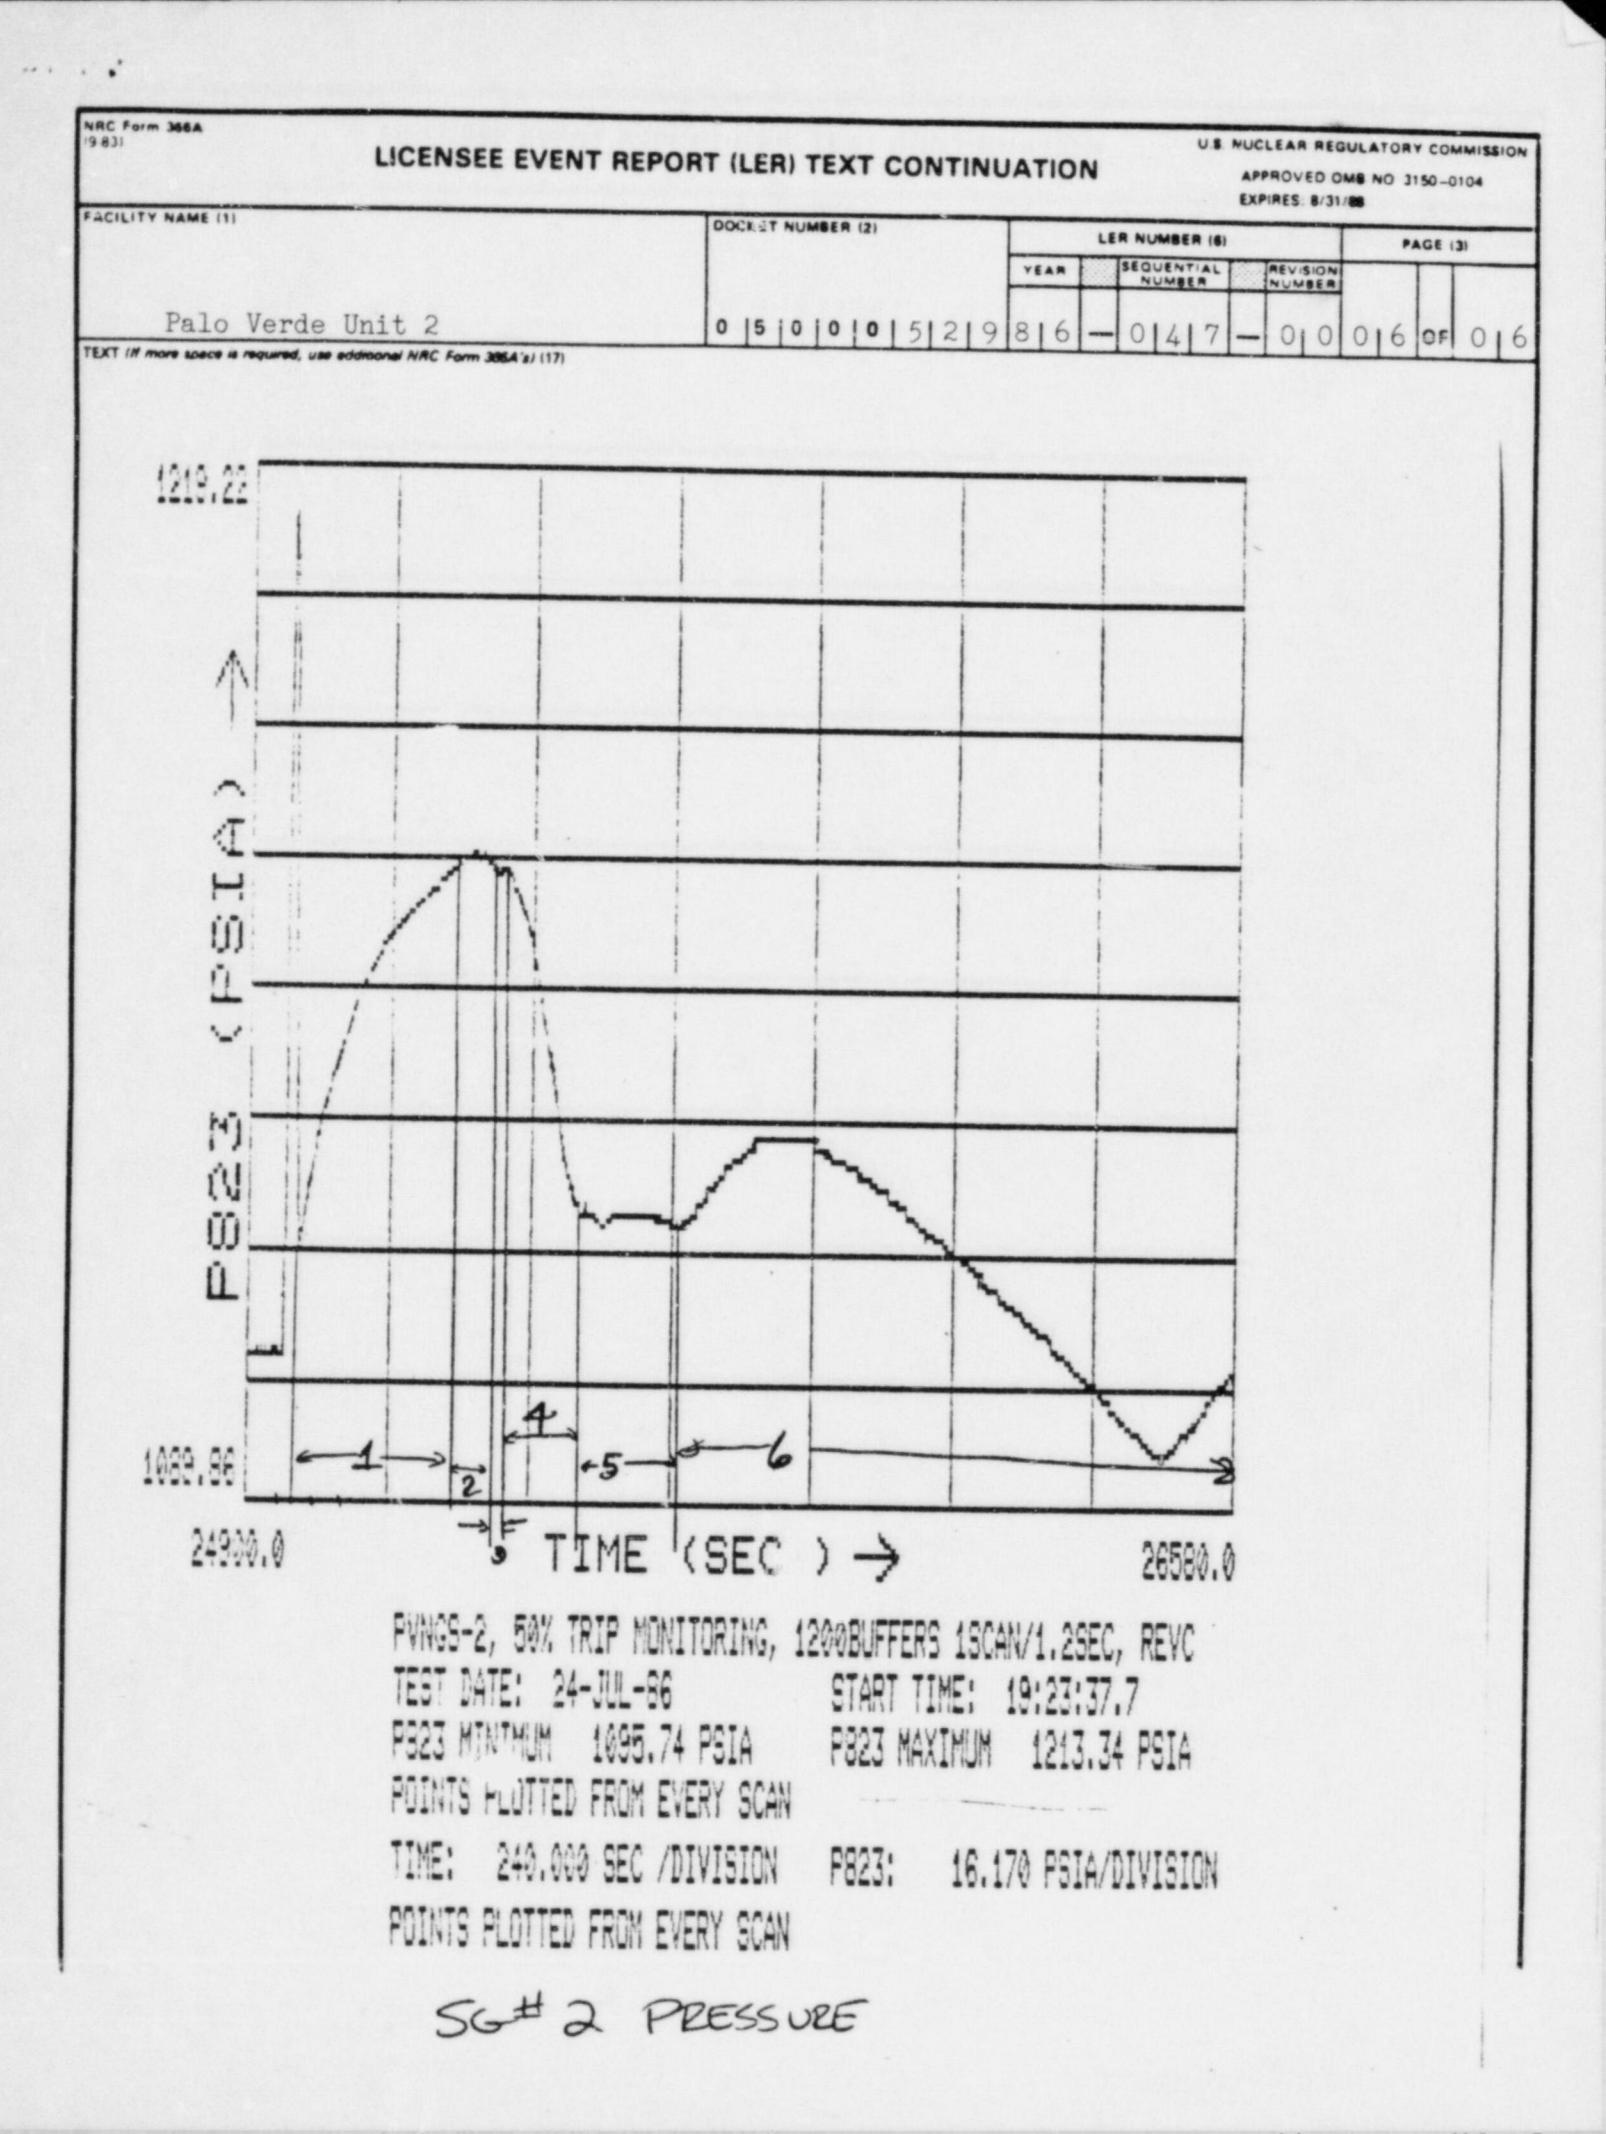
* Refer to Figure 1 CC #2	programo for the time int		
Refer to rigure 1 50 #2	pressure for the time int	ervals.

02:16:3" PZ	IR level bottomed	out at 24%							
*1 Do in de wi de	owncomer flowrate acreasing steam pr ecreased due to lo th a FW pump onli emand.	decreased due to essure. SG leve w feedwater flow ne with constant) ≱l ↓ (FW)(SJ) t steam

EXPIRES: 8/31/86	
Y NAME (1)	DOCKET NUMBER (2)	LER NUMBER (6)	PAGE (3)
		YEAR SEQUENTIAL REVISION NUMBER NUMBER	
Palo Verde Unit 2	0 15 10 10 10 15 12 19	816 - 01417 - 010 014	OF
nors space is required, use additional NRC Form 366A 's) (17)			
*2	SBCV #1 modulated	open to reduce SG pressur	re.
	Charging pump #3	was stopped approximately

4.8 minutes after	the reactor trip.	
*3	SG feed rate incr	eased due to reduction in	
	steam pressure.	The backpressure control	
	valve (PDV-240) w	as taken to manual 6.2	
	oscillations stor	trip and the	
	oborrigoroup prop	pou.	
*4	The Downcomer beg	an to modulate closed to	
	control level. S	G pressure continued to	4
	and recovering SG	level. Approximately 8.	2
	minutes after the	trip, charging pump #3 au	ito
	started on low PZ	R level. No oscillations	-
	were experienced	since PDV 240 was in manua	11.
*5	SG pressure staye	d constant, while the leve	el
	increased. The R	eactor Coolant System (RCS	5)
	temperature remai	ned constant, while the P2	2R
	pressure and reve	I recovered.	
*6	Operator opened s	uction valves for Auxilian	ry
	Feedwater Pump (A	FN-P01) and started the	
	pump. Operator c	decreased steam demand.	-
	MFWP was tripped	when operator realized it	
	was the cause of	the cooldown. This caused	i
	the rate of PZR p	ressure recovery to
