FACILITY: Fermi-2

SUBJECT: MEETING SUMMARY FOR DECEMBER 11, 1986, MEETING ON MAIN STEAM TUPPINE BYPASS FLOW LINE FAILURE

SUBJECT: FERMI UNIT 2: MAIN STEAM BYPASS LINE FAILURE (TAC #63376)

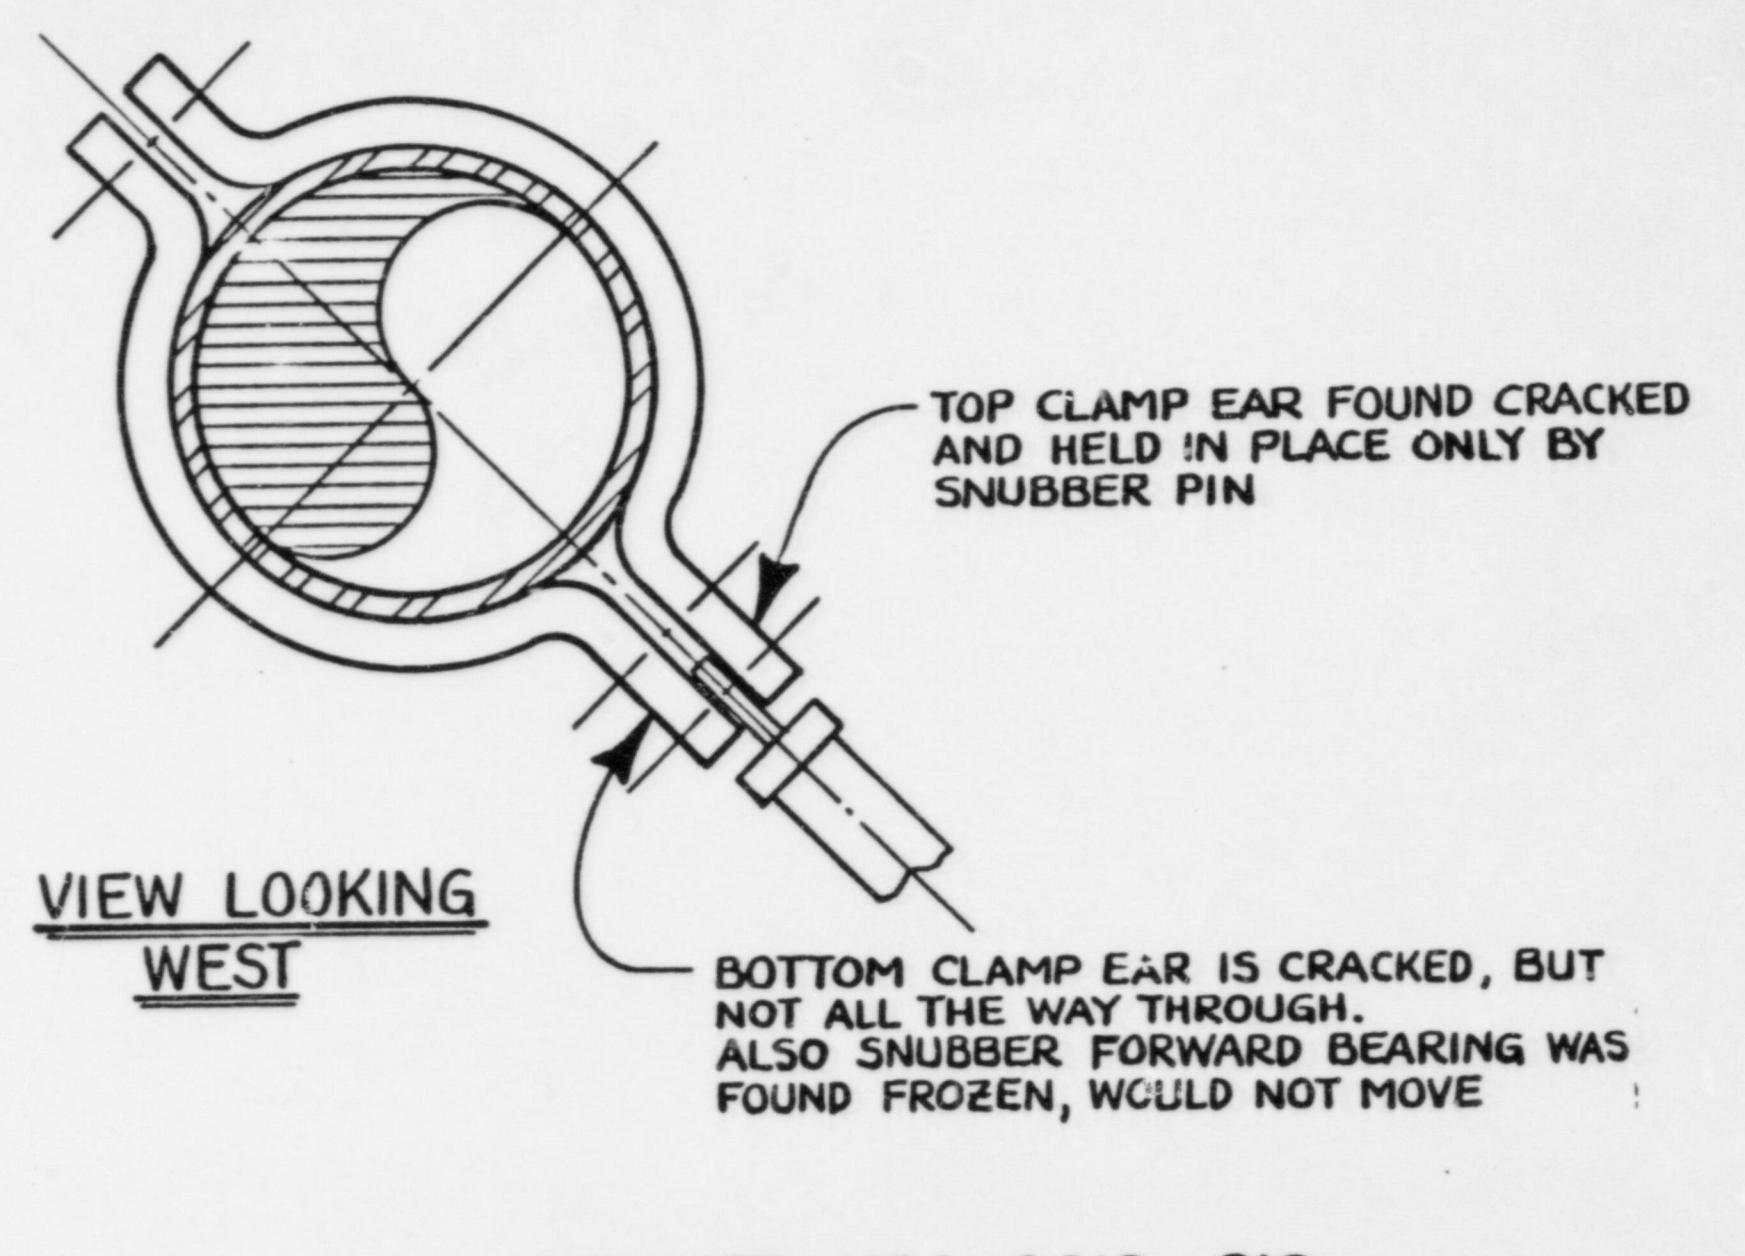
HANGER N30-3619-G19 MECHANICAL SNUBBER

- a) Minor loosening of clamp nuts, which was resolved.
- b) Some snubber clamp and one instance of hanger tube steel cracking which could have occurred during operation of the original 3/8" wall line. Also, an analysis of the line shows that the supports could have been removed with no detremental effects.
