Illinois Power Company
Clinton Power Station
P.O. Box 678
Clinton, IL 61727
Tel 317 935-6220
Fax 217 935-4632

Wayne D. Romberg
Assistant Vice President - Nuclear

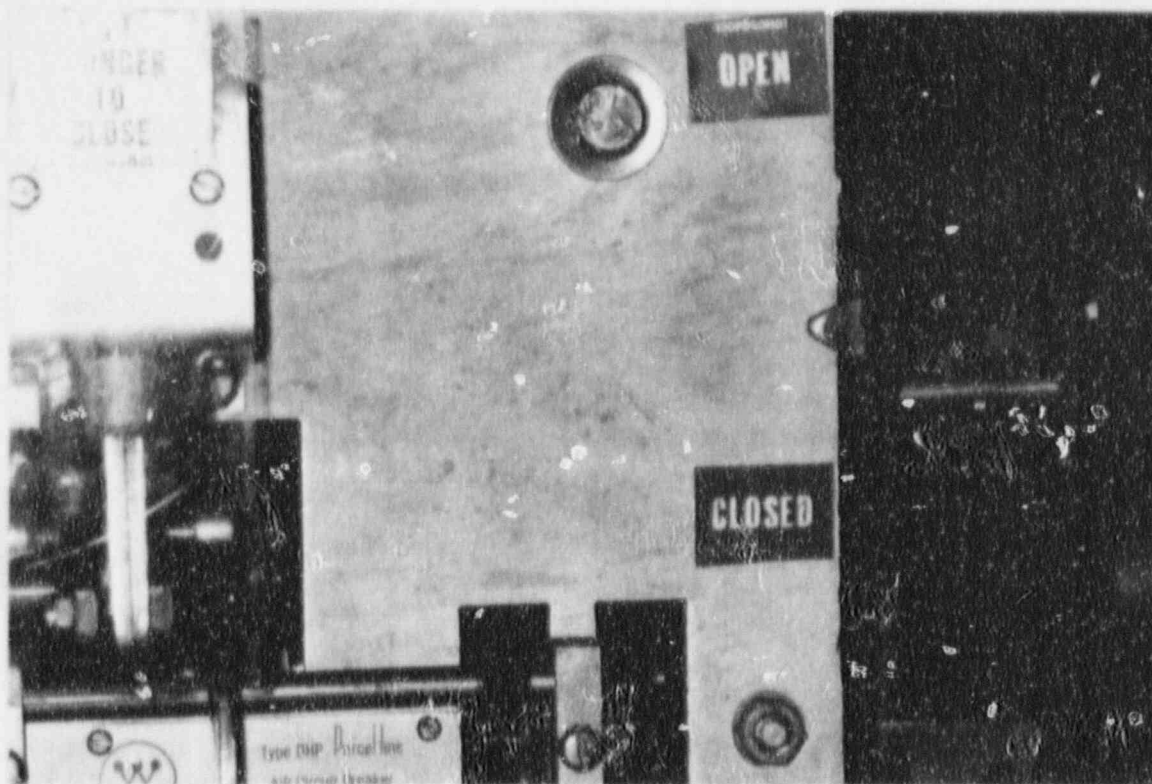
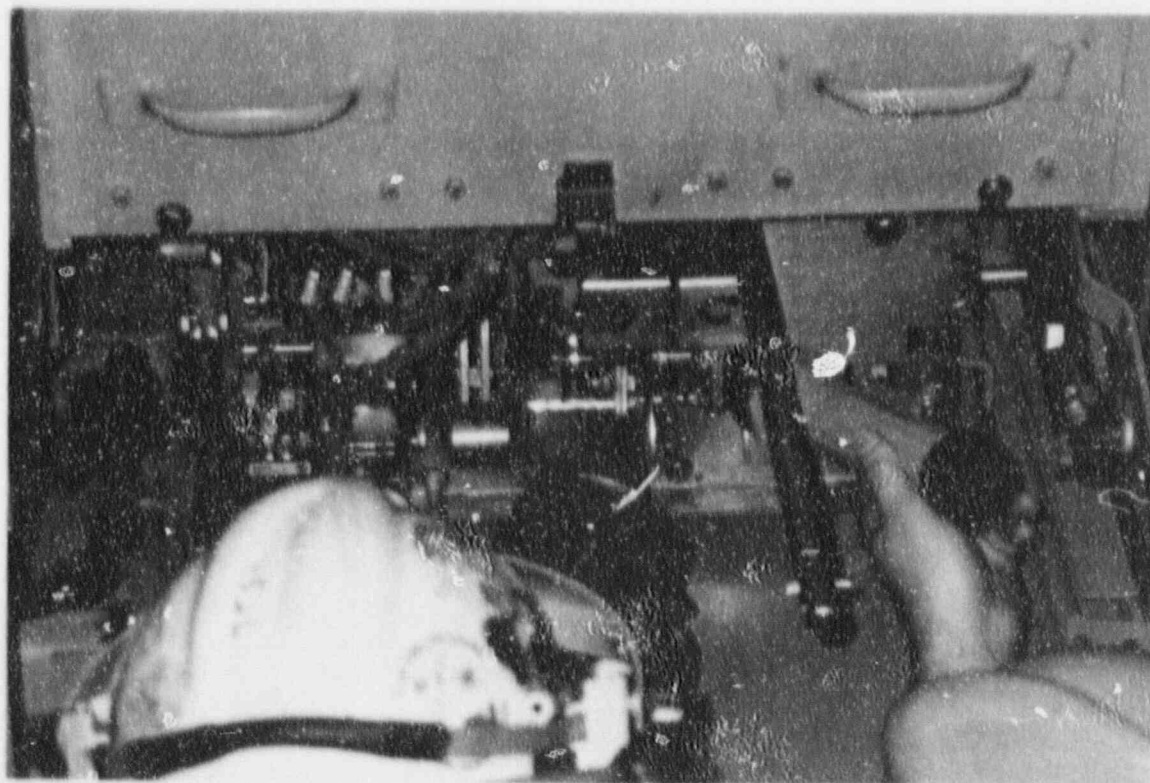
As found condition of Westinghouse 4160-volt safety-related circuit breaker
