UNITED STATES NUCLEAR REGULATORY COMMISSION OFFICE OF NUCLEAR REACTOR REGULATION WASHINGTON, DC 20555-0001

December 11, 2020

INFORMATION NOTICE 2007-21, Supplement 1: PIPE WEAR DUE TO INTERACTION OF FLOW-INDUCED VIBRATION AND REFLECTIVE METAL INSULATION

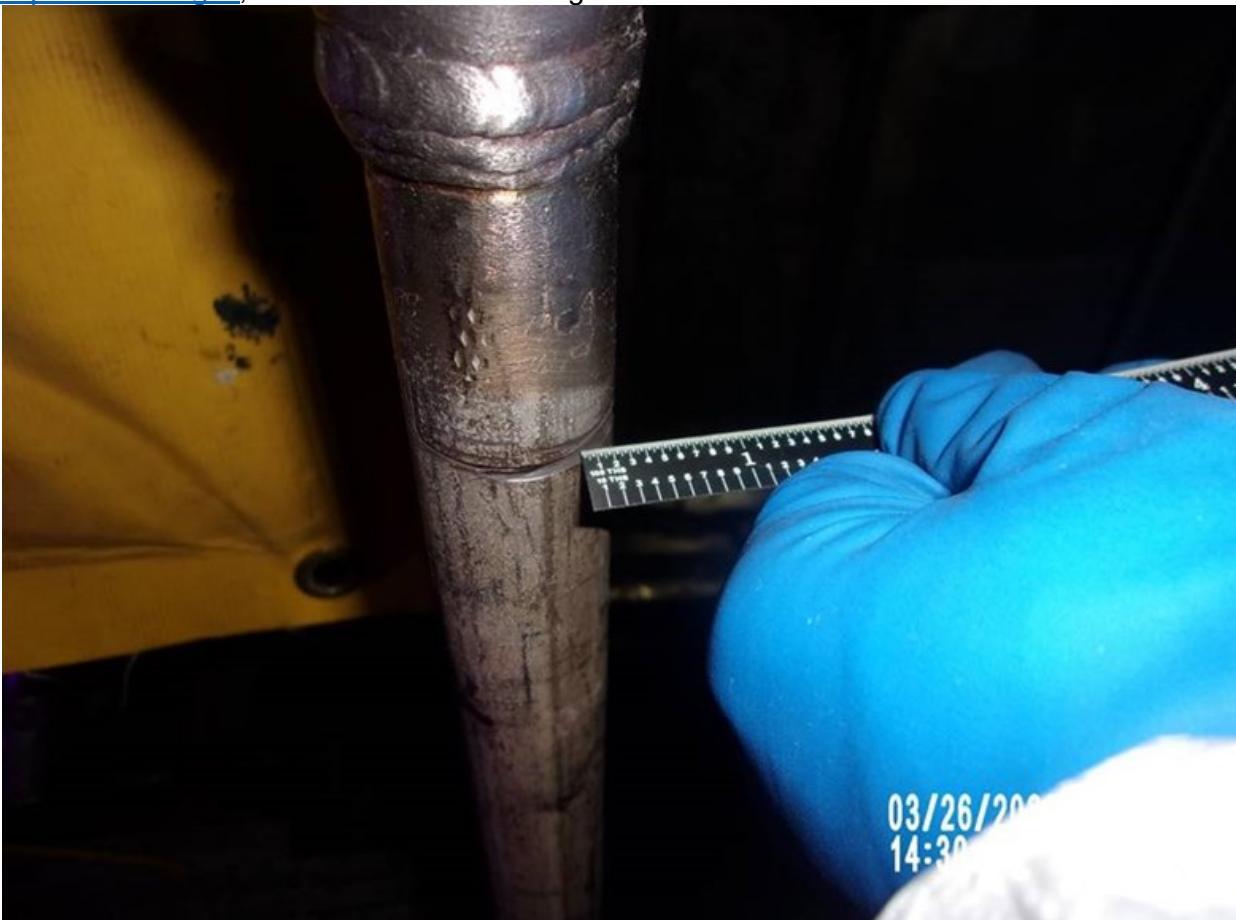
At ANO, Unit 2, the licensee confirmed that the RMI end caps had been installed in accordance with plant procedures and vendor instructions. The licensee repaired the deeply worn areas of the ASME BPV Code Class 1 piping that did not meet the required minimum wall thickness by welding to restore the piping to the original construction code. The licensee repaired the other worn areas of the piping by surface conditioning to meet the original construction code. The licensee then added stainless steel "cuffs," or banding, to protect the Class 1 piping at the ANO, Unit 2, locations that experienced abrasive wear.

example, one of the wear marks on the pressurizer spray line at ANO, Unit 2, reached a depth of 25 percent of the through-wall thickness of the piping. The ANO licensee discovered the wear in this section of the pressurizer spray line because of its piping inspections in response to vibration-related failures of snubber connections to the pressurizer spray line. Unchecked, this type of wear could cause a small break loss of coolant accident and challenge the plant emergency core cooling systems.

Figure 1. First example of ANO, Unit 2, Pressurizer Spray Line Wear caused by Flow-Induced Vibration between Piping and RMI End Cap

To mitigate the wear of affected piping, some licensees have installed temporary stainless steel "cuffs" or banding (or, alternatively, fiberglass insulation if "cuffs" could not be added) directly on the outer surface of the piping at the RMI end cap locations. This mitigation method provides a physical barrier that protects the piping from abrasive wear until the insulation can be replaced with an improved design.

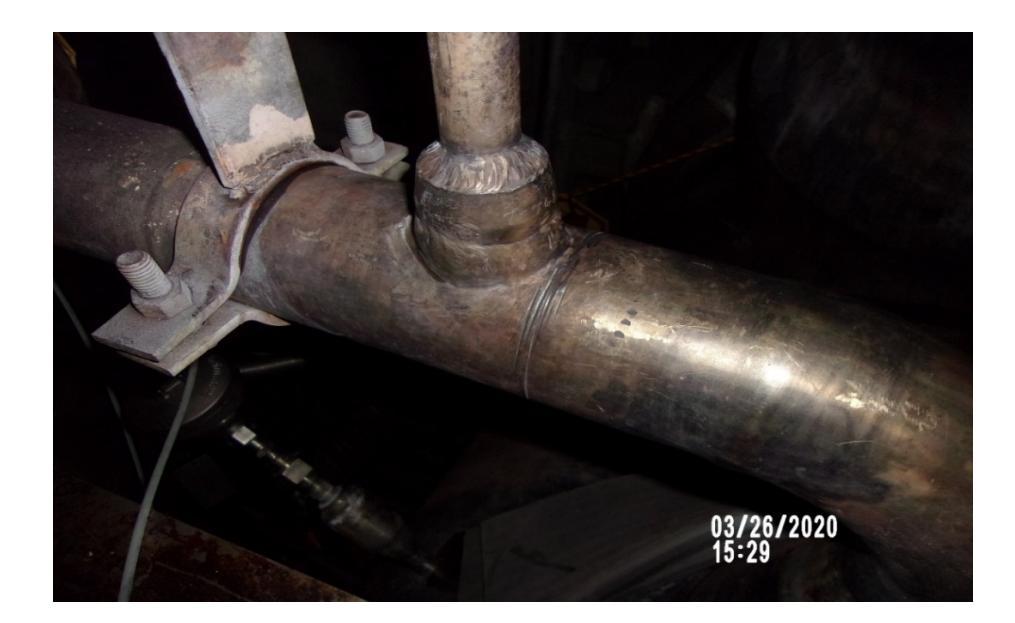
Figure 2. Second example of ANO, Unit 2, Pressurizer Spray Line Wear caused by Flow-Induced Vibration between Piping and RMI End Cap
