SUBJECT: CRACKED REACTOR COOLANT INLET NOZZLE ON A LETDOWN HEAT EXCHANGER AT PALO VERDE 3

Reference: Palo Verde Nuclear Generating Station - Unit 3 Letdown Heat Exchanger - Cracked Reactor Coolant Inlet Nozzle RECO Mfg. Serial No. N-2376 Bechtel Deficiency Report # 86-29

Subject: Final Report - DER 86-29 A 50.55(e) Condition Relating to Letdown Heat Exchanger Nozzle Crack File: 87-006-216

Records Center Institute of Nuclear Power Operations 1100 Circle 75 Parkway - Suite 1500 Atlanta, Georgia 30339 FINAL REPORT - DER 86-29 DEFICIENCY EVALUATION 50.55(e) ARIZONA NUCLEAR POWER PROJECT (ANPP) PVNGS UNITS 1, 2, 3

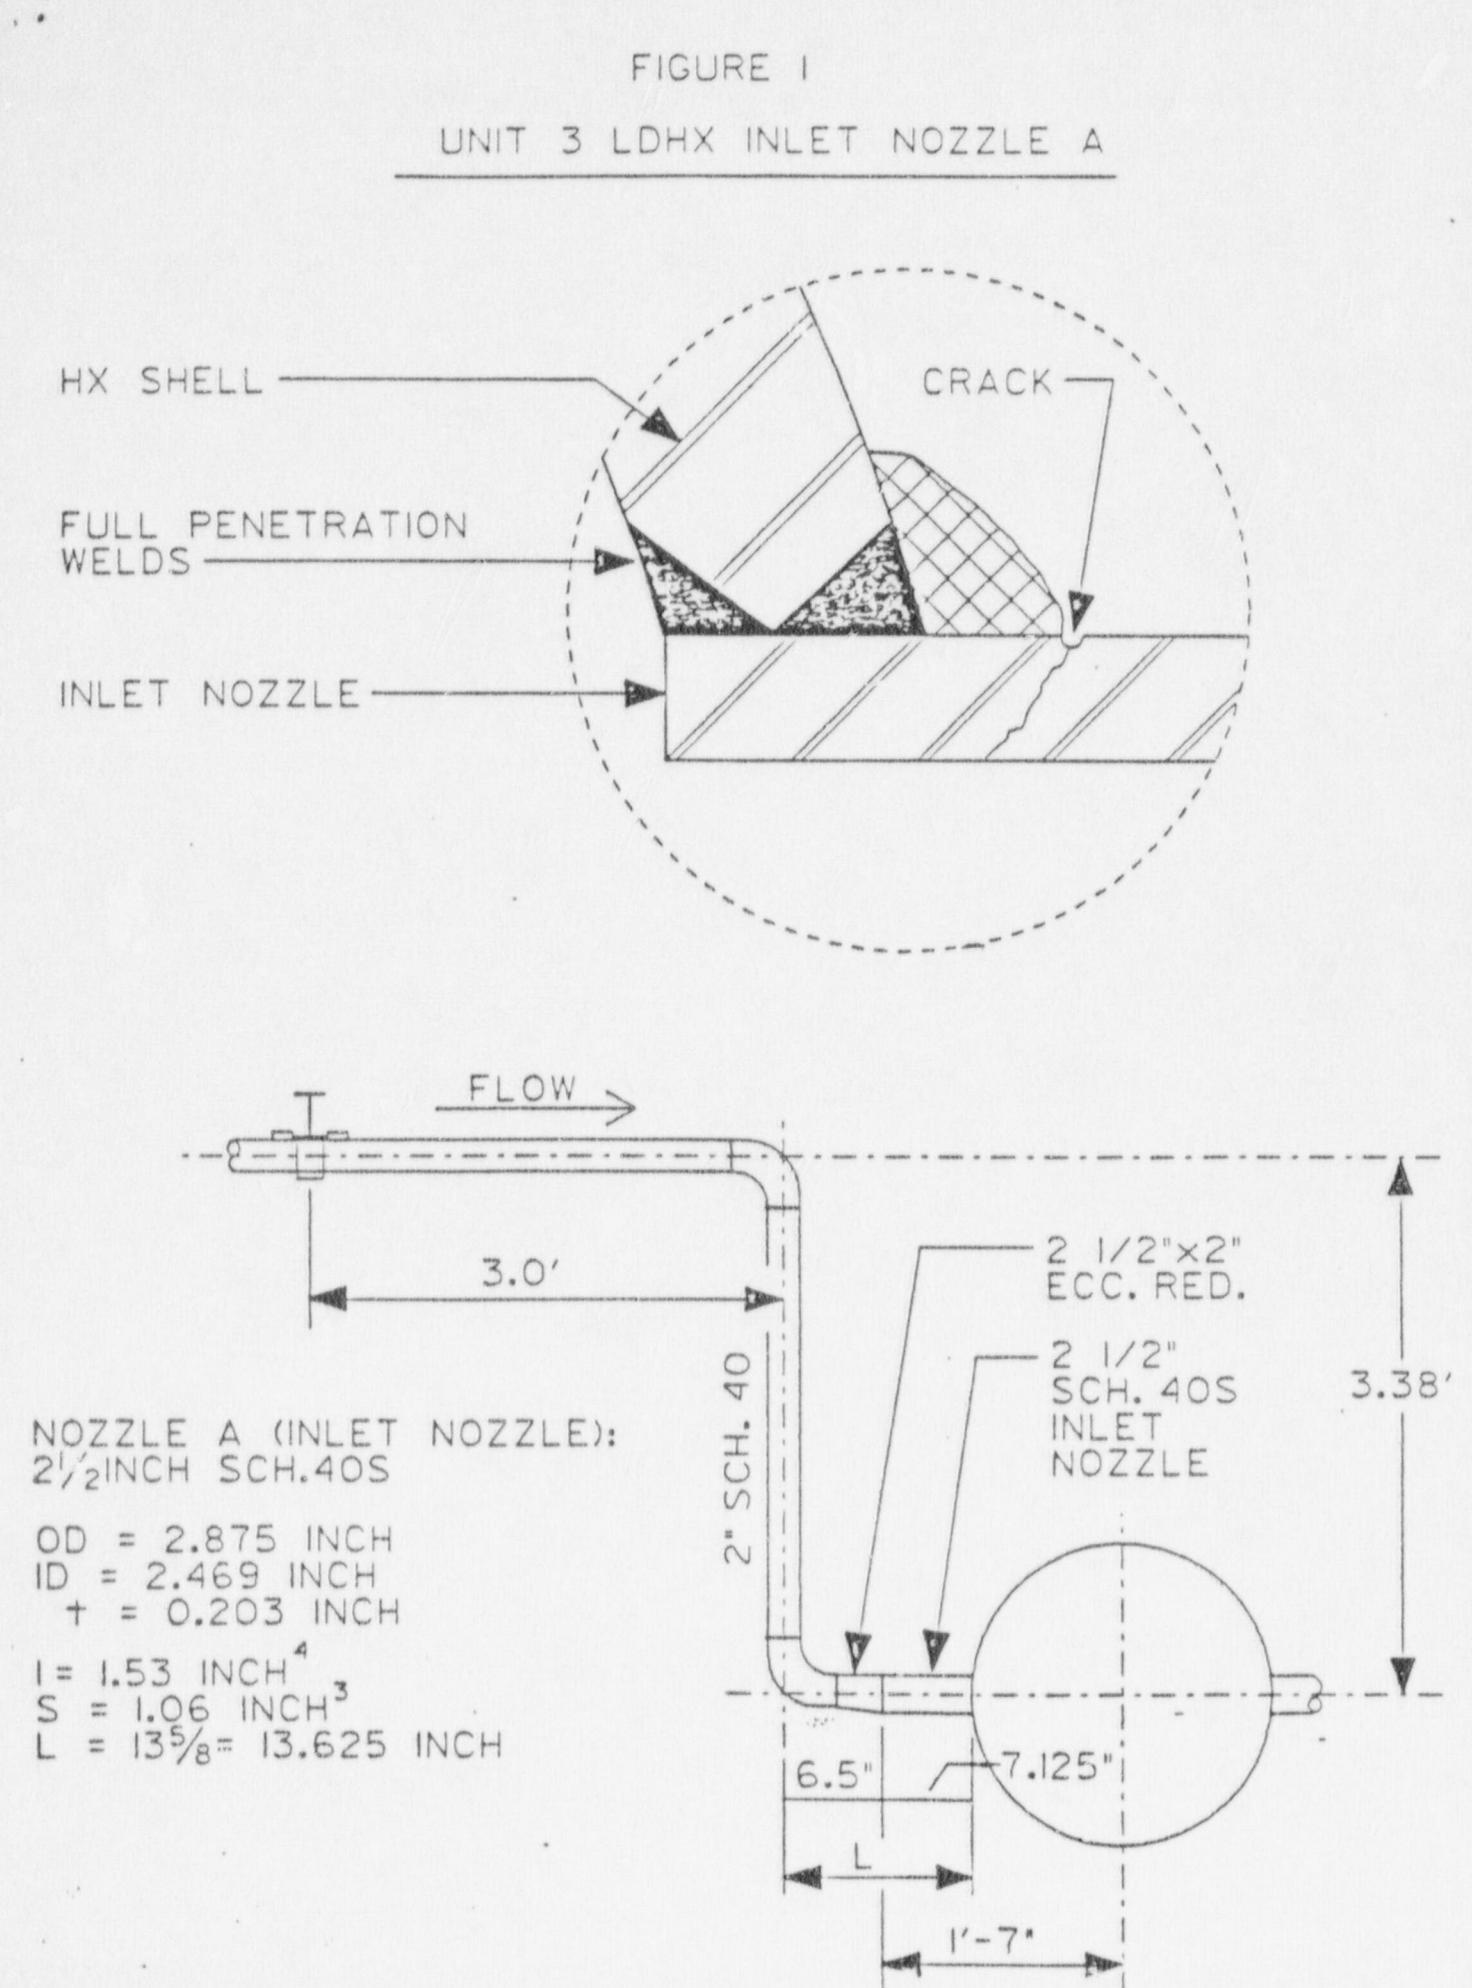
Nozzle A is a 2-1/2 inch diameter, Schedule 40, stainless steel (SA312-TP304) pipe stub, attached to the heat exchanger shell by a full penetration, double-ended bevel weld, which is reinforced with an external 1/2 inch fillet weld. (See Figure 1) This nozzle configuration conforms to ASME III, Class 2 Code requirements.

A visual inspection performed by the an ANPP metallurgist of the cracked nozzle resulted in the following observations: The failure occurred on the top side of the nozzle adjacent to the toe of the reinforcing weld. As indicated in Figure 1, the toe of the weld adjacent to the failure had been ground back leaving a groove approximately 1/32 inch deep by 1/8 inch wide and 2 inches long where the failure occurred. In addition, the geometry of the weld did not provide a smooth transition between the vessel and nozzle. As discussed later, this geometry and groove resulted in a stress concentration which significantly contributed to the nozzle failure.

The failure consisted of a main through-wall circumferential crack approximately 3 inches long on the nozzle exterior, and two other disconnected cracks parallel to the first, which did not penetrate the nozzle wall. The main crack was not perpendicular to the nozzle surface, but sloped back under the fillet weld at a slight angle. The length of this crack on the nozzle interior was about 1 inch shorter than on the nozzle exterior. This indicates that the crack started on the outside at the toe of the reinforcing fillet weld (where the groove was located) and propagated through the nozzle base metal. The main crack appears to be made up of two smaller hairline cracks that grew together as they propagated. This is a typical configuration for a high cycle/low stress fatigue failure.

The nozzle crack was initially weld repaired under NCR NA-1942 in order to support HFT. After HFT was completed, additional welding was performed to increase the size of the reinforcing weld from the original 1/2 inch size to 3/4 inch. The final weld provides four benefits:
