FOIA-84-743

RESPONSE TO FREEDOM OF INFORMATION ACT (FOIA) REQUEST

DIABLO CANYON
NUCLEAR POWER PLANT

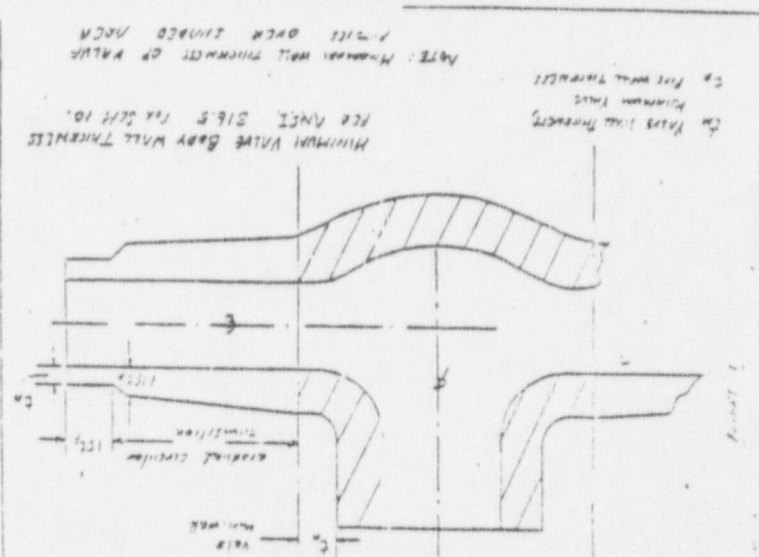
<p>OBSERVATION</p> <p>N. Westinghouse Letter #PG&E 2080 list the valves that are to be investigated for minimum wall thickness. There are 14 valves listed on the Westinghouse letter for which there is no documented evidence of being UT examined for minimum wall thickness. This a nonconformance to the Westinghouse Letter and PG&E DR 103-R1. These valves are:</p> <p style="margin-left: 40px;">Location # 1-8010-A, B, C 2-8010-A, B, C 1-8368-A, B, C, D 2-8368-A, B, C, D</p> <p>M. W. Kellogg documentation indicates these valves deleted but there is no explanation for the deletion. Locations # 2-8010-A, B, C valves were examined and found to have ASME NB Code stamps. Locations # 2-8368-A, B, C, D valves were examined but no code stamps were found.</p> <p>O. Five individuals were identified as performing the ultrasonic measurements. A review of personnel files revealed all were certified per ASNT-TC-1A Supplement C. The personnel checked were:</p> <ul style="list-style-type: none"> A. Paul Dawson B. Donald Geske C. Ray Crosno D. Ed Martindale E. Warren Johnson <p>P. Many Data Reports were found to have information whited out and new information</p>
