SUBJECT: NOTICE OF MEETING WITH WESTINGHOUSE REGARDING CLASS IE
SWITCHGEAR MODELS DS-416, DSL-416, DS-420, DS-206 AND DSL-206

PURPOSE: To discuss the technical basis for Westinghouse's
recommended actions, criteria and conclusions in Enclosure 1
and related breaker failures due to inadequate welds of the
pole shaft assembly at Calvert Cliffs 1 (Enclosure 2) and
Sequoyah 2.

To: J. P. McVicker
From: D. A. Wright
Subject: CCNPP 480 Volt Breaker No. 52-1108 - NCR 3894

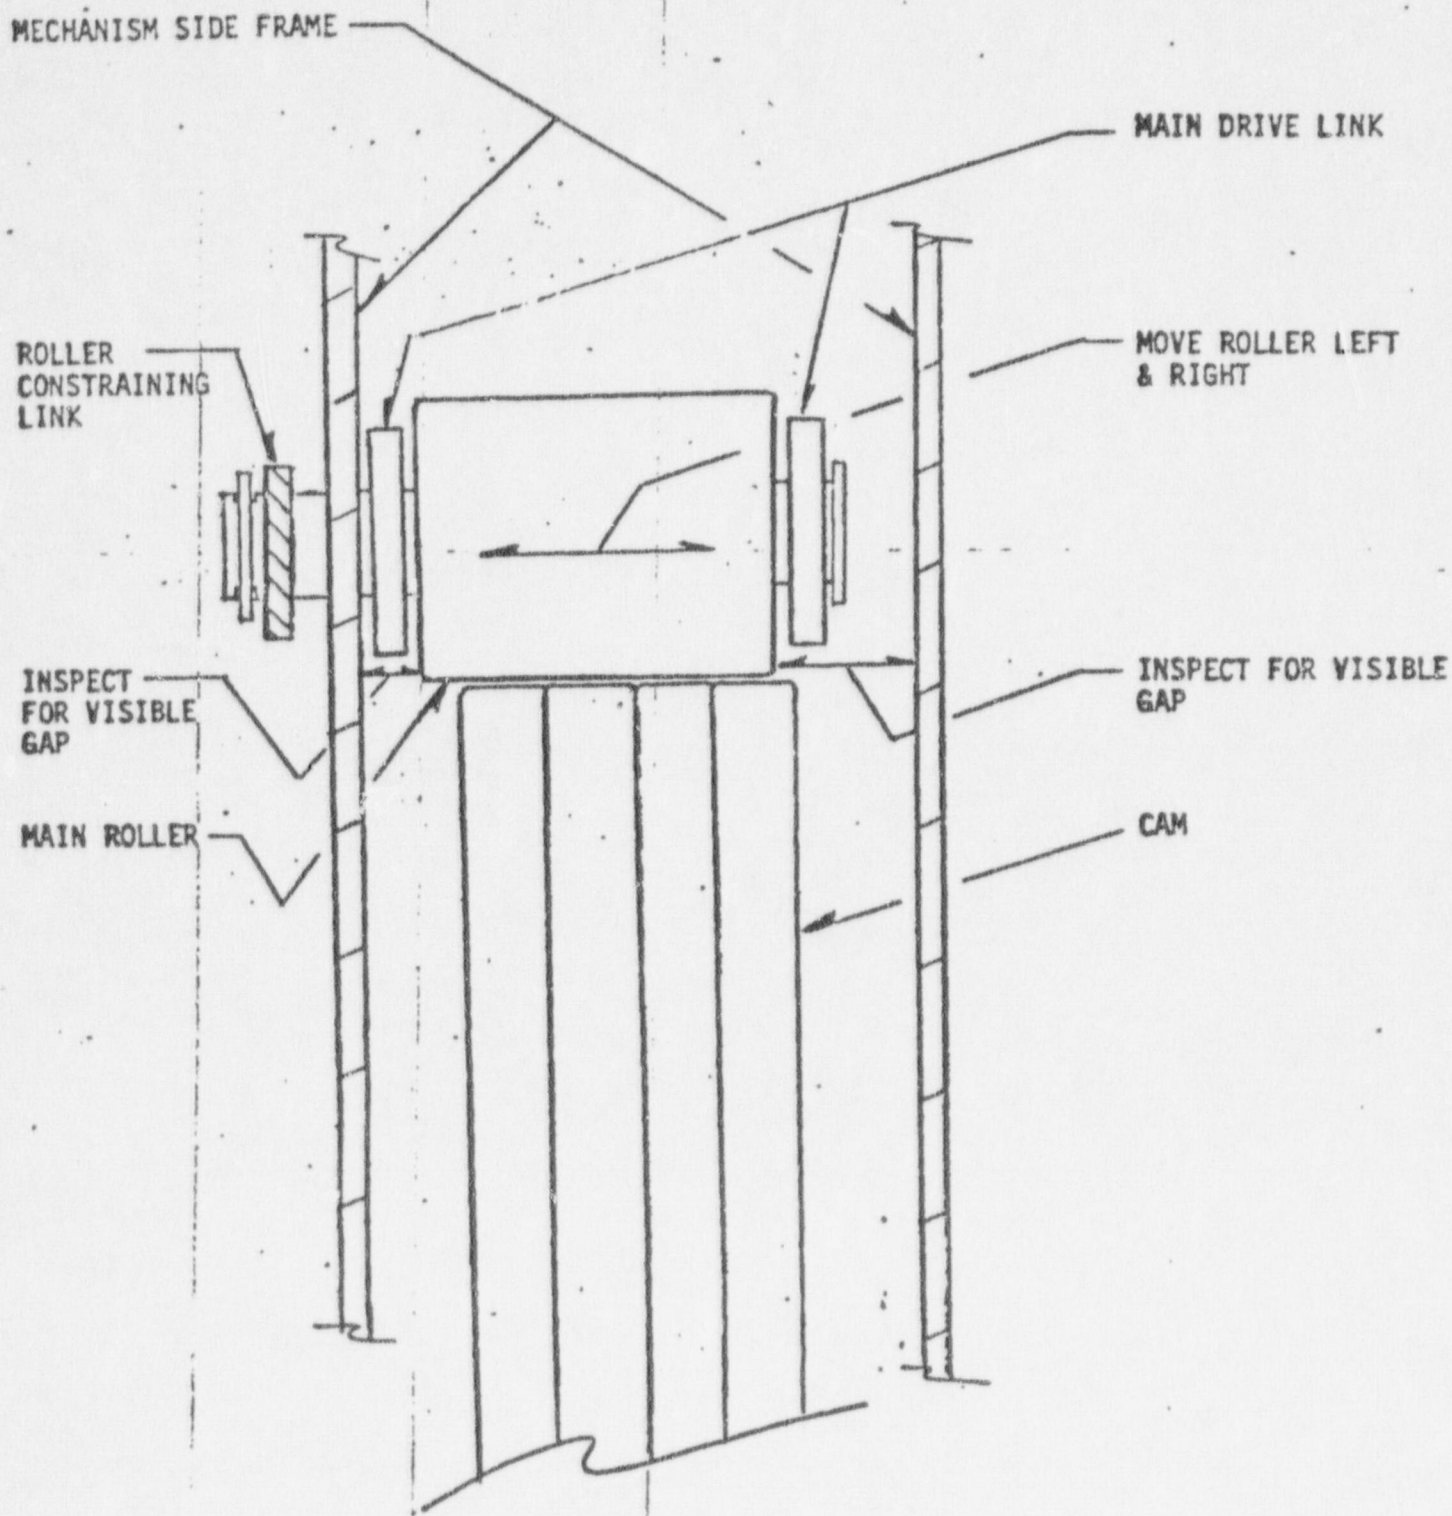
FIGURE 1

Refer to Figure 1. This tolerance check should be performed on the bench with the closing springs disconnected from the cam-shaft (common shaft going through the close cam).

6. With pressure applied to roller as indicated in Figure 1, slowly turn the closing cam manually by the spring charging handle. (Note: To release the cam to turn, depress both manual trip and close buttons simultaneously.) Continue to turn the cam until the breaker contacts reach the closed position.

At this time, the maximum lateral play of the roller is in effect.

7. Through the front of the breaker, sight the close cam, the roller and the side frames. Using a flashlight, check to see that -
 - a. roller is making contact with the two outer laminates of the close cam. It is not required to be centrally placed.
 - b. there is visible gap between the side frame and the roller side at each end of the mechanism.

If either of the two checks are not satisfactory, contact Westinghouse.

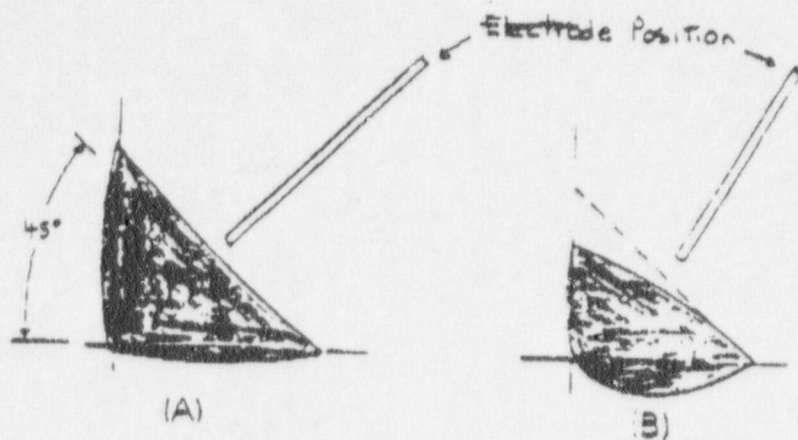
A measurement of the fillet legs indicates that the leg on the pole shaft side was 0.30 inch and the leg on the lever arm side was 0.10 inch. This mismatch of leg sizes of 3 to 1 and lack of fusion on the lever arm side indicates an improper welding technique in manufacture. We suspect from the weld morphology and spatter that these arms were welded to the pole shaft in production using Gas Metal Arc Welding (GMAW) process. It appears that the welder did not properly position the electrode in the joint. The electrode was positioned more toward the pole shaft resulting in leg mismatch and lack of fusion on the lever arm side (see Figure No. 3).

Figure No. 3 Fillet Weld Profiles Showing Acceptable (A) and Unacceptable (B) Profiles

We conclude from the analysis that the failure was caused by lack of fusion of the weld as a result of improper welding technique. Inspection of the welds on both assemblies sent to ME&AU indicates a potential exists that more failures may have occurred or will occur on the pole shaft assemblies now in service. ME&AU recommends that provisions be made to nondestructively examine and/or repair all breakers that are now operating with similar pole shaft assemblies. We believe the most efficient fix would be to fillet weld the backside of the joint. For more details on weld repair contact R. E. Cantrell on 787-5505.

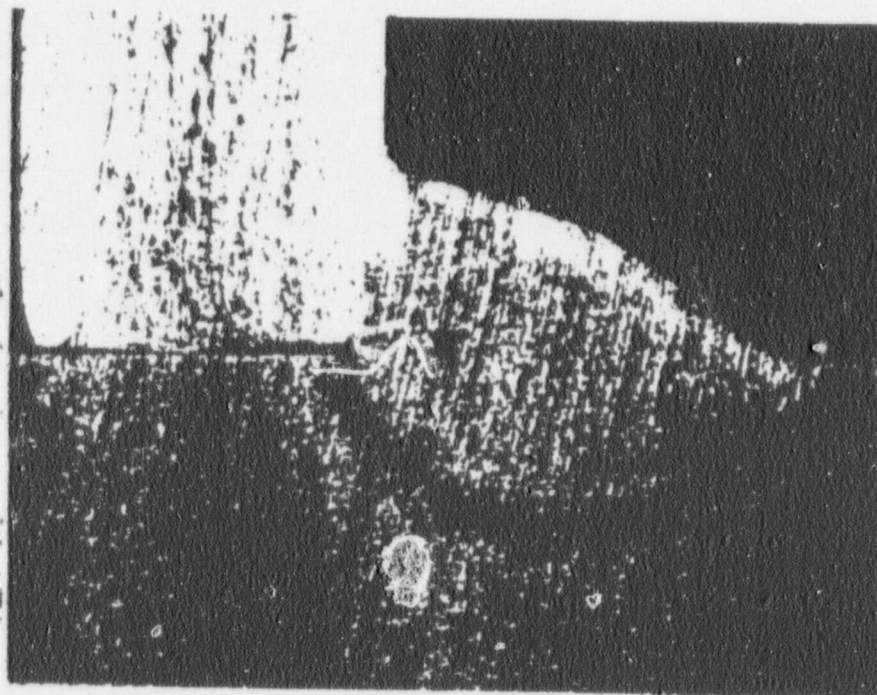
To further investigate the problem of welder technique a section was removed from the center of all unfailed welds. The sections were ground to a 240 grit finish and the welds were macroetched with ammonium persulfate to reveal the depth of fusion. Depth of fusion measurements were made for all sections and the results recorded in Table No. 1. A photograph representative of welds examined is shown in Figure No. 4. These results reveal that the depth of fusion on the pole shaft was significantly greater than the depth of fusion on the lever arm. It is important to note that the depth of fusion does not determine the adequacy of the joint. If complete fusion is present the joint is adequate. The results indicate that the welder's technique was poor, but in most cases there was adequate fusion outside of the start of the weld.

Figure No. 4 A Fillet Weld Profile Representative of the Macroetched Cross Sections

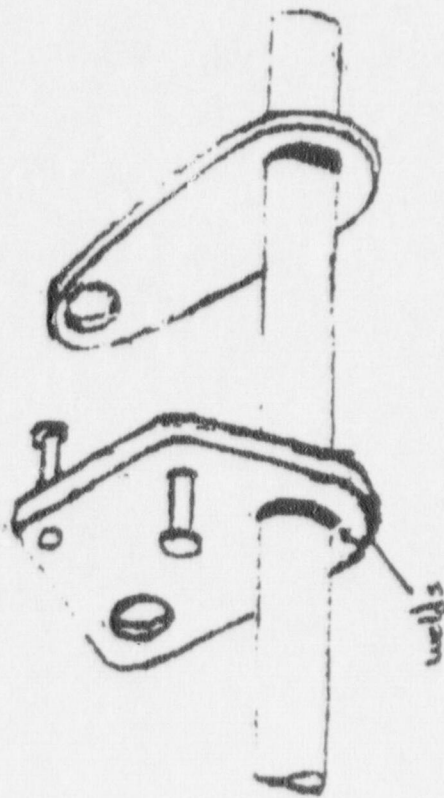
Electrical Pole Shaft

Visual examination performed prior to magnetic particles examination. Lack of fusion was noted at the start of eight of the Ten welds examined.

Each pole shaft has six welds. There are fillets approx. 1/4 inch in size and are located on one side of each attachment.

There is undercut at the toe of the welds. The undercut was removed by grinding to reveal no fusion problem beyond the start of the weld. In order to perform a valid examination the welds must be prepared by grinding and the weld starting points must be dressed.
