RADIATION PROTECTION SURVEY

CO-60 FACILITY

Emma L. Bixby Hospital Adrian, Michigan

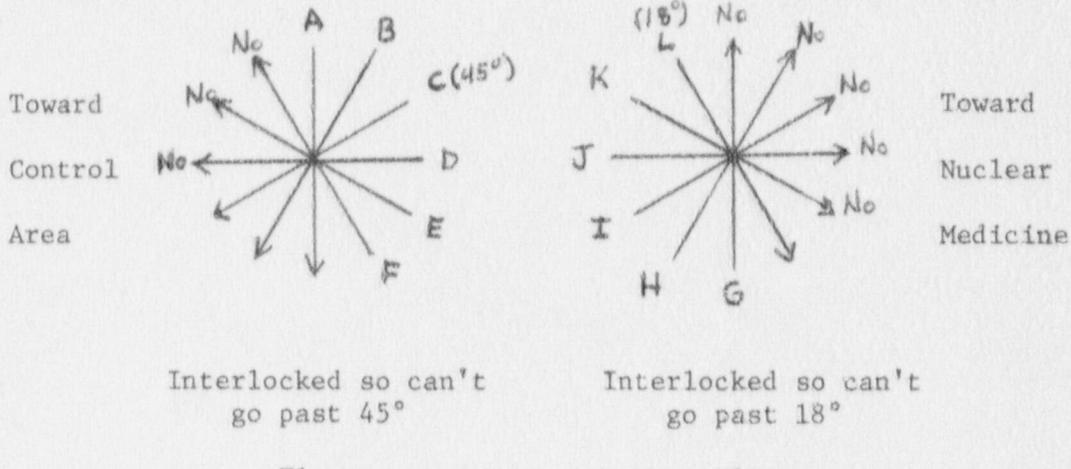
A radiation survey was made at the occupied areas of this installation. The survey was made with a phantom in the primary beam and the beam directed in each of the directions shown below.

The beam is interlocked so that it can not be turned on when directed at an angle greater than 45° from the floor toward the Nuclear Medicine facility and 18° from the floor toward the control area. The directions M, N, and O correspond to the unit being pointed vertically downward toward the floor and the head being swiveled 30, 60, and 90° toward the outside wall.

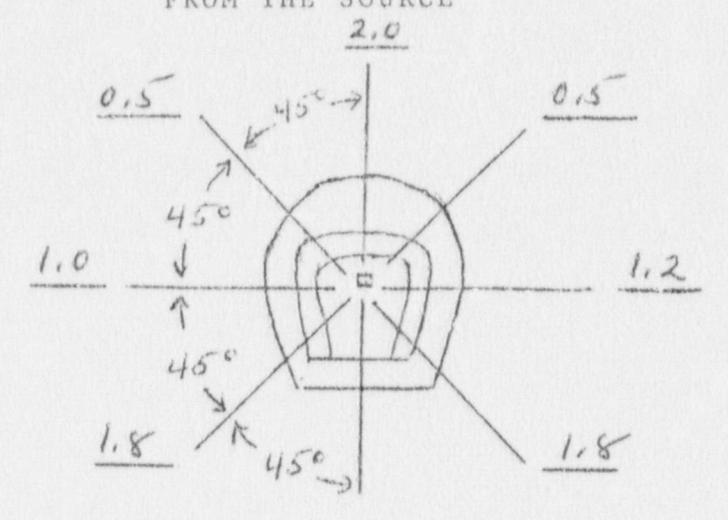
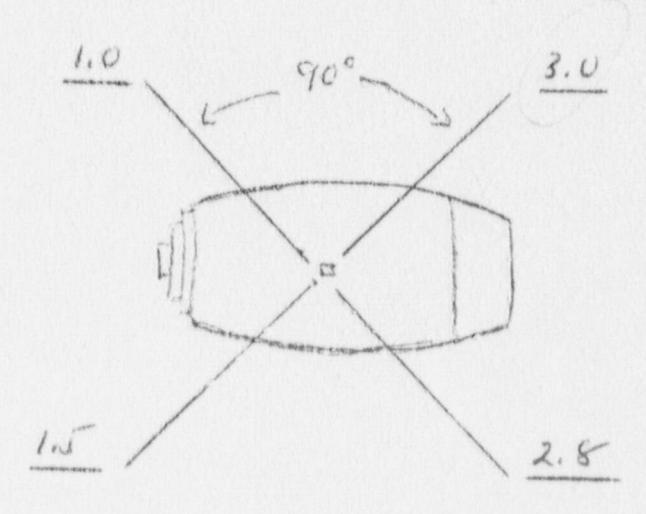
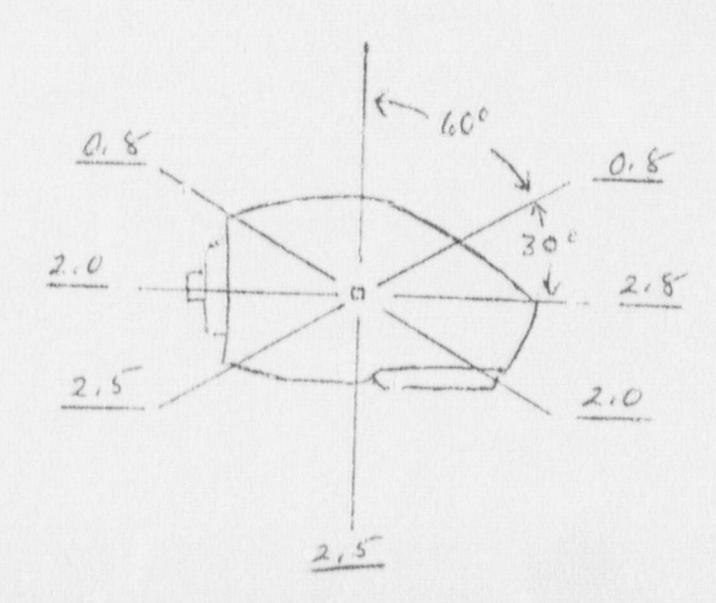
TELETHERAPY HEAD RADIATION SURVEY REPORT

A radiation survey of the teletherapy head was made with the source in the "off" position. The readings were taken at 1 meter from the source at the 8 prime compass points in each of the three mutually perpendicular planes. See attached data sheet. With these 18 8ndependent measurements, the average leakage value was 1.69 mF'hr at 1 meter, the maximum value was 3.0 mR/hr.

Maximum Reading at Contact With Head

40 mR/hr
