July 1, 1998 L-98-137

Beaver Valley Power Station, Unit No. 1 Docket No. 50-334 License No. DPR-66 LER 98-024-00

LER 98-024-00, 10 CFR 50.73(a)(2)(ii) and 10 CFR 50.73(a)(2)(v), "Internal Flooding Discrepancy in the Intake Structure Pump Cubicles."

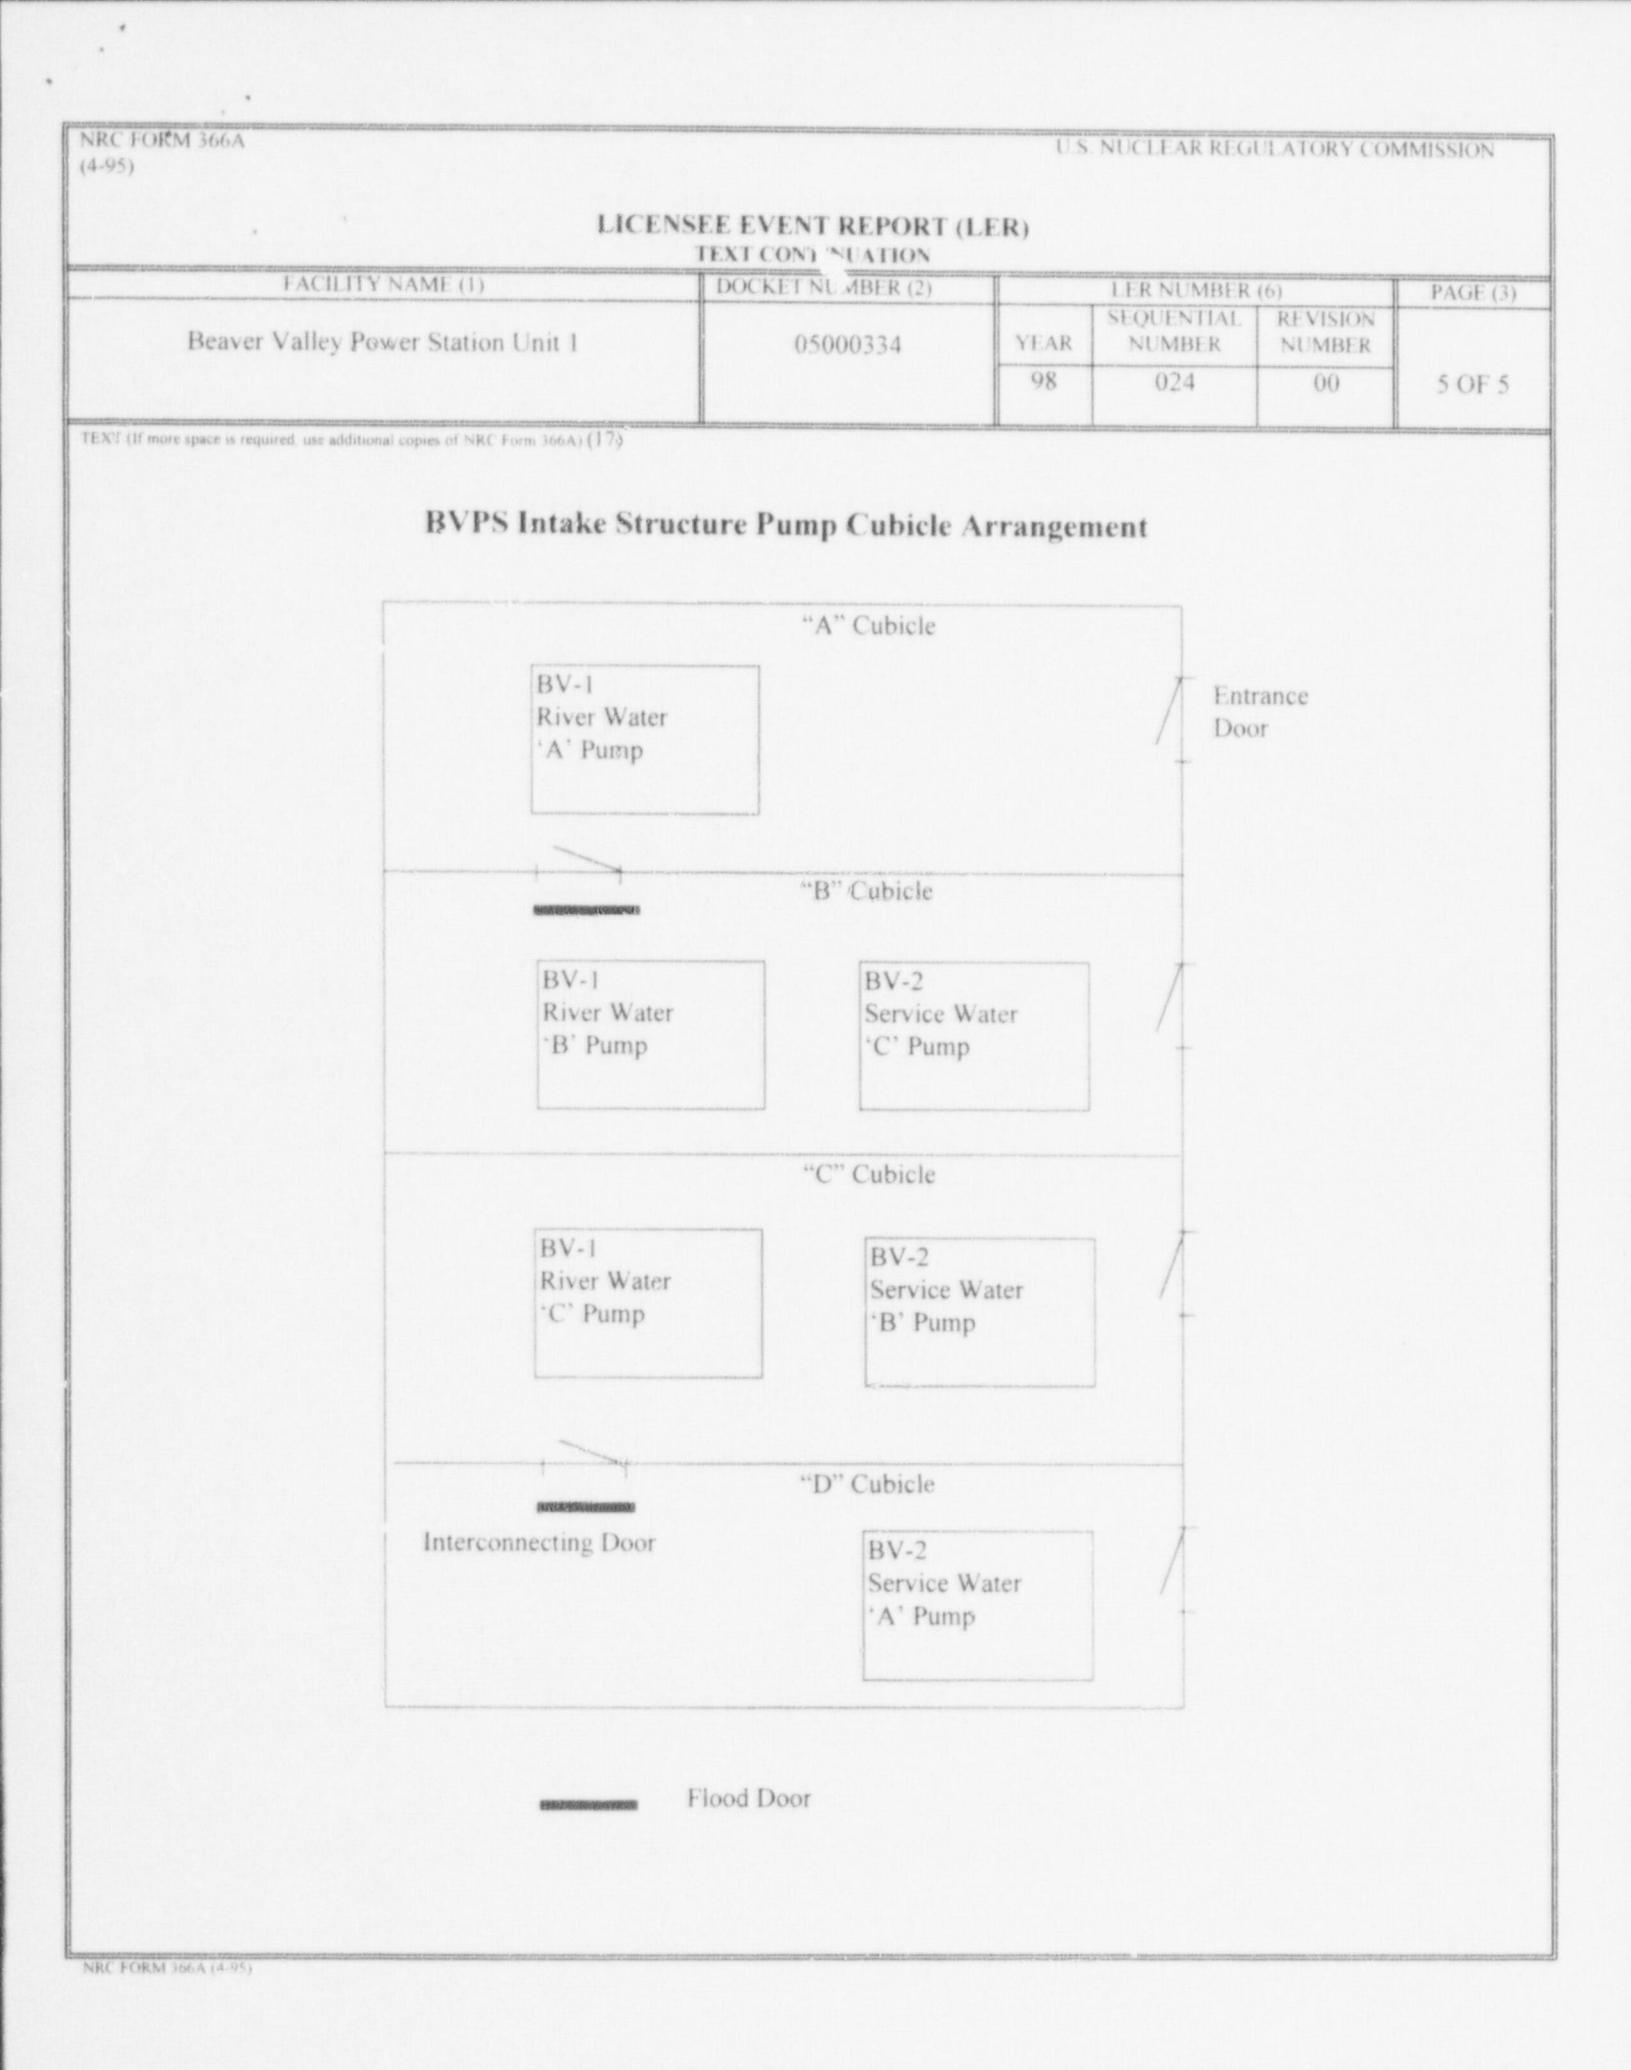
The BVPS Intake Structure pump cubicle arrangement is shown on Page 5. Each cubicle has one main entrance door and one door which connects to the adjacent cubicle. Pump Cubicle 'A' and 'B' have one interconnecting door way and Pump Cubicle 'C' and 'D' have one interconnecting door way. There is no door way between Pump Cubicle 'B' and 'C'.

Flood doors over each of the two interconnecting pump cubicle doors in the Intake Structure were closed on June 4, 1998 and have remained closed. This will prevent any postulated internal flood in one Intake Structure pump cubicle from adversely affecting the safety related components in the adjacent pump cubicle. A placard has been posted on the outside of the two interconnecting flood door waraing personnel that the flood door must remain shut and to contact both Unit Control Rooms prior to opening.
