Reactor Water Cleanup (RWCU) System Isolations (2) Following RWCU Pump Maintenance Due To Not Adhering To Procedures

Event Date: 09/10/87 Event Time: 1046 and 1339 This LER was initiated by Incident Report Nos. 87-139 & 87-140

HOPE CREEK GENERATING STATION DOCKET NO. 50-354 UNIT NO. 1 LICENSEE EVENT REPORT 87-040-01

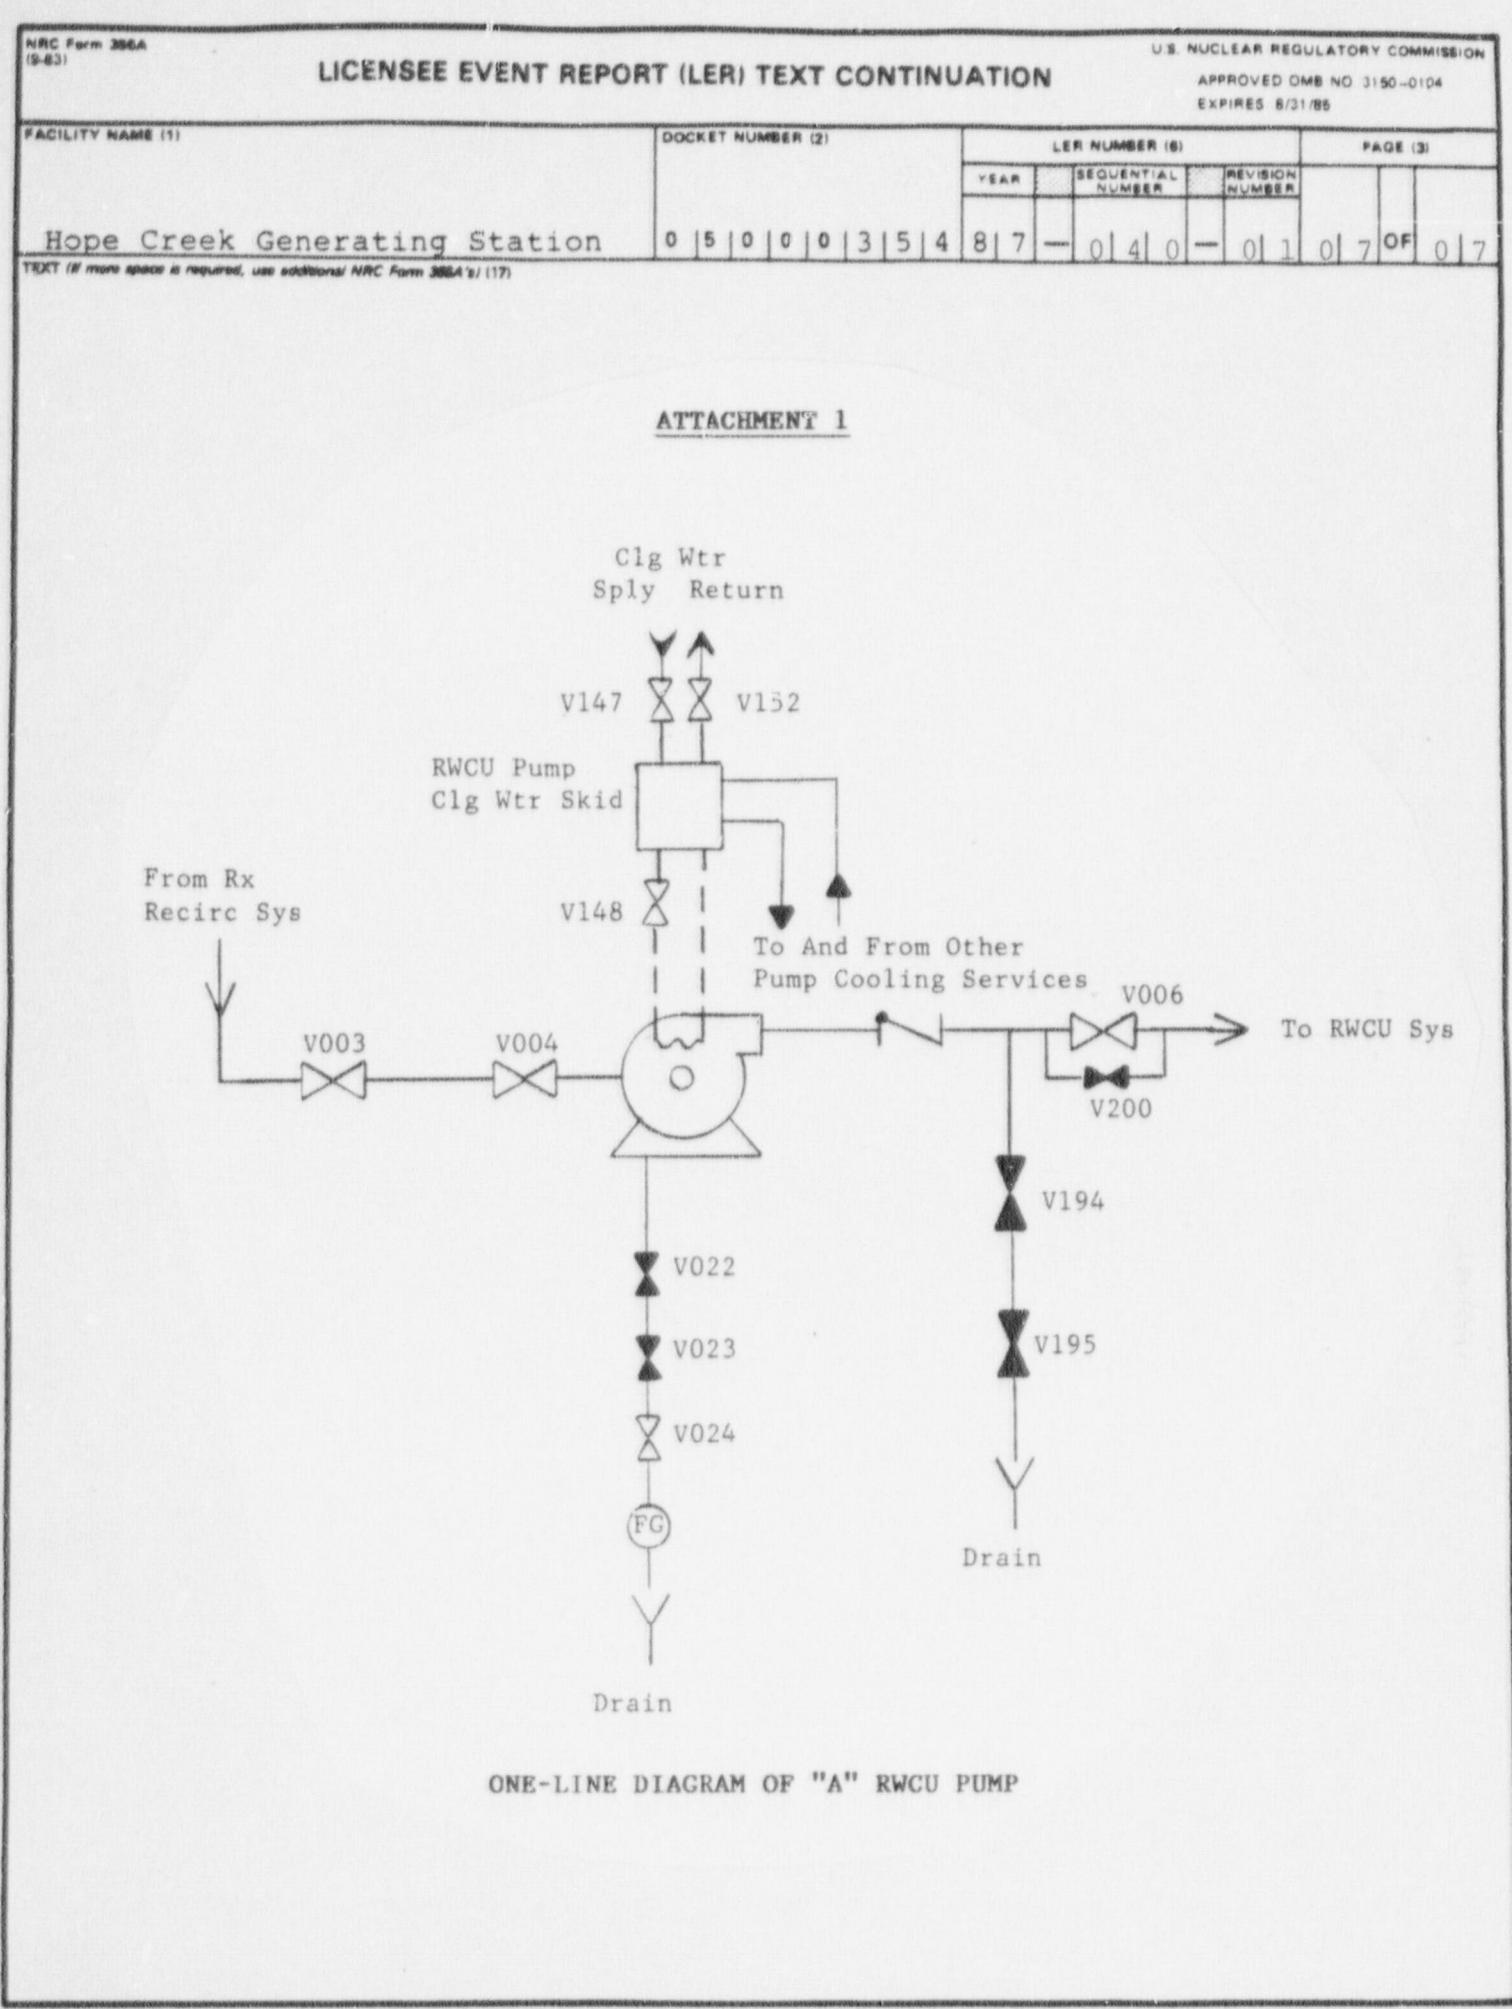
Refer to attachment 1, which is a one line diagram of the "A" RWCU pump piping and valve arrangement. On 9/7/87, the mechanical seal on "A" RWCU pump failed, and a safety tagging request was initiated in preparation for repairing the pump. The following valves were used as blocking points:

Additionally, a note on the tagging request required draining the discharge line via V194 and V195, however, these valves were not used as blocking points.

At 1210, both RWCU pumps were placed in service. The pumps ran until 1339, when the mechanical seal on "A" RWCU pump failed again, resulting in the second RWCU isolation. An EO was dispatched to the pump and determined that the seal cooler cooling water inlet valve (V148) was closed. The lack of cooling water caused the seal to burn up. Although the seal cavity is provided with a high temperature alarm, the alarm was inoperable at the time of this occurrence due to a broken thermoccuple. A new thermocouple had been on order but had not been received prior to this incident. Since the RWCU system was needed to reduce Reactor water conductivity, a decision was made to return both RWCU pumps to service without the high temperature alarm being operable.

- 5. Systems Engineering will investigate the feasibility of modifying the RWCU pump cooling water skids to provide latching mechanisms for the valves to prevent inadvertent operation.
