POWER REACTOR EVENTS United States Nuclear Regulatory Commission

Date Published: December 1987

NUREG/BR-0051 Vol. 9, No. 2

Period Covered: March-April 1987

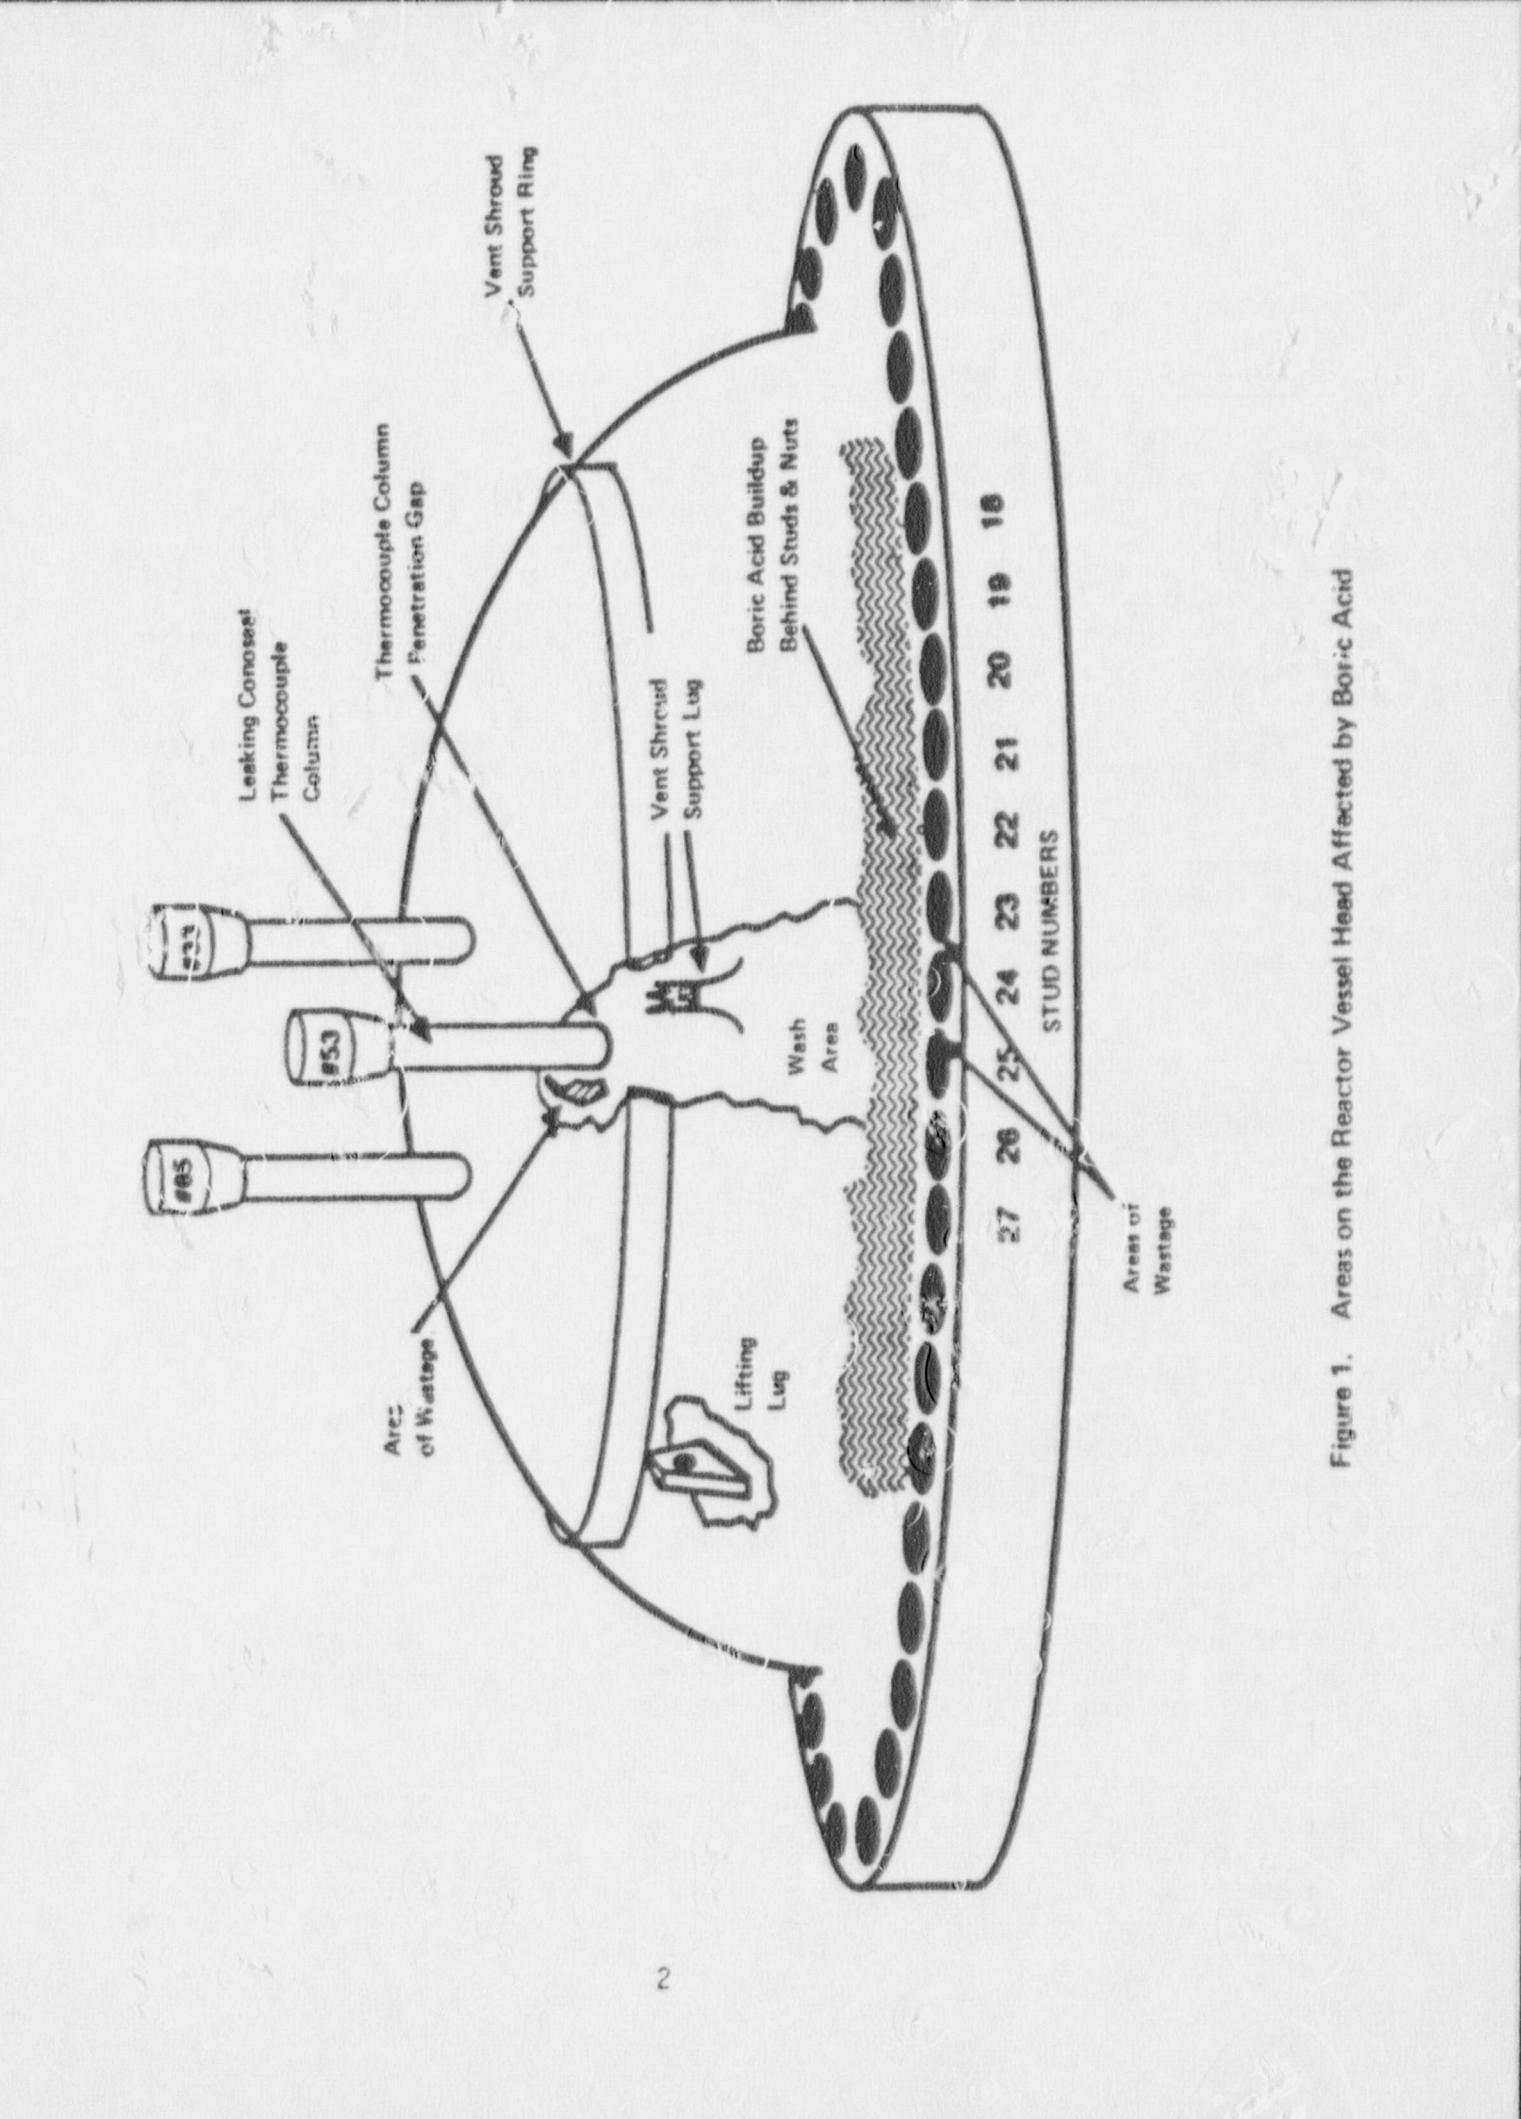
On March 13, 1987, during an inspection of the Turkey Point Unit 4* reactor pressure vessel (RPV) head area, the licensee found that a significant amount of boric acid crystals had been deposited on the reactor vessel head due to a leak in the lower seal (conoseal) of a thermocouple instrumentation port column assembly. (See Figure 1.) Two comprehensive reports have been issued concerning this finding. One is the licensee's "Report on Instrumentation Port Column Assembly Leakage" (Ref. 1), issued April 27, 1987. The other is the May 15, 1987 NRC report (Ref. 2) compiled by the Augmented Inspection Team sent from the NRC's Region II Office to review circumstances associated with the problem. Both reports identify the components which have been affected by the conoseal leak and the potential leakage mechanisms, and discuss the licensee's corrective actions. The reports are summarized below.

The affected lower conoseal joint consists of a stainless steel conoseal gasket between stainless steel male and female flanges. The flanges are held in place by a carbon-steel clamp. This design has been used at Turkey Point since it first began operation and has also been used on other Westinghouse nuclear plants.

(about 500 lbs) of boric acid crystals on the reactor vessel head area. Montyeight of the 58 reactor vessel head studs were affected by the boric acid reak; eight of the studs were encrysted, with three showing thread damage.

The licensee also performed an investigation to identify the potential leakage mechanisms associated with the conoseal leakage. As a result of these inspections, it was determined that the clamp shim and the conoseal gasket had significant damage and may have been associated with the conoseal leak mechanism. Based upon this information, it was determined that the two most likely potential leakage mechanisms were corrosion of the shim due to unidentified leakage from an external source and debris or imperfections in the conoseal; however, the existence of either or both of these potential leakage mechanisms could not be confirmed. In any case, once the lower conoseal leak initiated, it was probably exacerbated by corrosion wastage of the clamp and shim. The licensee is taking actions to address these and other mechanisms, including (1) changing procedures and training of manintenance and inspection personnel; and (2) modifying the thermocouple column assembly to provide for, among other things, the use of iron based superalloy clamps which do not use shims and which are not subject to any significant corrosion by boric acid. These steps will help prevent recurrence of leakage of the conoseal.
