FACILITY: Palo Verde, Units 1, 2 and 3

SUBJECT: SUMMARY OF MEETING HELD IN PHOENIX, ARIZONA, AUGUST 11 - 13, 1987

ANPP - NRC MANAGEMENT MEETING
PHOENIX, ARIZONA
AUGUST 12, 1987

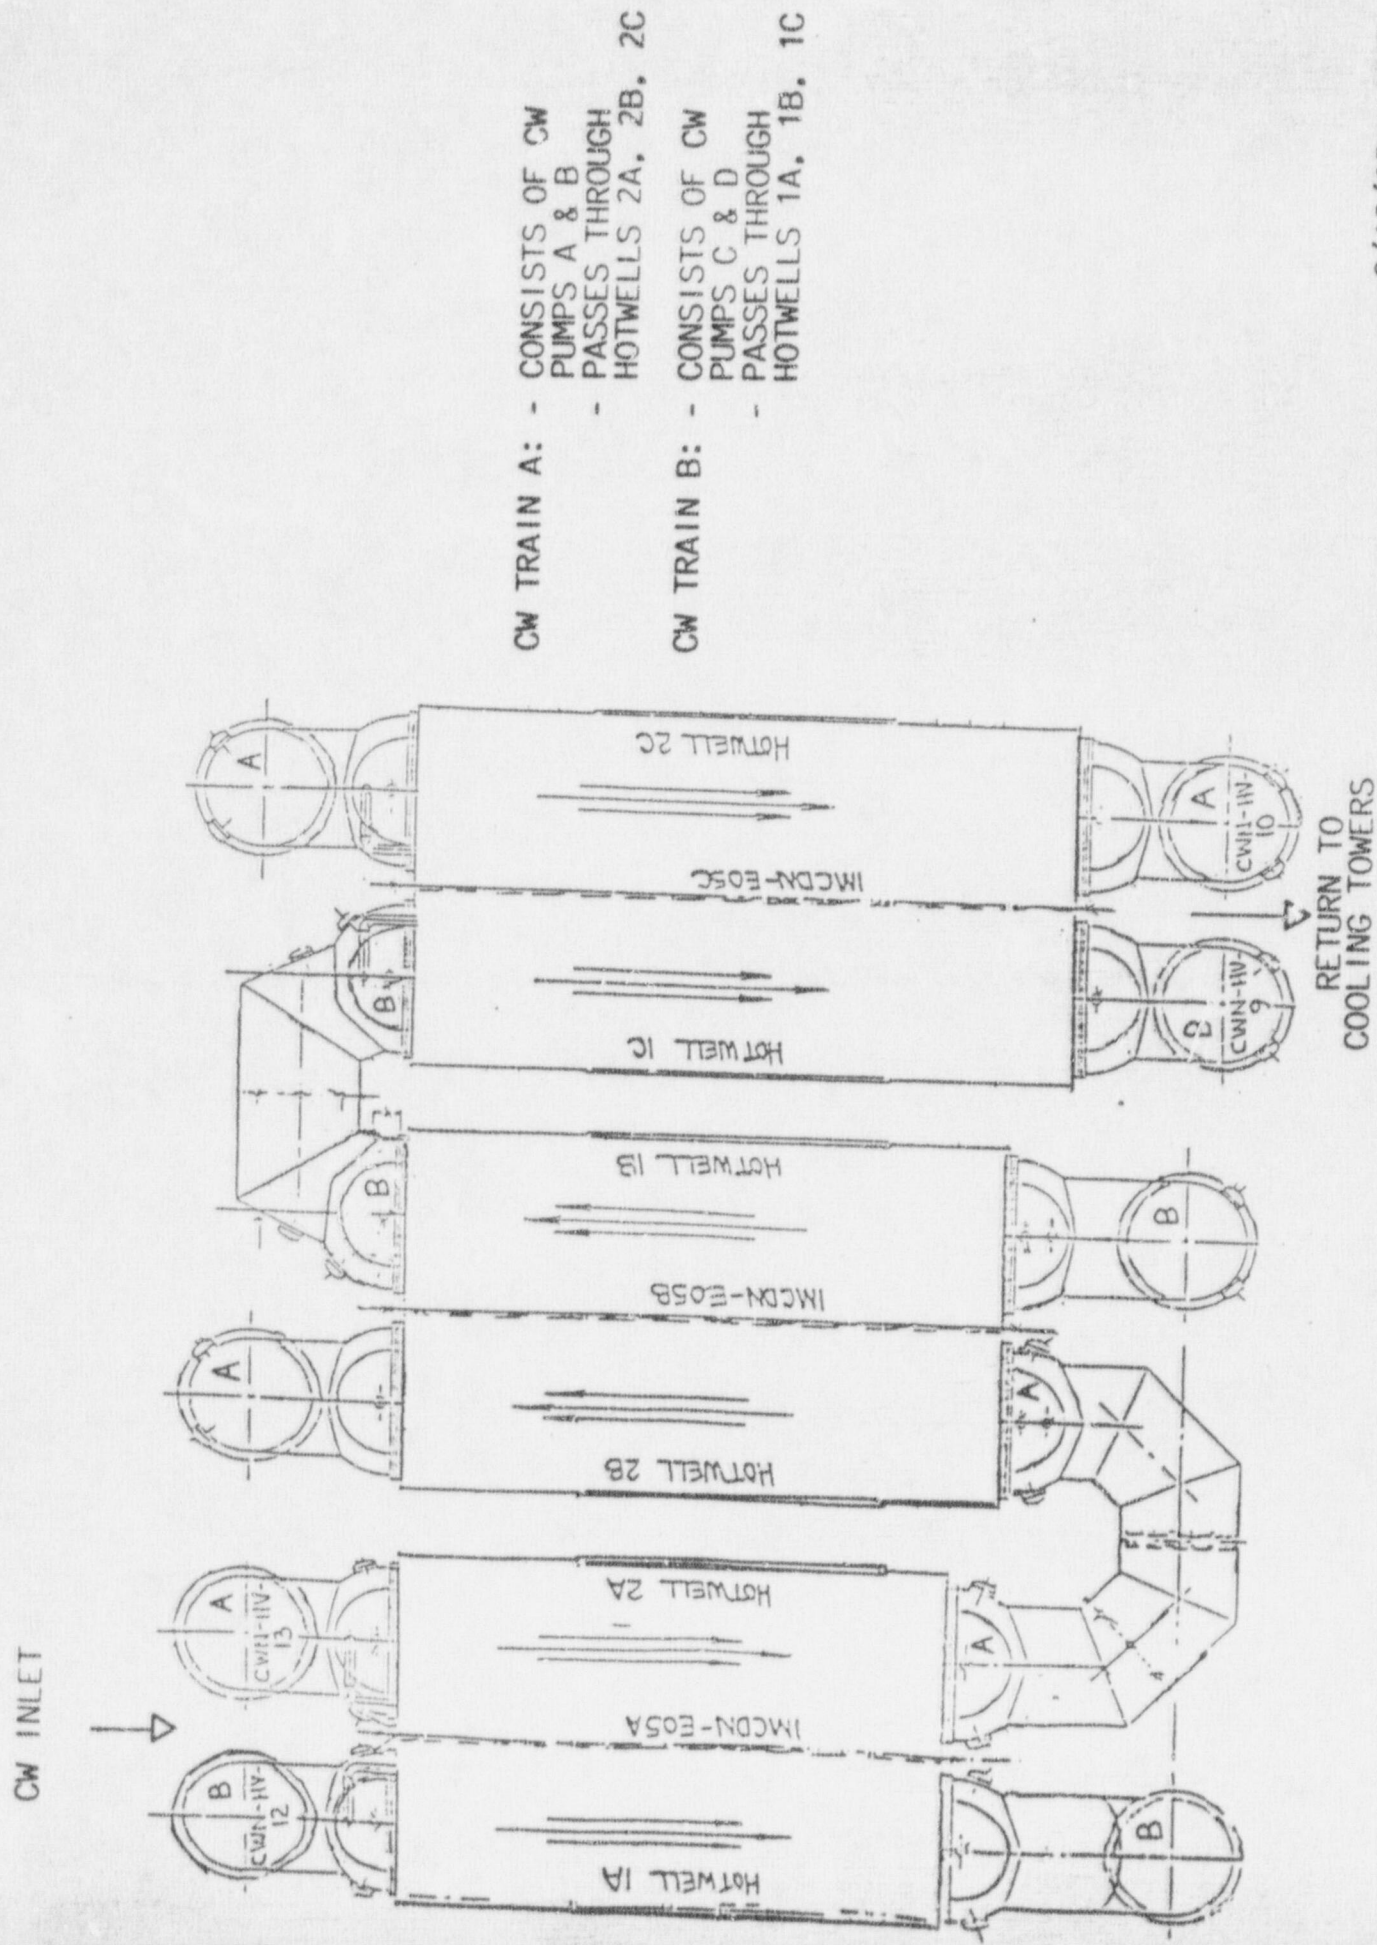
CIRCULATING WATER SYSTEM

- TRAIN 'A' OF CW SYSTEM EXPERIENCES PIPE WELD FAILURES PLANT IS SHUTDOWN.
- EVENT IS CAUSED BY HOTWELL '2C' OUTLET VALVE CLOSING.
- WELDS ON WATERBOX '2C' INLET AND OUTLET FAILED - WATERBOX '2B' OUTLET AND '2A' INLET CRACKED.
- EXPANSION JOINT STUDS BENT, STRETCHED AND DAMAGED ON BOTH LOOPS.

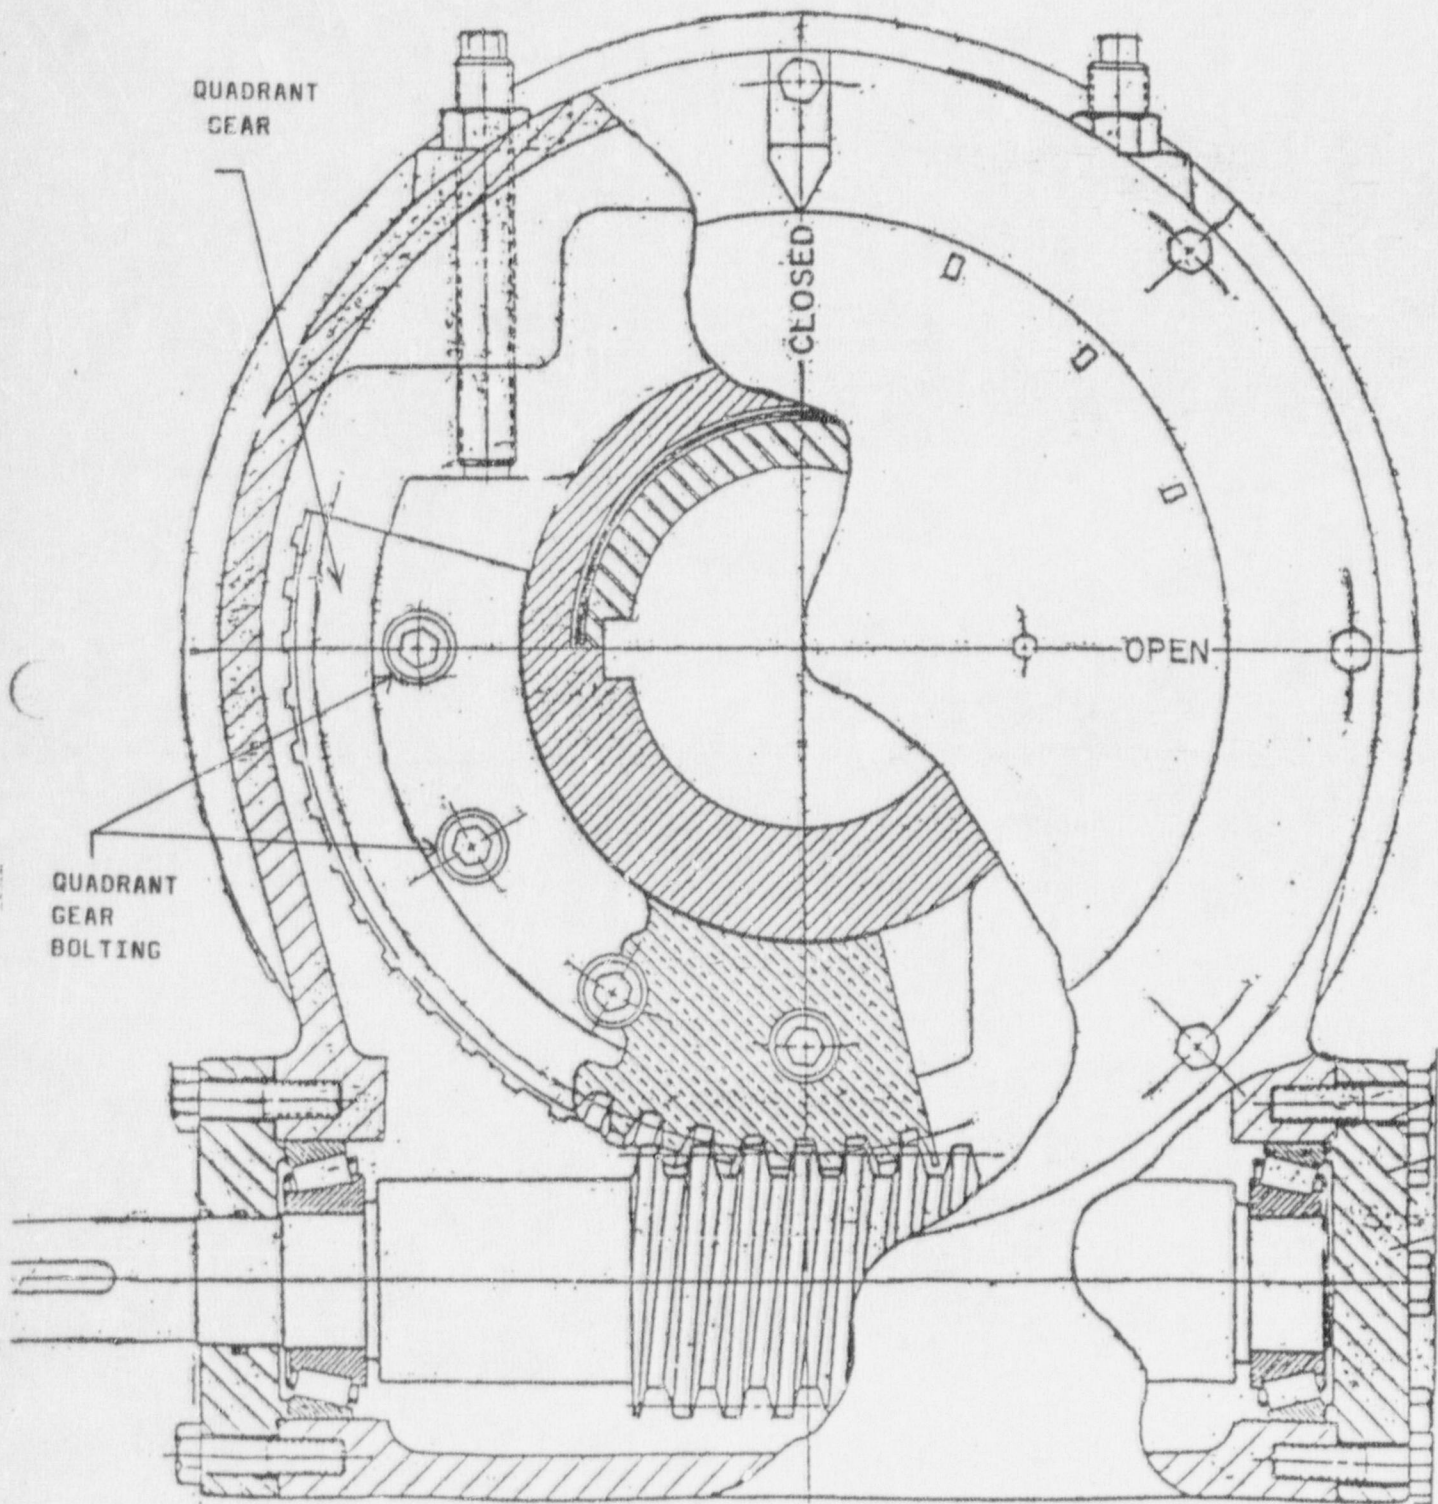
"2C" OUTLET VALVE QUADRANT GEAR

The Unit 1 Circulatory Water (CW) system water hammer event was discussed. The root cause of the condenser waterbox damage was the failure of the quadrant gear bolts on the '2C' waterbox outlet valve. The bolts failed due to improper setting of the electrical limit switches and

mechanical stops caused by incorrect interpretation of the valve technical manual. The valve manufacturer provided training of licensee personnel and the electrical limit switches and mechanical stops were reset in Unit 1. The licensee stated that the use of locktite and hardened washers to distribute torque loading and an increase in preloading on the bolts should reduce the vibration induced fatigue loading on the bolts. Similar actions will be taken on Unit 2 CW valves at the next outage and on Unit 3 CW valves prior to power ascension.

- ROOT CAUSE OF THE WATERBOX DAMAGE WAS FAILURE OF THE QUADRANT GEAR BOLTS
- ROOT CAUSE OF THE BOLT FAILURE WAS IMPROPER SETTING OF THE ELECTRICAL AND MECHANICAL STOPS
- ROOT CAUSE OF THE IMPROPERLY SET STOPS WAS INADEQUATE/INCORRECT INTERPRETATION OF THE TECHNICAL MANUAL.

- ELECTRICAL LIMIT SWITCHES AND MECHANICAL STOPS WERE RESET IN UNIT 1
- '2C' OUTLET VALVE REPAIRED. BOLTING MATERIAL REPLACED. LOCKTITE AND HARDENED WASHERS ADDED TO DISTRIBUTE TORQUE LOADING AND ASSIST IN MAINTAINING TORQUE LOADING.
- ALL OTHER SIMILAR VALVES IN UNIT 1 CHECKED FOR WEAR, TORQUE, AND WASHERS AND LOCKTITE USED AS DESCRIBED ABOVE.
- BOLTS IN UNITS 2 AND 3 CHECKED TO VERIFY TIGHTNESS
- WATERBOX REPAIRS COMPLETED
- ONE TUBE LEAK IDENTIFIED AND PLUGGED
- NO INDICATIONS OF TUBE SHEET LEAKS OBSERVED

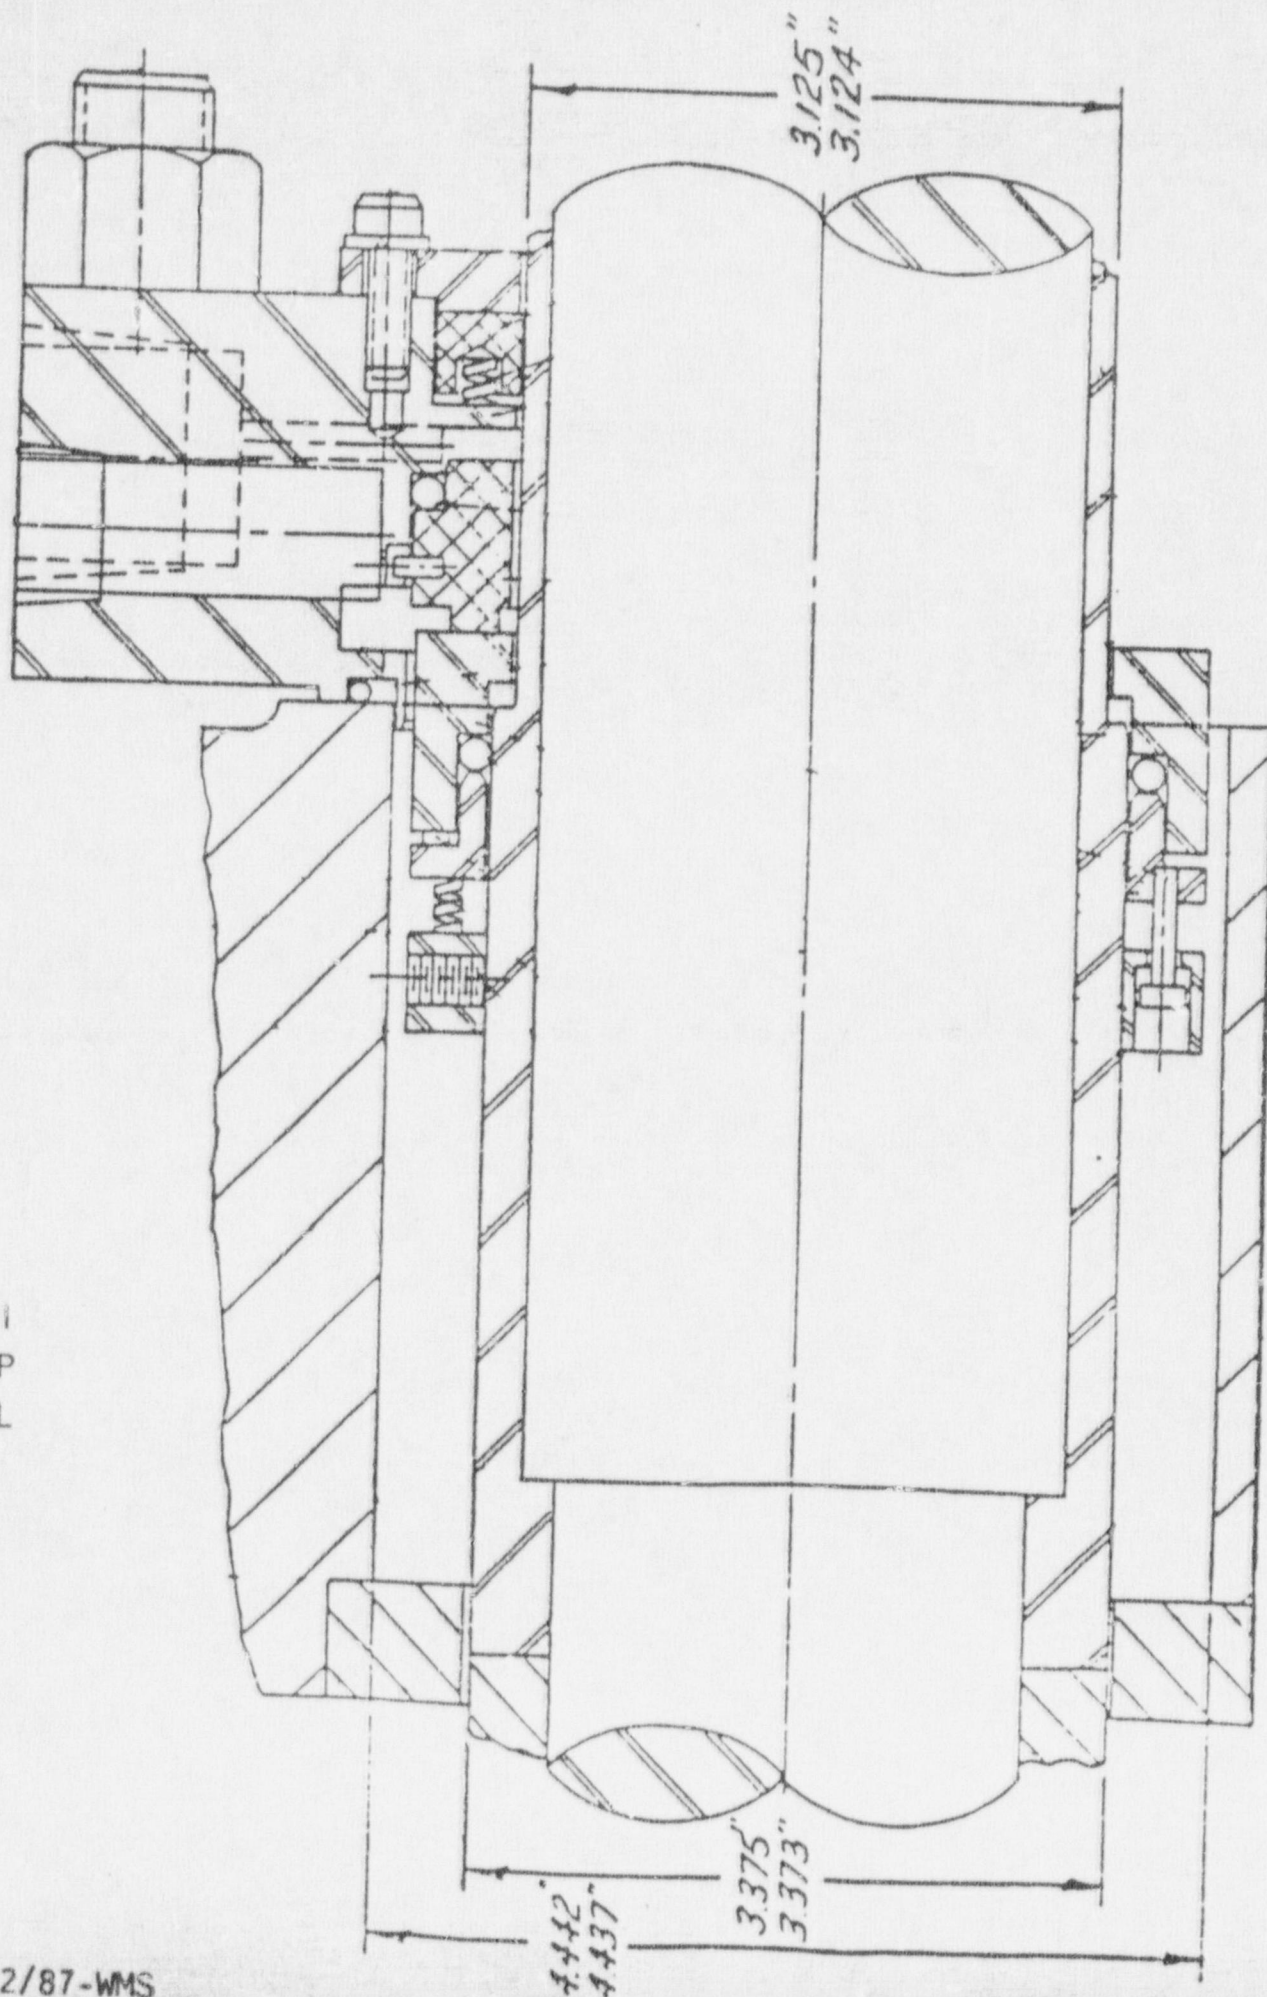
LPSI
PUMP
SEAL

The Unit 1 LPSI pump seal failures of early July 1987 were discussed. When the Unit remained at approximately 325°F for steam generator cleanup following the condenser water hammer event, the continued operation at high temperature caused degradation of the seals. The swelling of the 'O' rings was apparently due to the application of a solvent to the 'O' ring surface. On the 'A' LPSI pump the increased seal leakage up the pump shaft displaced bearing lubricating oil and resulted in bearing failure and motor damage. As corrective actions slingers are being installed on all LPSI and CS pumps, no solvent or petroleum lubricants are to be used on 'O' rings, operating time above 210°F is being restricted on LPSI pumps, and a seal life monitoring program by the system engineer has been established. The licensee is looking at different seal designs and/or materials. The staff commented that a common theme in several recent events has been that technical manuals were not specific. Increased interaction and information feedback between vendors and the licensee, and vendor involvement in maintenance activities might preclude similar problems in the future. The staff also recommended that information about seal degradation at high temperature should be shared with the rest of the industry.

- VENDOR INVOLVEMENT (PUMP VENDOR AND SEAL VENDOR)
- SWOLLEN 'O' RINGS APPARENTLY DUE TO SOLVENT APPLICATION
- LOWER (ROTATING) SEAL SEIZES AXIALLY ON SHAFT PREVENTING WEAR COMPENSATION
- HIGH TEMPERATURE ACCELERATES WEAR RATE

- VENDOR INVOLVEMENT
- SEAL LEAKAGE UP PUMP SHAFT TO LOWER MOTOR BEARING
- BEARING OIL DISPLACED BY SEAL LEAKAGE WATER
- BEARING FAILURE
- MOTOR UPLIFT & DAMAGE

- VENDOR INVOLVEMENT (PUMP VENDOR AND SEAL VENDOR)
- DEBRIS IN ROTATING SEAL CAUSES MISALIGNMENT OF SEAL FACES
- "BEVELED" WEAR PATTERN ON STATIONARY CARBON SEAL FACE - SEALING SURFACE REDUCED
- HIGH TEMPERATURE ACCELERATES WEAR RATE
- CHIPPING ON CARBON SEALING FACE
- SEAL LEAKAGE UP PUMP SHAFT TO LOWER MOTOR BEARING

1. SLINGERS ON ALL LPSI AND CONTAINMENT SPRAY PUMPS
2. NO SOLVENT OR PETROLEUM LUBRICANTS ON O-RING/RUBBER MATERIAL
3. LIMIT OPERATION TIME ON LPSI PUMPS WHEN ABOVE 210°F
4. SEAL LIFE MONITORING BY SYSTEM ENGINEER
