U. S. NUCLEAR REGULATORY COMMISSION REGION I

Report No. 50-245/89-13

Facility Name: Millstone Nuclear Generating Station Unit 1

CONTAMINATION OF THE WESTINGHOUSE HYDROLAZER SYSTEM USED AT MILLSTONE UNIT ONE

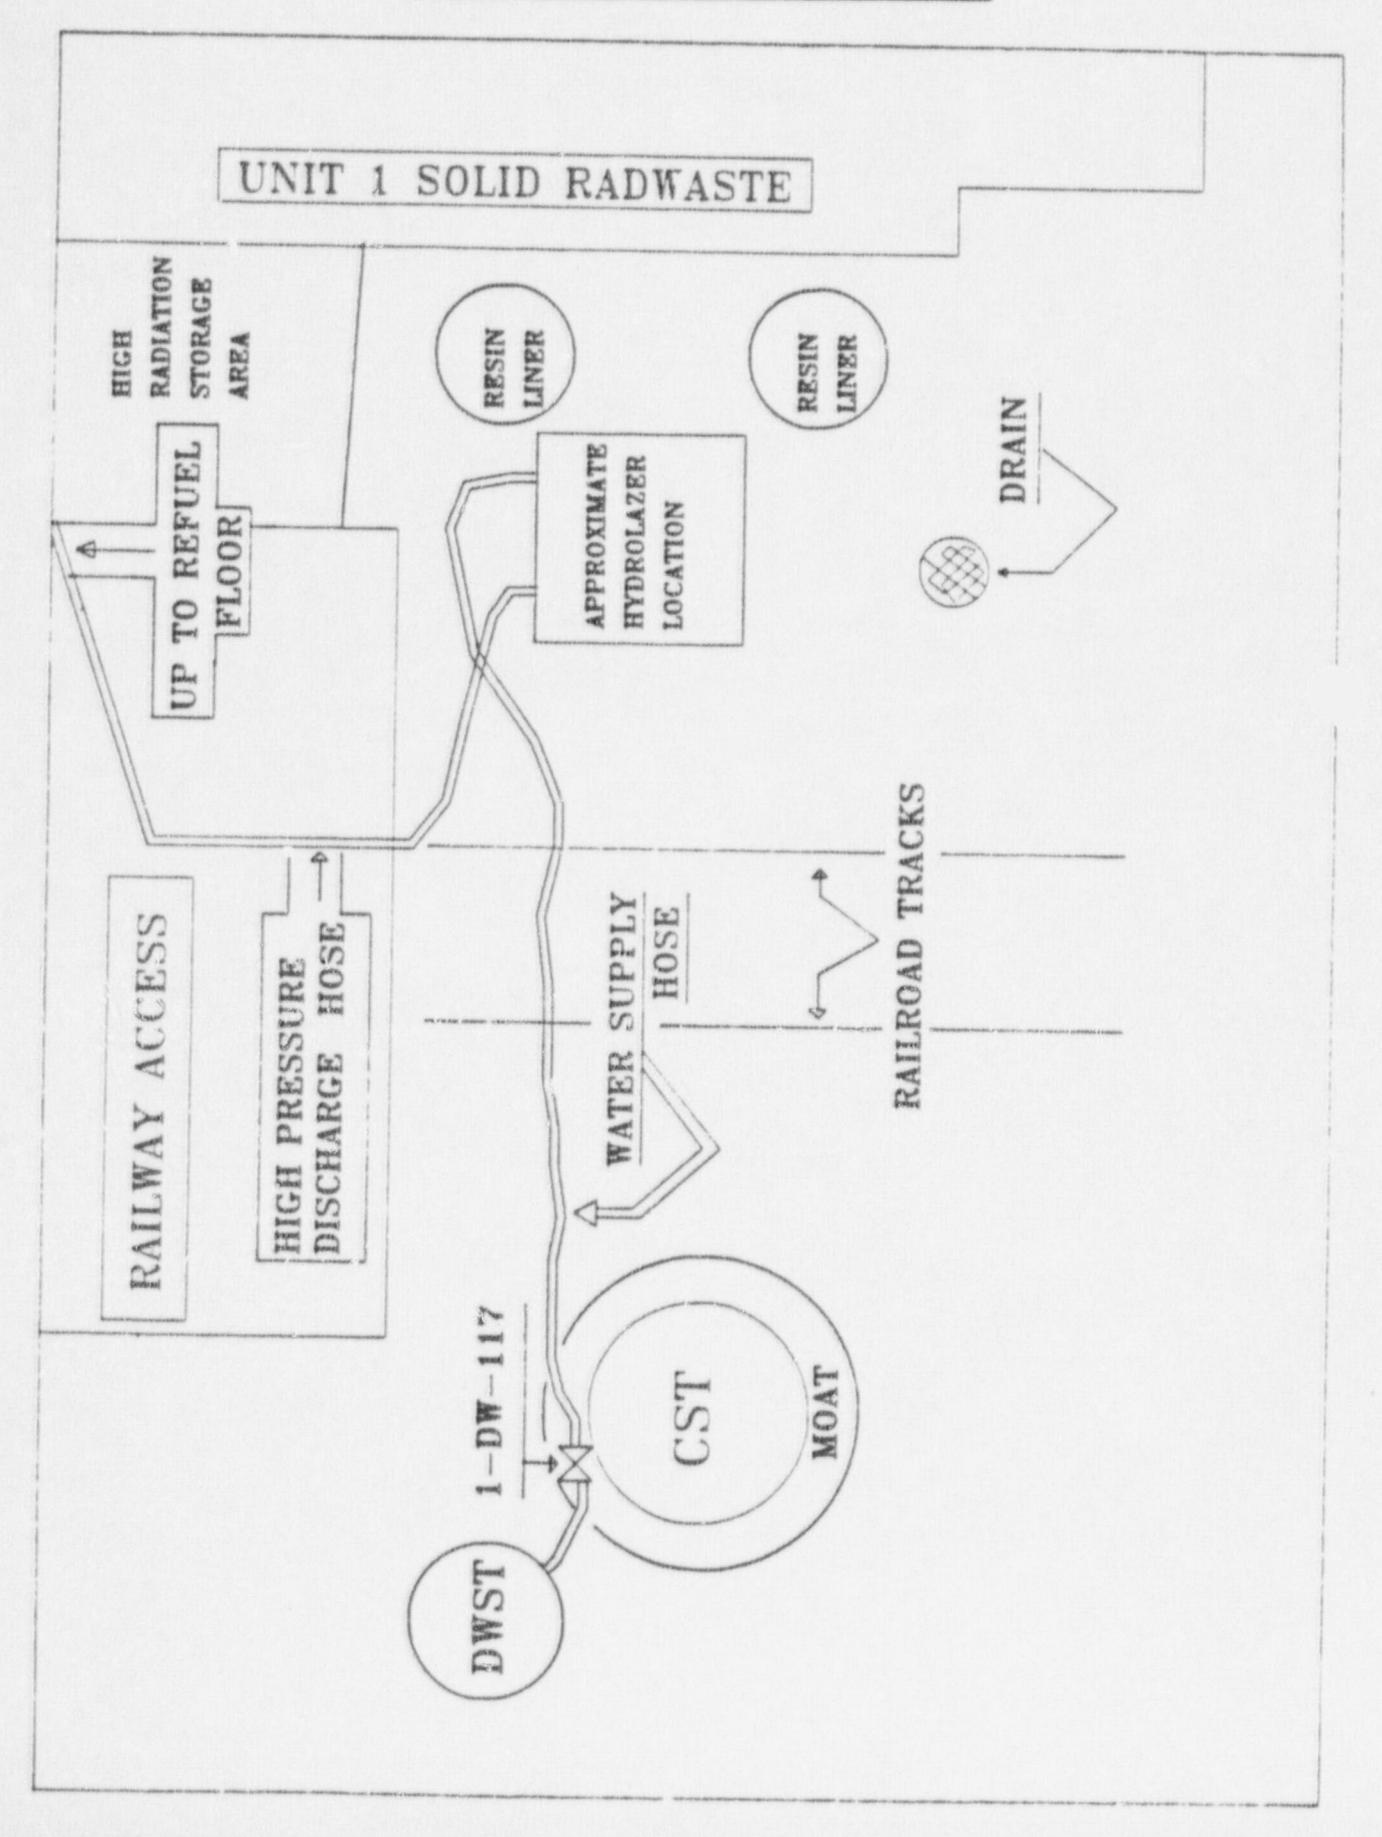
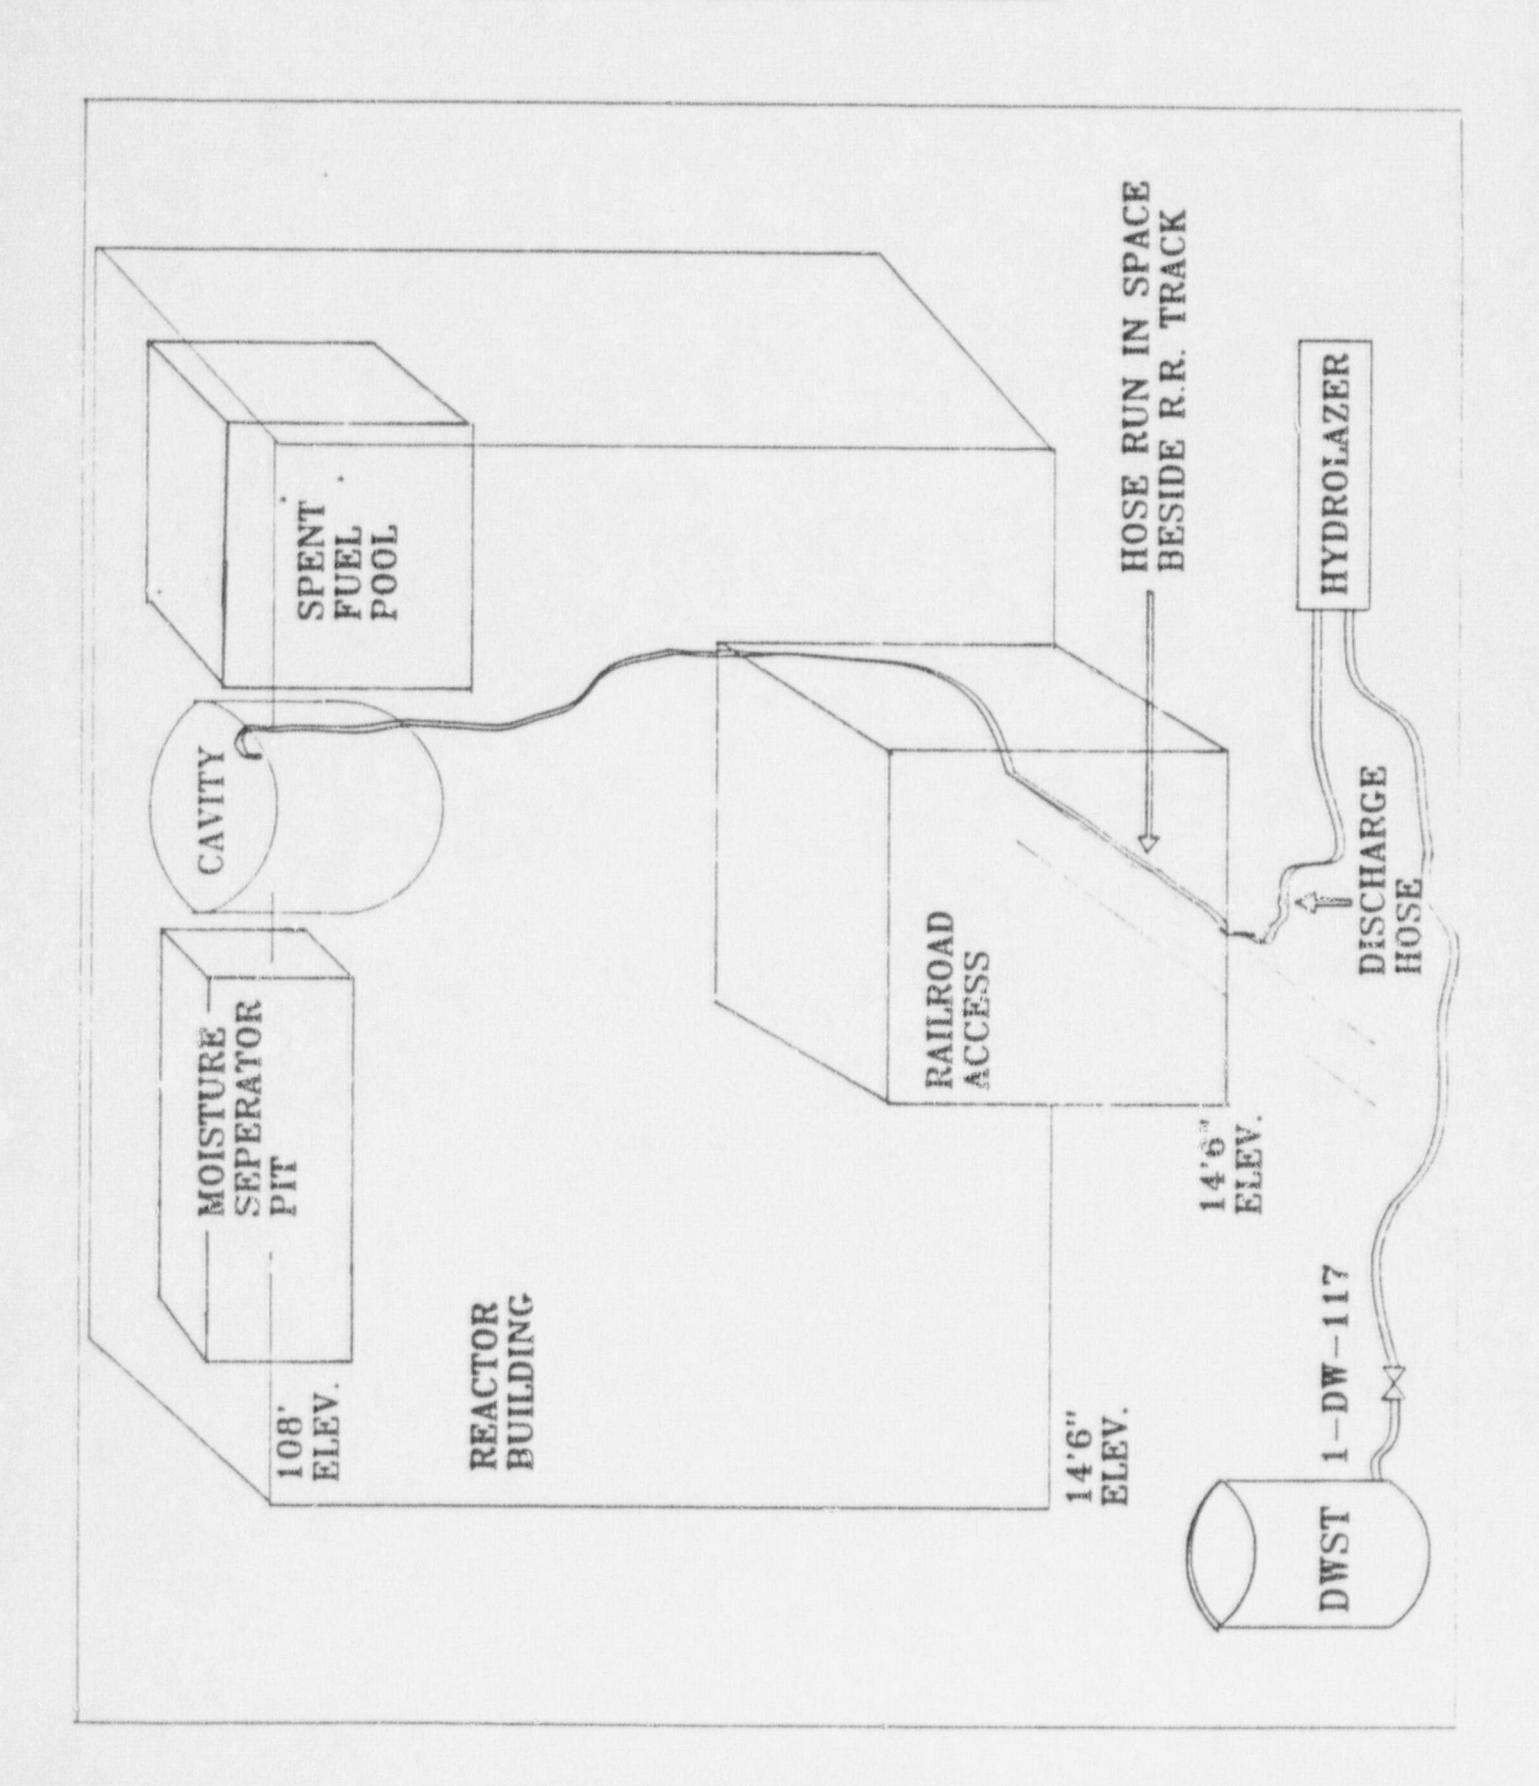
HYDROLAZE TRAILER LOCATION

For operation at Millstone Unit One, the hydrolazer trailer was situated outside of the Reactor Building at the railway access as illustrated in Attachment One. As shown in Attachment One, water was supplied from the demineralized water storage tank to the hydrolazer supply tank. The hydrolazer pump discharge line was run into the Reactor Building, and up approximately 100 feet to the refuel floor where the hydrolazing was performed. Page 3 of Attachment One is a schematic of the water supply.

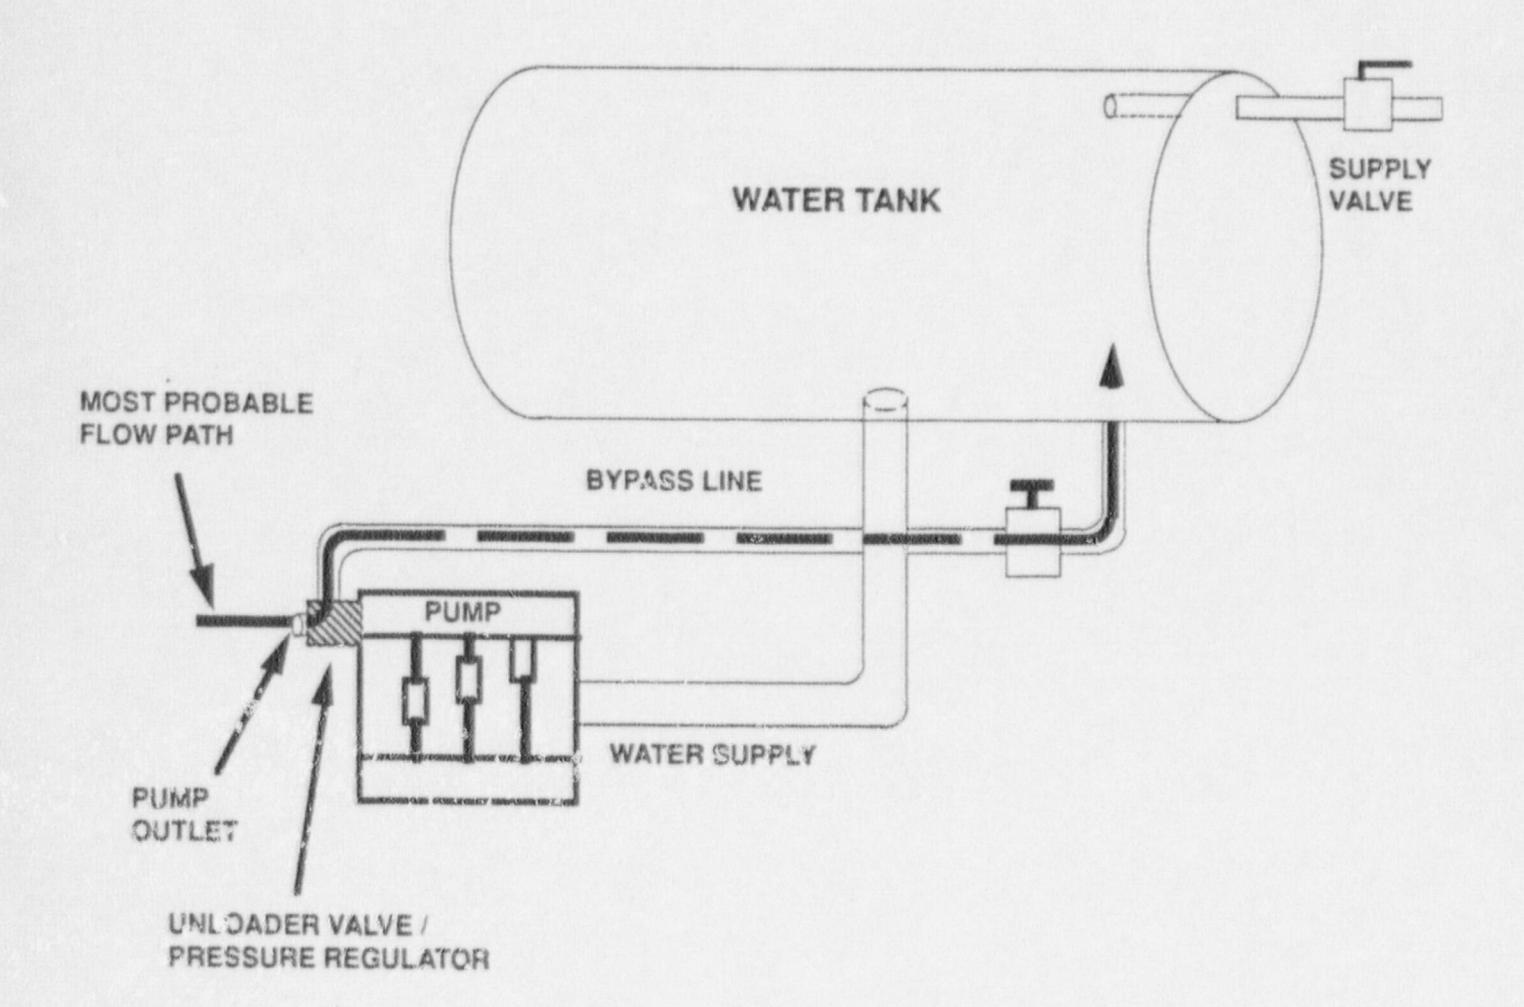
HYDROLAZE SYSTEM DESIGN

The hydrolazer trailer consists of a 60 gallon supply tank, a pump, and a diesel engine. Attachment Two is a diagram of the trailer. There are three connections to the tank: an inlet located on one end at the top, a pump suction located on the bottom center, and a bypass line located near the bottom, below the inlet line. The tank is vented to atmosphere through a vent panel near the top of the tank. The bypass line has an in-line valve and connects the discharge side of the pump back to the tank. Tank level is normally regulated by an inlet float valve. However, it was learned from Westinghouse that the float was not operable during the period of May 4 – May 12, 1989 and tank level was being maintained by the equipment operator through visual inspection. The hydrolazer pump is a positive displacement pump designed to deliver discharge pressures up to 11,000 PSI.

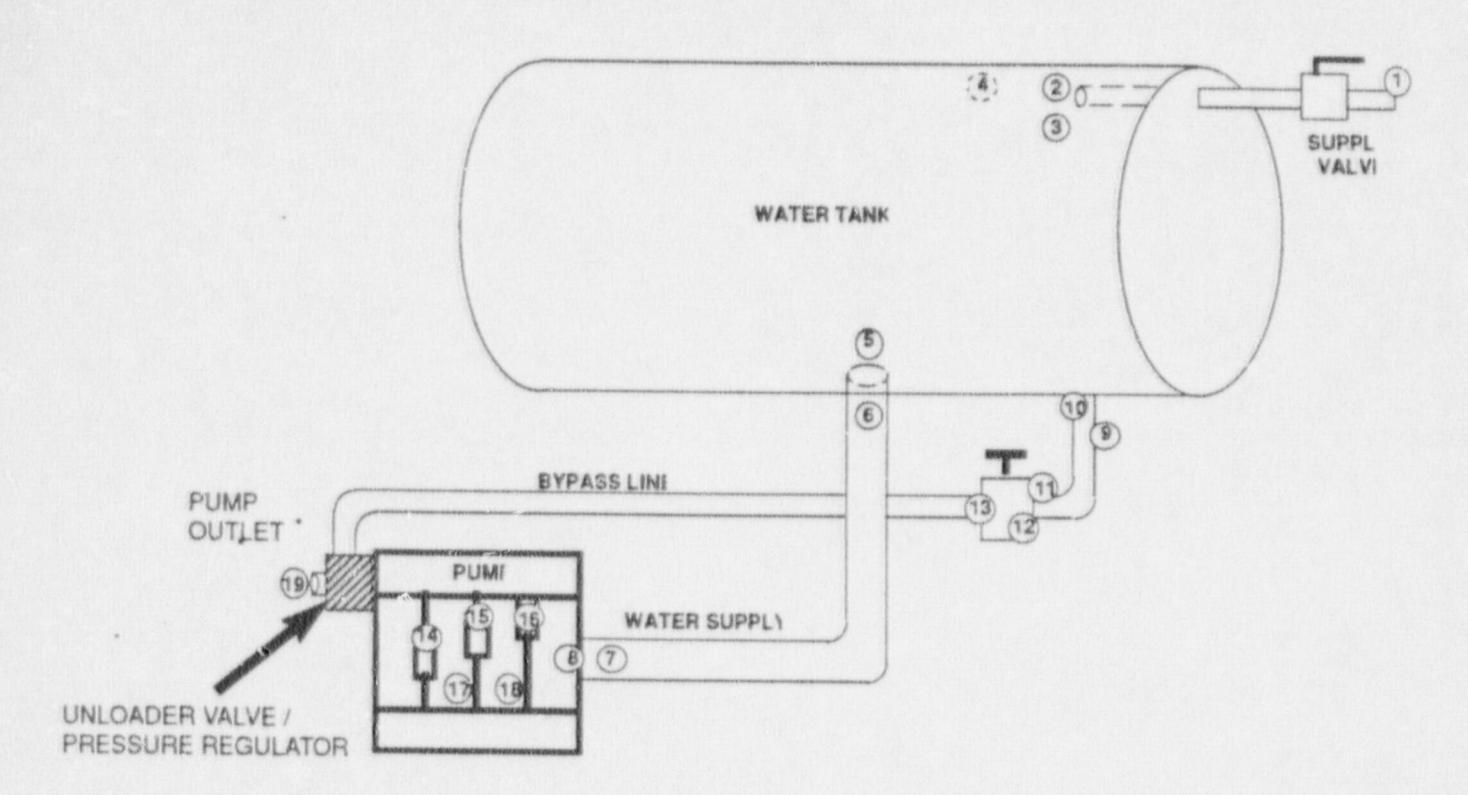
BADIOLOGICAL DATA: HYDROLAZE TRAILER SURVEY OF MAY 15, 1989

<u>Hydrolazer trailer</u> – All the survey results on pages one through eight of Attachment Six are Westinghouse results provided to NNECo. The highest level of contamination was inside the tank below the supply inlet near the bypass inlet. There was also contamination inside the inlet connector on both sides of the supply valve, inside the bypass line on both sides of the bypass valve, and inside the tank outlet fitting for the pump suction line. The interior of the suction line from the tank to the pump was not contaminated except for some small amount of contamination in the line near the tank. These levels and distribution of contamination suggests that the contamination could have entered the tank either through the inlet supply line or through the bypass line. Since there is a lack of evidence of supply water contamination, the bypass line becomes the suspected route of contamination. Moreover, the absence of any significant level of contamination in the pump suction line suggests contamination of the tank after completion of pumping activities. There is also contamination on the tank, on the tank mount structures, and on the deck of the trailer under and around the tank. External contamination is thought to have occurred as a result of draining the supply tank by the Westinghouse operators in preparation for transporting the unit offsite.

No.	dpm/100cm ²	Location
1	1263	Water Inlet Fittings
2	1663	Water Inlet Inside
3	10863	Water Inlet Inside
4	2863	Inside Lid
5	1963	Tank Fitting for Suction Hose
6	550	Inside Suction Hose Tank End
7	<mda< td=""><td>Inside Suction Hose Pump End</td></mda<>	Inside Suction Hose Pump End
8	<mda< td=""><td>Pump Inlet</td></mda<>	Pump Inlet
9	15413	Bypass Hose by Water Tank
10	5125	Tank Fitting for Bypass
11	<mda< td=""><td>Bypass Hose by Valve</td></mda<>	Bypass Hose by Valve
12	1188	Inside Bypass Valve Tank
13	438	Inside Bypass Valve Pump
14	<mda< td=""><td>Plunger</td></mda<>	Plunger
15	<mda< td=""><td>Plunger</td></mda<>	Plunger
16	<mda< td=""><td>Plunger</td></mda<>	Plunger
17	<mda< td=""><td>Plunger Housing Base</td></mda<>	Plunger Housing Base
18	<mda< td=""><td>Plunger Housing Base</td></mda<>	Plunger Housing Base
19	-MDA-	Water Outlet

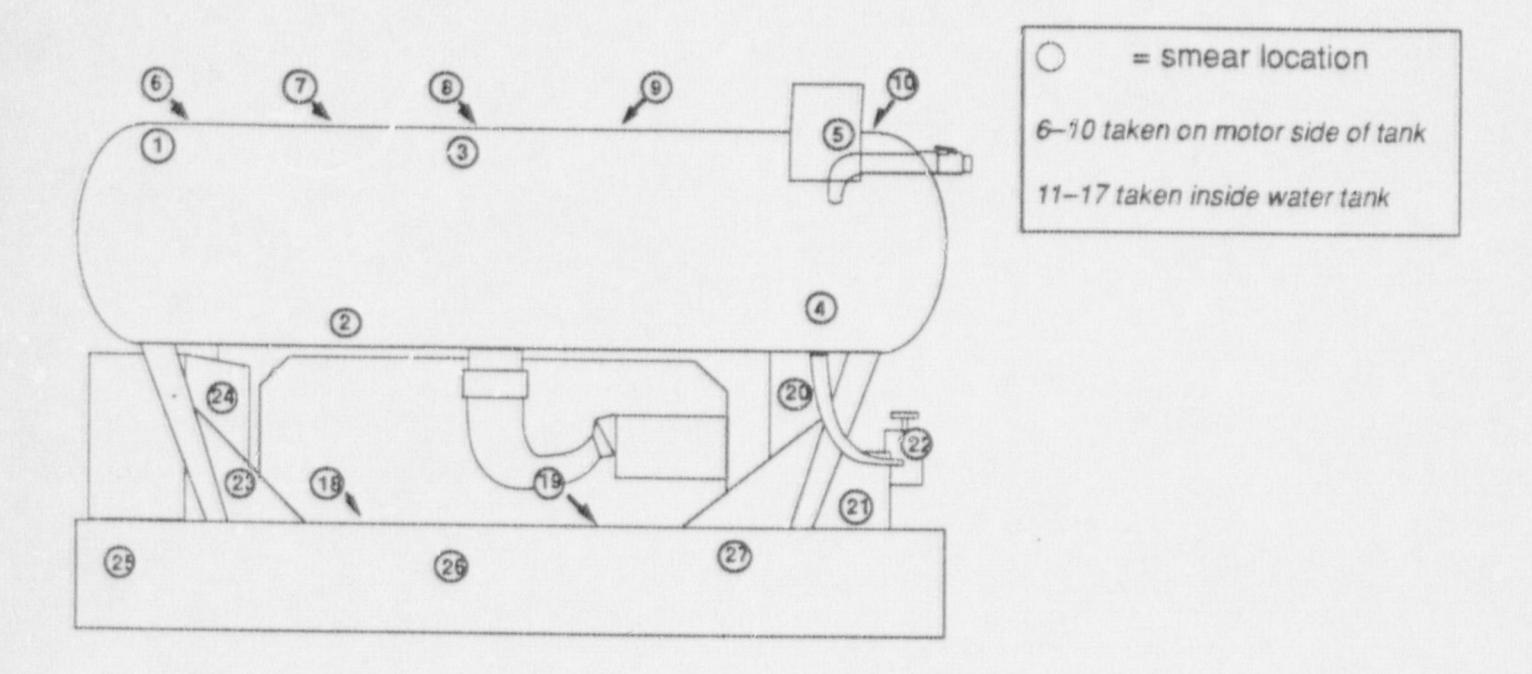
RADIOLOGICAL DATA: SURVEY OF HYDROLAZE TRAILER WATER TANK AND TRAILER EXTERNAL CONTAMINATION

Smear Number	Results	Smear Number	Results
1	<mda< td=""><td>18</td><td>15538</td></mda<>	18	15538
2	<mda< td=""><td>19</td><td>4538</td></mda<>	19	4538
3	613	20	<mda< td=""></mda<>
4	<mda< td=""><td>21</td><td>438</td></mda<>	21	438
5	1063	22	<mda< td=""></mda<>
6	<mda< td=""><td>23</td><td><mda< td=""></mda<></td></mda<>	23	<mda< td=""></mda<>
7	<mda< td=""><td>24</td><td><mda< td=""></mda<></td></mda<>	24	<mda< td=""></mda<>
8	<mda< td=""><td>25</td><td>2538</td></mda<>	25	2538
9	300	26	1200
10	600	27	2875

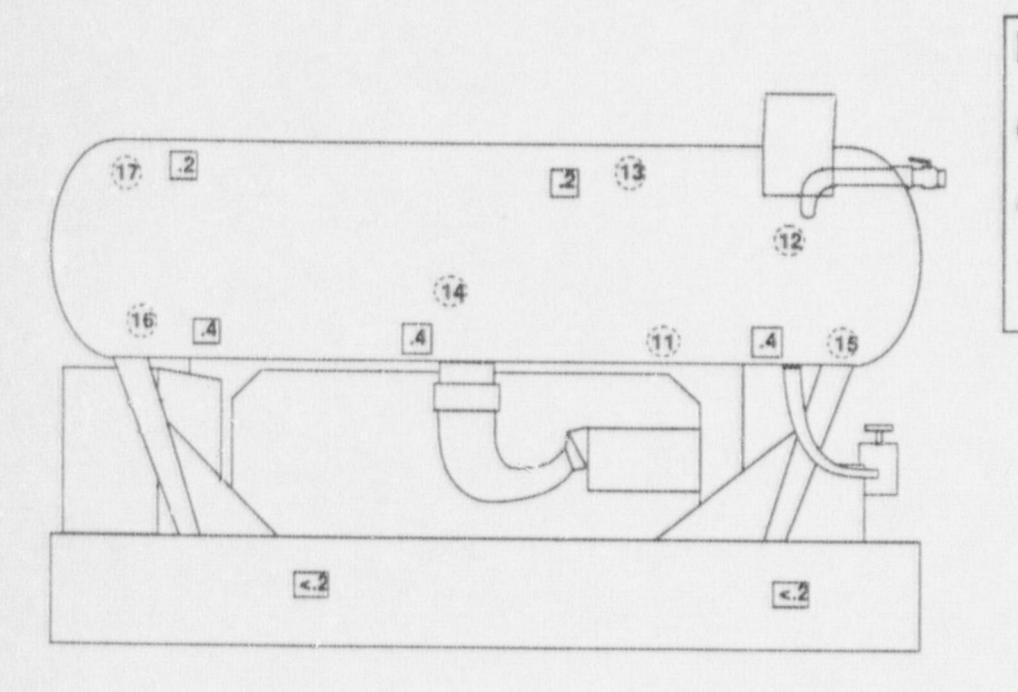
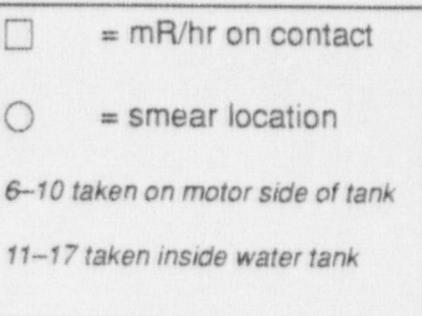
RADIOLOGICAL DATA: SURVEY OF HYDROLAZE TRAILER WATER TANK AND TRAILER

<u>Smear #</u>	Results		
11	675		
12	1150		
13	3400		
14	9925		
15	225088		
16	813		
17	3788

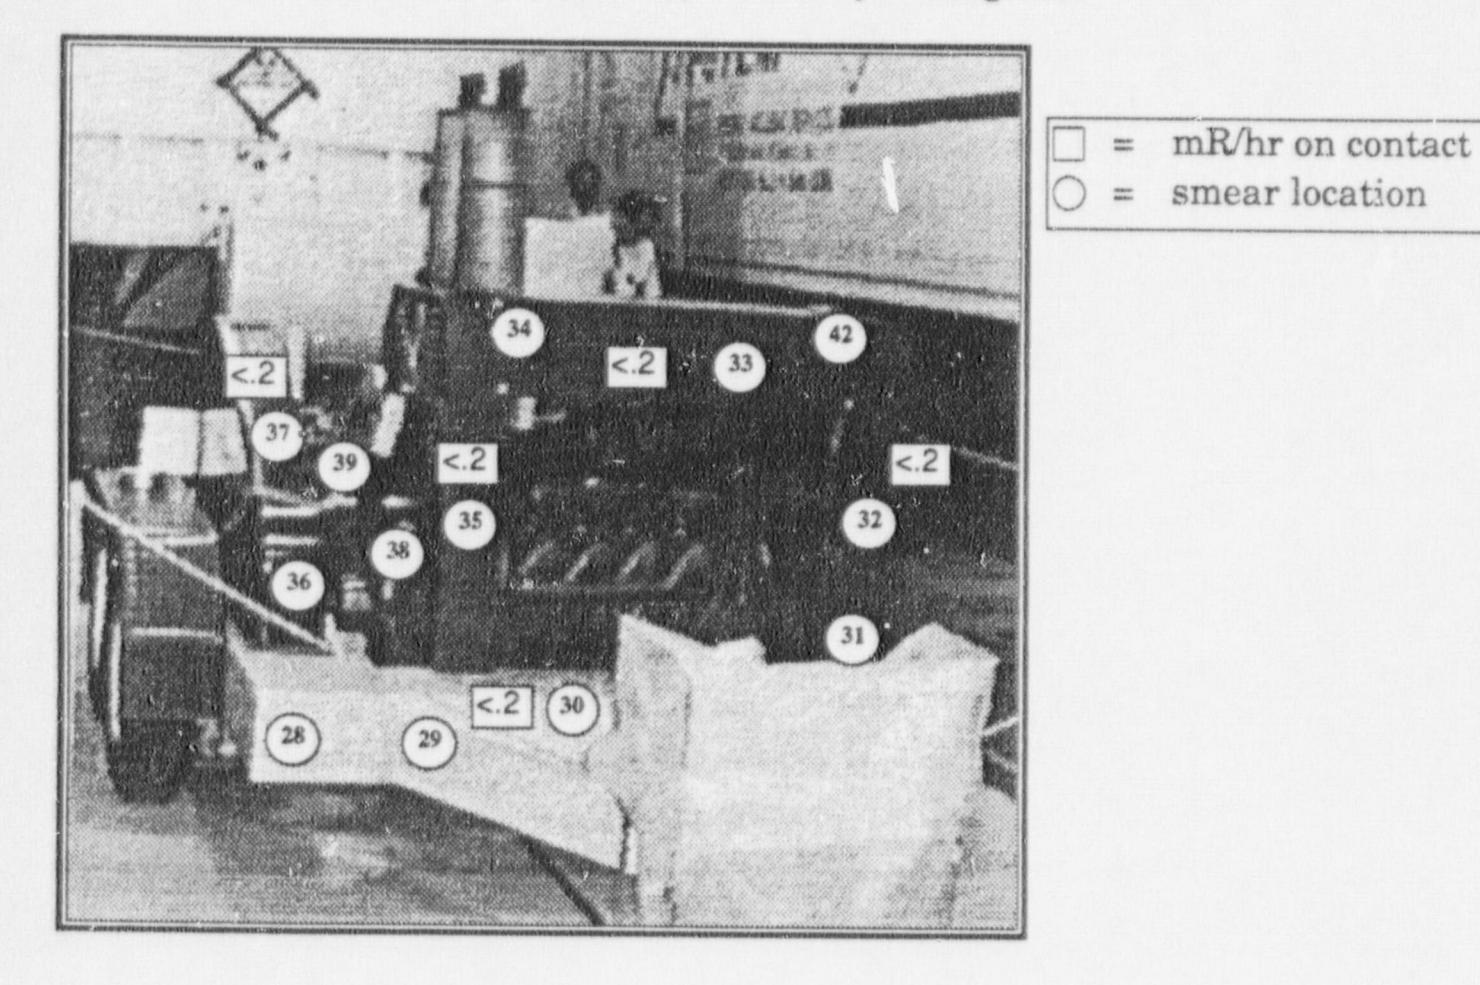
RADIOLOGICAL DATA: SURVEY OF HYDROLAZE TRAILER EXTERNAL CONTAMINATION AND DOSE RATES

Smear #	Results
28	<mda< td=""></mda<>
29	<mda< td=""></mda<>
30	<mda< td=""></mda<>
31	<mda< td=""></mda<>
32	<mda< td=""></mda<>
33	<mda< td=""></mda<>
34	<mda< td=""></mda<>
35	<mda< td=""></mda<>
36	<mda< td=""></mda<>
37	<mda< td=""></mda<>
38	<mda< td=""></mda<>
39	<mda< td=""></mda<>
40	<mda< td=""></mda<>
