LICENSEE EVENT REPORT (LER)

FACILITY NAME (1) Arkansas Nuclear One, Unit One

TITLE (4) Reactor Trip Caused by Turbine Generator Exciter Failure and Failure of Various Components in Main Feedwater System Results in Steam Generator Overfill

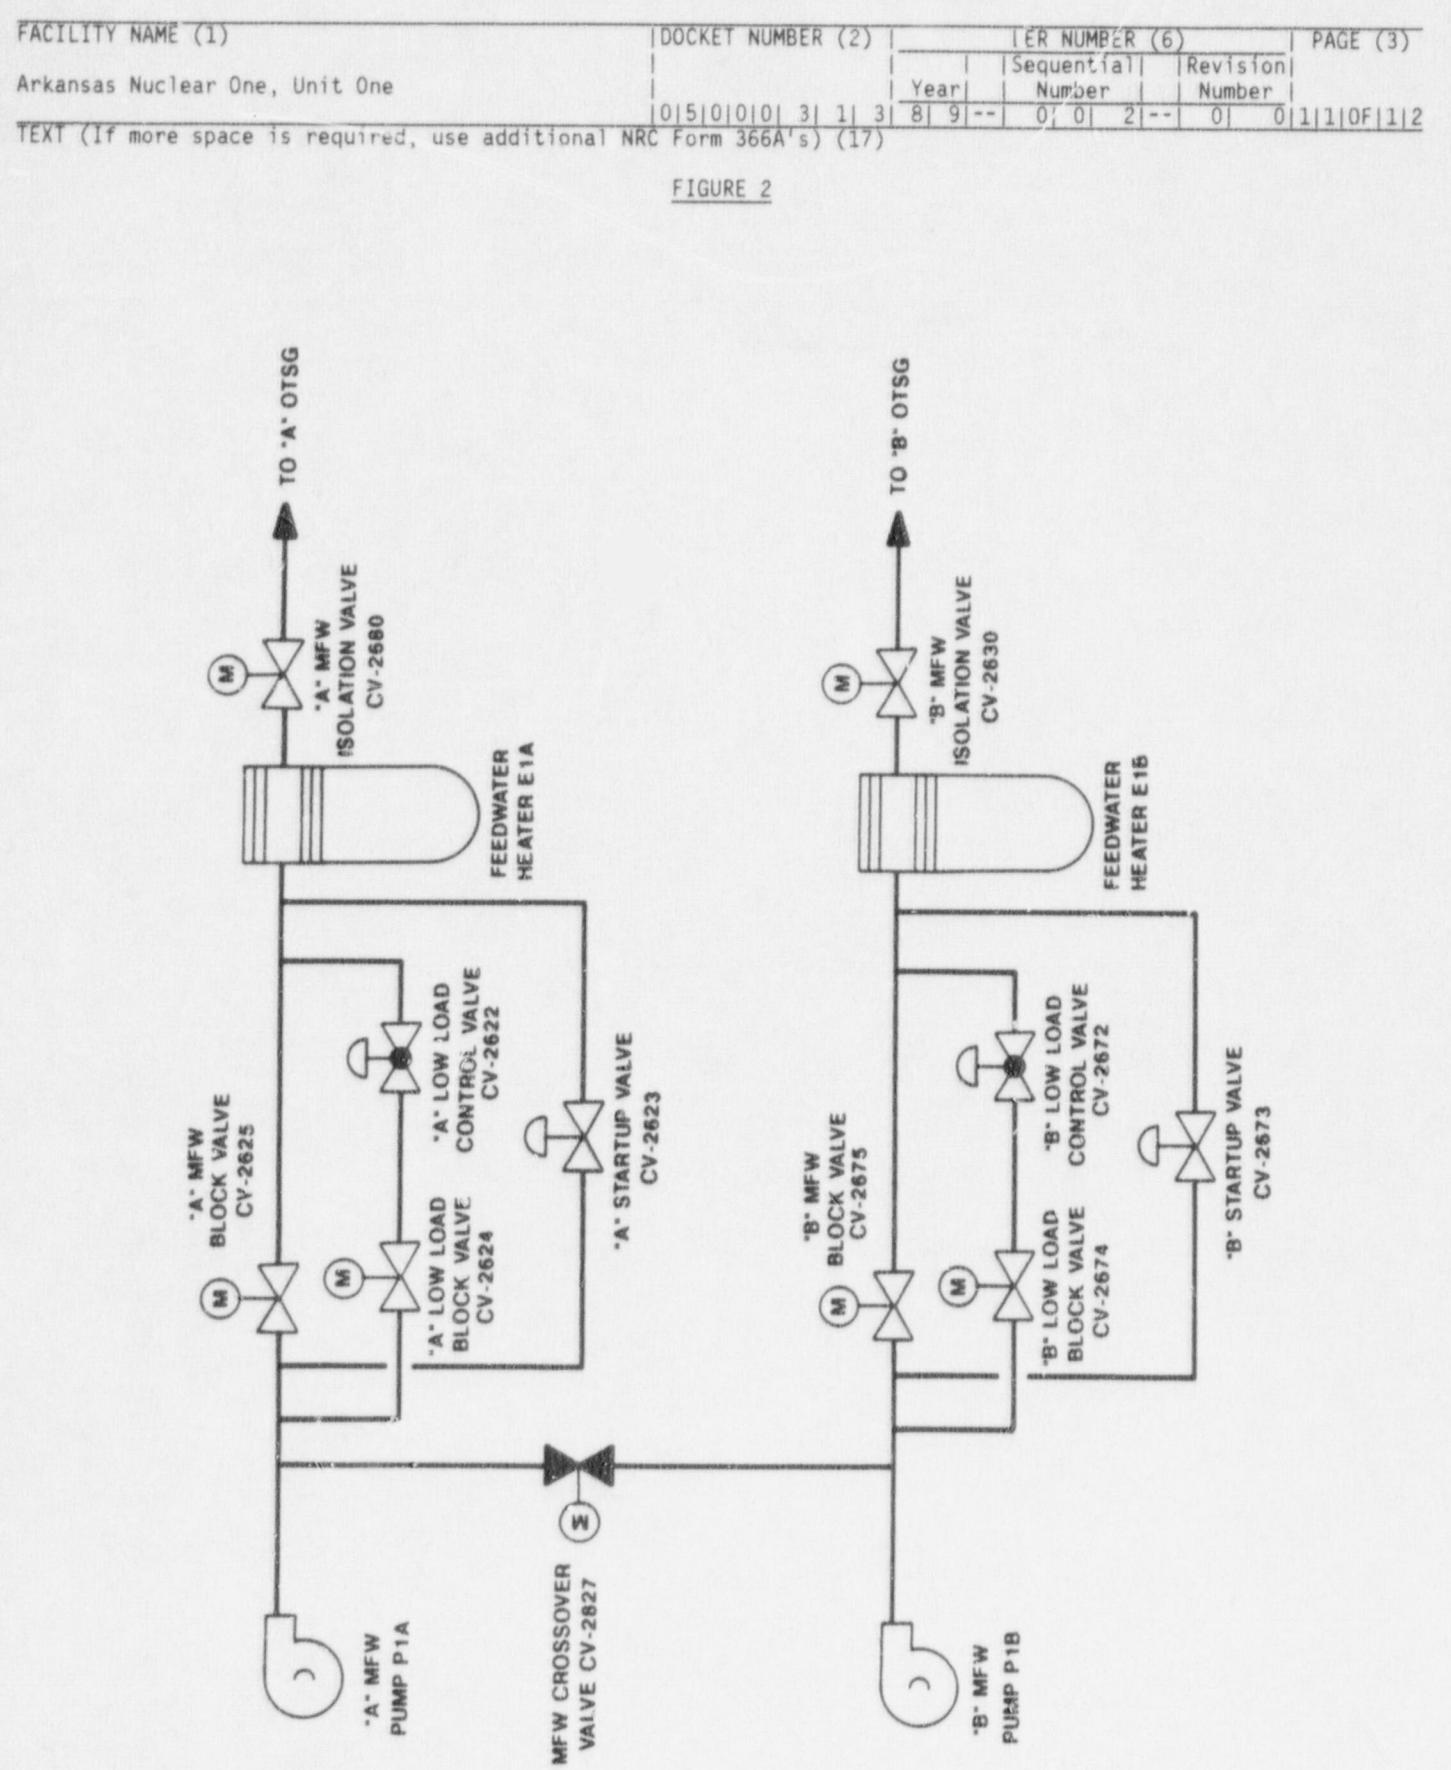
- Various Main Feedwater (MFW) [SJ] system anomalies occurred (reference Figure 2 for a simplified MFW valve configuration):
 - a. The 'B' MFW block valve CV-2675 [SJ-20] did not fully close as designed.

- b. The 'A' and 'B' startup valves, CV-2623 and CV-2673 [SJ-FCV], respectively, and the 'A' and 'B' low load control valves, CV-2622 and CV-2672 [SJ-FCV], respectively, failed to close as designed.

The miswiring in the RFR circuit which caused the failure of the startup valves and low load valves to perform as designed was corrected. Continuity checks and functional tests were performed on the circuit. Reviews were performed of the Design Change Package (DCP) used to install the modification which caused the wiring error, as well as the work plan used for post-modification testing, to determine if any other ICS modifications performed at that time needed additional testing. All other areas of the DCP were determined to have been functionally tested after the installation was finished; however, certain areas were functionally tested again after the miswiring was corrected as an additional verification measure.

Engineering has revised the pressure differential calculations for the 'A' and 'B' MFW block valves and the 'A' and 'B' low load block valves. The revised maximum pressure differential for these valves is now 800 psid. This calculation has also been reviewed and approved by Operations, and this review process will be continued. The torque switch settings for the MFW block valves and the low load block valves have been adjusted based on the revised calculation.

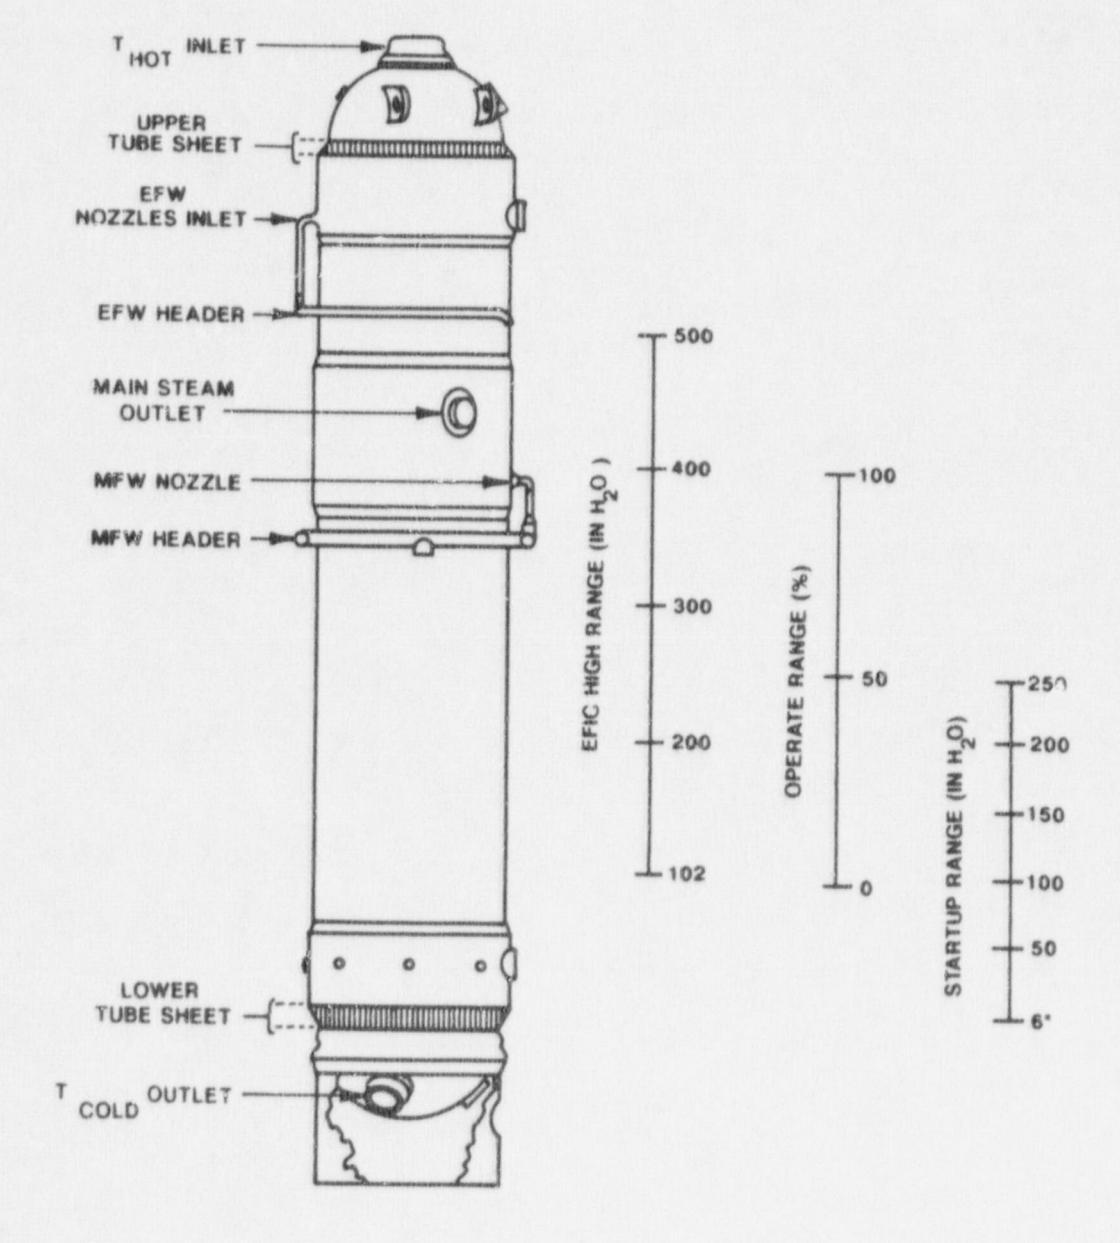
FIGURE 3

- e. The zero set on the 'B' SG operate range water level recorder was low by approximately 3 to 4 percent, causing the indicated level being used by the operators to be lower than the actual SG level. The level was verified during the post-trip review by comparisons with the 'B' SG EFIC high range level indication, which is considered to be more accurate after a reactor trip. (See Figure 3.)

One minute after the crossover value was opened, '8' SG level beaked at 425 inches on the EFIC SG level indication, or greater than 100 percent actual operate range (Figure 3). The indicated operate range level during this overfill was stable at 97 percent. The level in '8' SG then began to decrease, possibly due to the decreasing steam pressure to the PIA turbine caused by exhaustion of the MSR inventory. At 2202 hours operators manually tripped P18.

The operate range level recorders for both 'A' and 'B' SG were calibrated to ensure that the zero set is as accurate as possible.
