From: [Kozak, Laura](#)
To: [Lara, Julio](#)
Subject: FW: Clinton Inspection Report
Date: Friday, October 12, 2018 10:03:00 AM
Attachments: [CLI 2018 051.docx](#)

Failure to Follow Multiple Procedures			
Cornerstone	Significance	Cross-Cutting Aspect	Report Section
Mitigating Systems	Preliminary White AV 05000461/2018050-01 Open EA-18-104	[H.2] – Human Performance, Field Presence	93812–Special Inspection
On August 23, 2018, the NRC issued Inspection Report 05000461/2018050 which discussed a self-revealed finding with a To-Be-Determined (TBD) significance and an associated Apparent Violation of Title 10 of the Code of Federal Regulations (10 CFR) Part 50, Appendix B, Criterion V, “Instructions, Procedures, and Drawings,” and Technical Specification 3.8.2, Condition B.3. The issue involved the licensee’s failure to follow multiple procedures that affected quality which resulted in the unavailability and inoperability of the Division 2 Emergency Diesel Generator when it was relied upon for plant safety.

The purpose of this inspection was to complete the preliminary significance determination for an apparent violation 10 CFR Part 50, Appendix B, Criterion V and Technical Specification

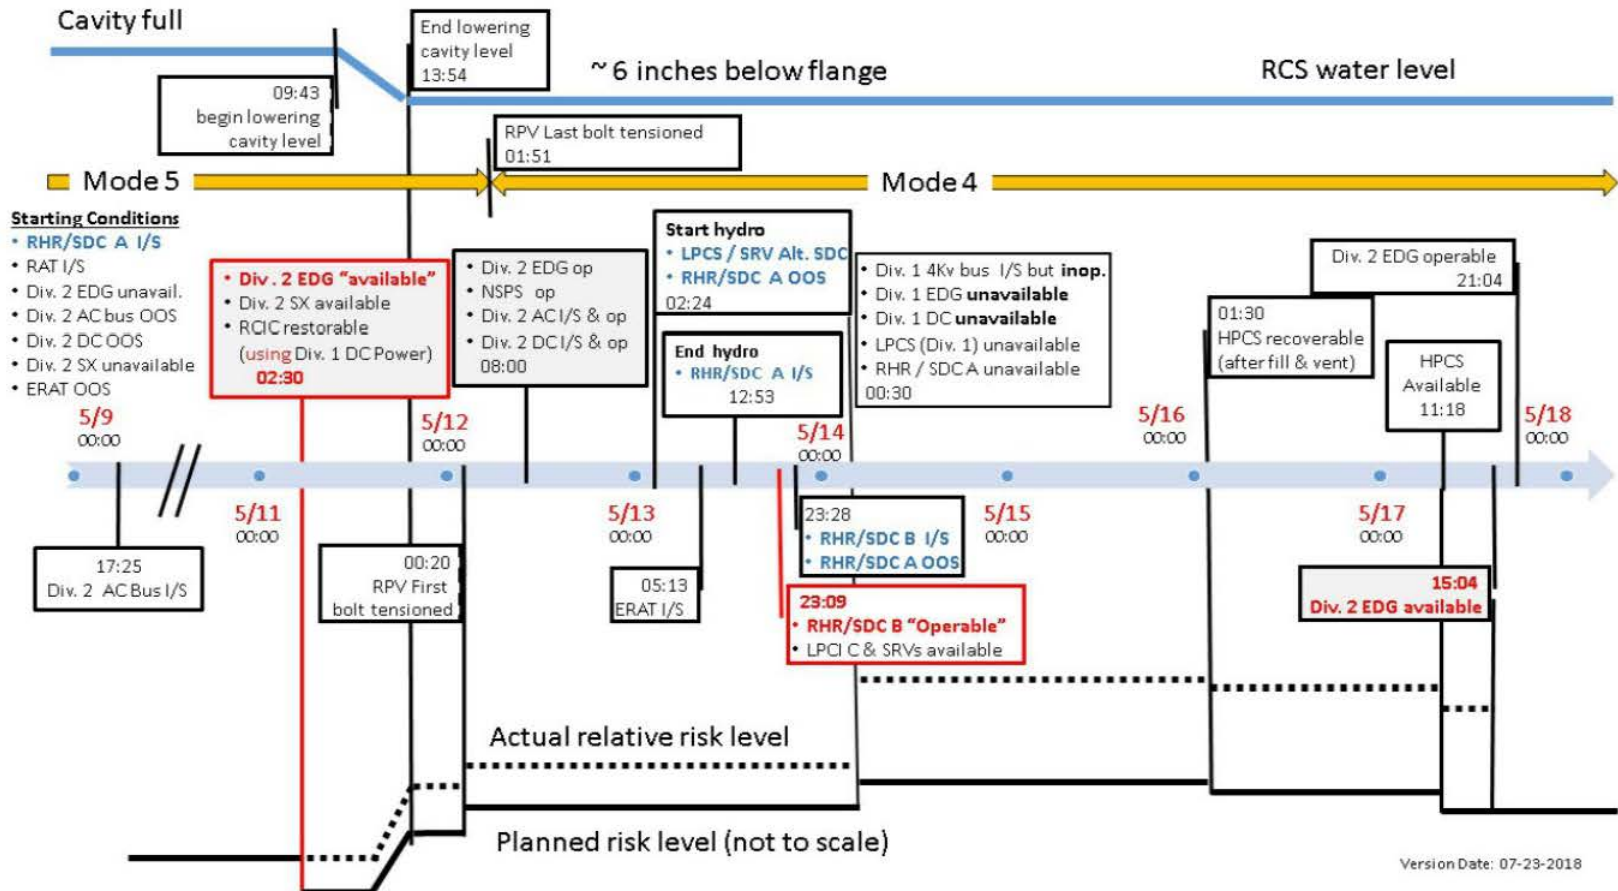
The Division 2 EDG unplanned unavailability started after the reactor had been refueled and the associated reactor cavity was full. That is, there was over 23 feet of water above the reactor core. Early in the unavailability, the licensee installed the reactor pressure vessel (RPV) internals, lowered water level to about six inches below the RPV flange, installed and tensioned the reactor vessel head. The unit entered cold shutdown or Mode 4 when the last reactor head bolt was tensioned. See Figure 1 for a time line of these events.

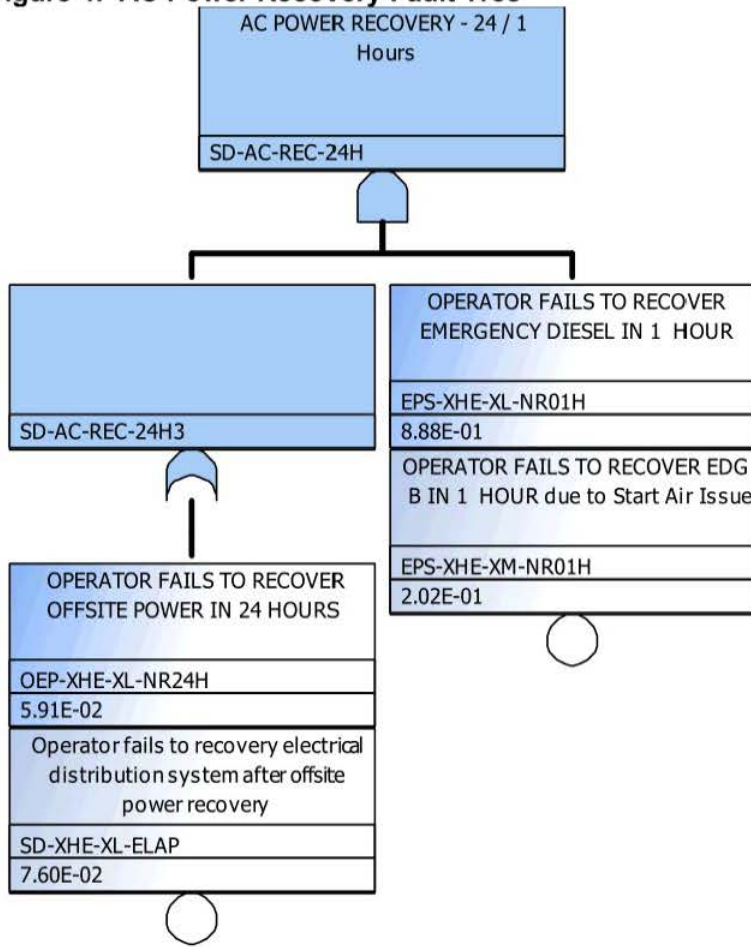
Figure 4: AC Power Recovery Fault Tree

13. The human error probability for the failure to recover Division 2 EDG was estimated at 0.202. The performance shaping factors that were determined to be performance drivers were Stress and Experience/Training for Diagnosis, and Stress for Action. Stress was considered to be "high" because the plant would be in a station blackout condition. Experience/Training for Diagnosis was considered to "low." Plant staff perform troubleshooting as a regular job task, however, operators have not trained on, experienced or been exposed to troubleshooting a failure of the "protected" diesel generator during a shutdown SBO.

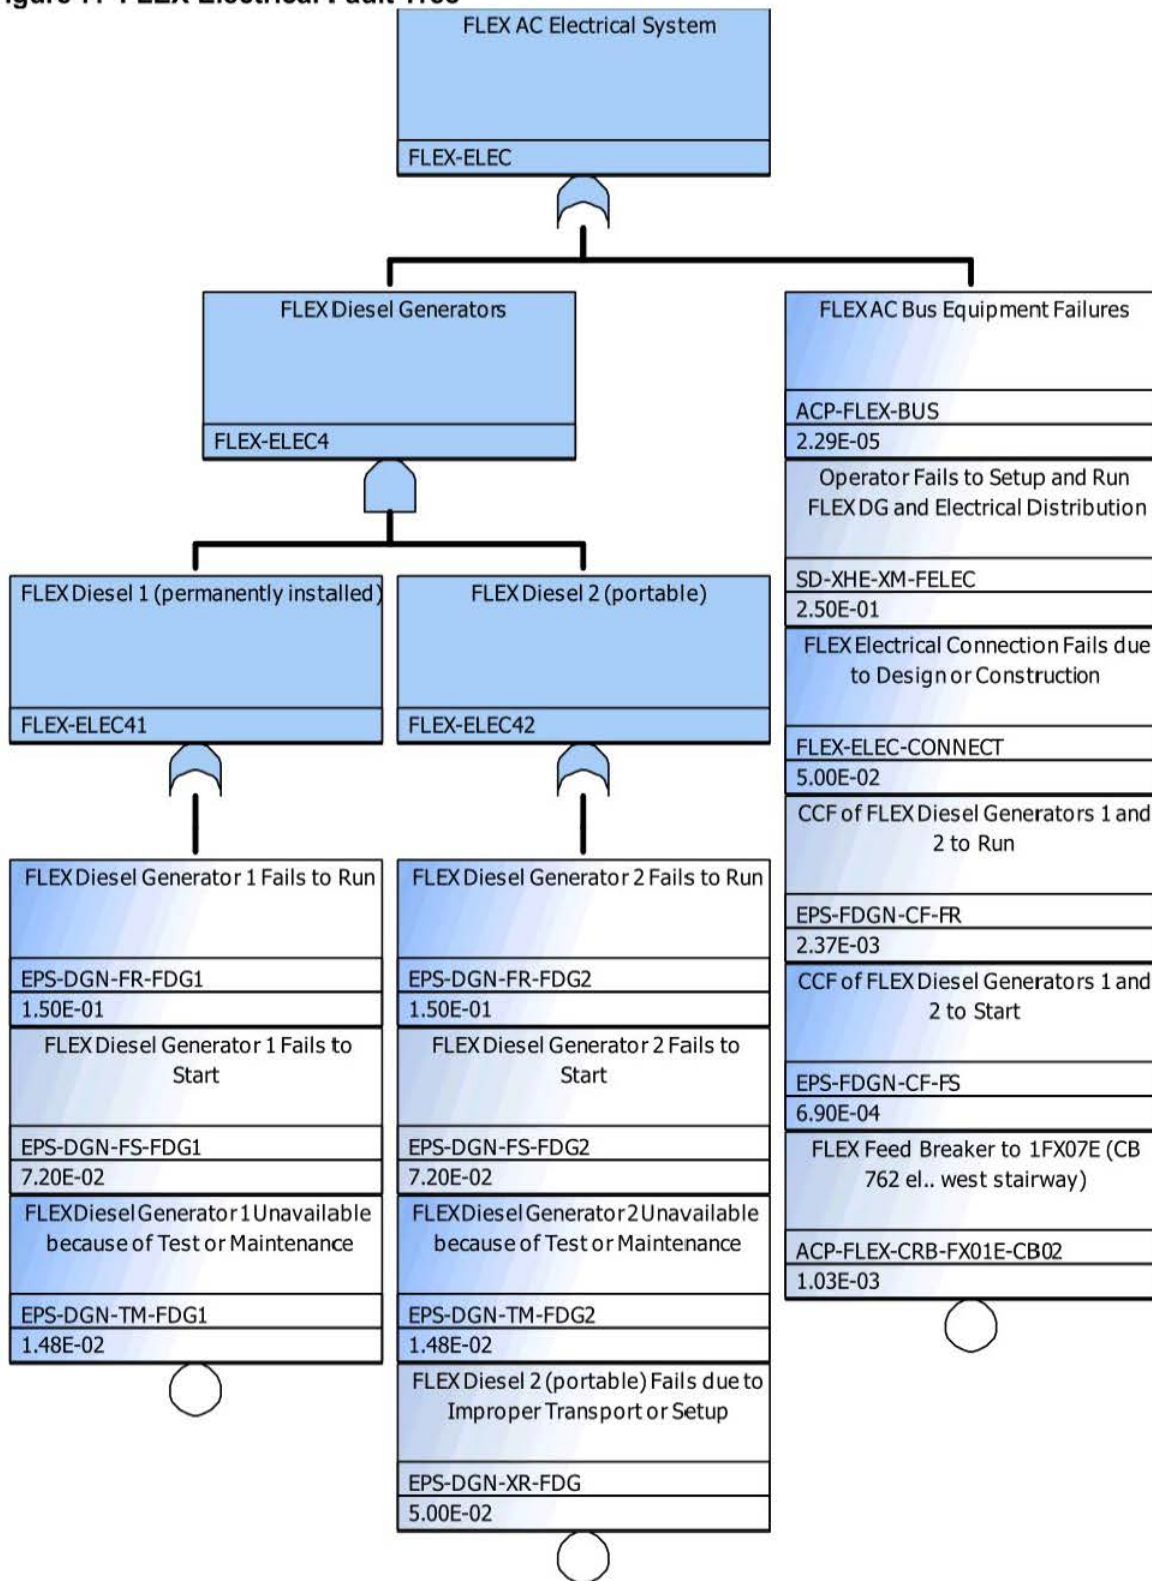
Figure 7: FLEX Electrical Fault Tree

14. The human error probability for the failure to implement the FLEX electrical line-up was estimated at $2.5E-1$. The performance shaping factors that were determined to be performance drivers were stress for diagnosis and action, and complexity and experience/training for action. Stress was considered to be "high" because the plant would be in a station blackout condition. The action to align the FLEX electrical system was considered to be both "highly" complex and was assigned "low" experience/training. The procedure requires many in-plant actions under difficult conditions and the alignment has never been implemented.

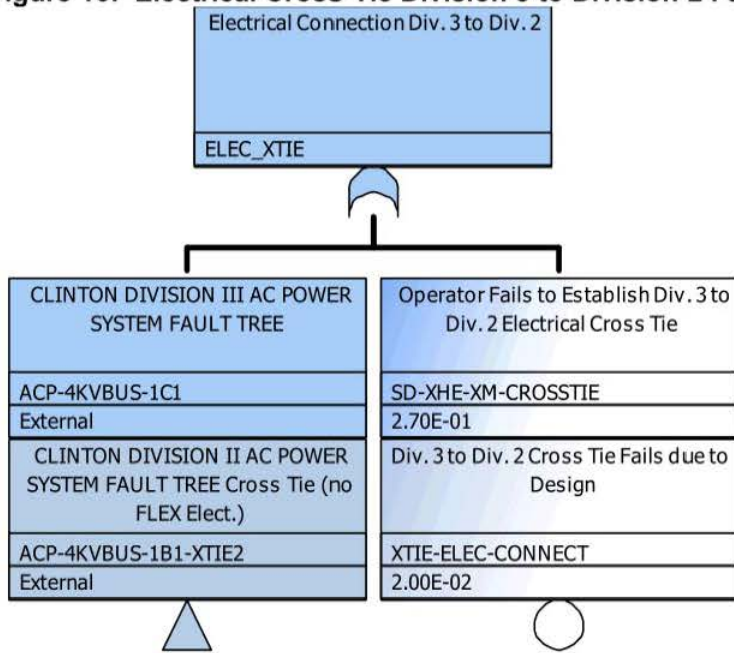
Figure 16: Electrical Cross-Tie Division 3 to Division 2 Fault Tree

15. The human error probability for the failure to implement the Division 3 to Division 2 crosstie was estimated at $2.7E-1$. The performance shaping factors that were determined to be performance drivers were stress for diagnosis and action, and complexity, experience/training, and ergonomics for action. Stress was considered to be "high" because the plant would be in a station blackout condition. The action to implement the cross-tie was considered to be "highly" complex and was assigned "low" experience/training and "poor" ergonomics. The procedure has both in-plant and control room actions in multiple locations and has received very little training.

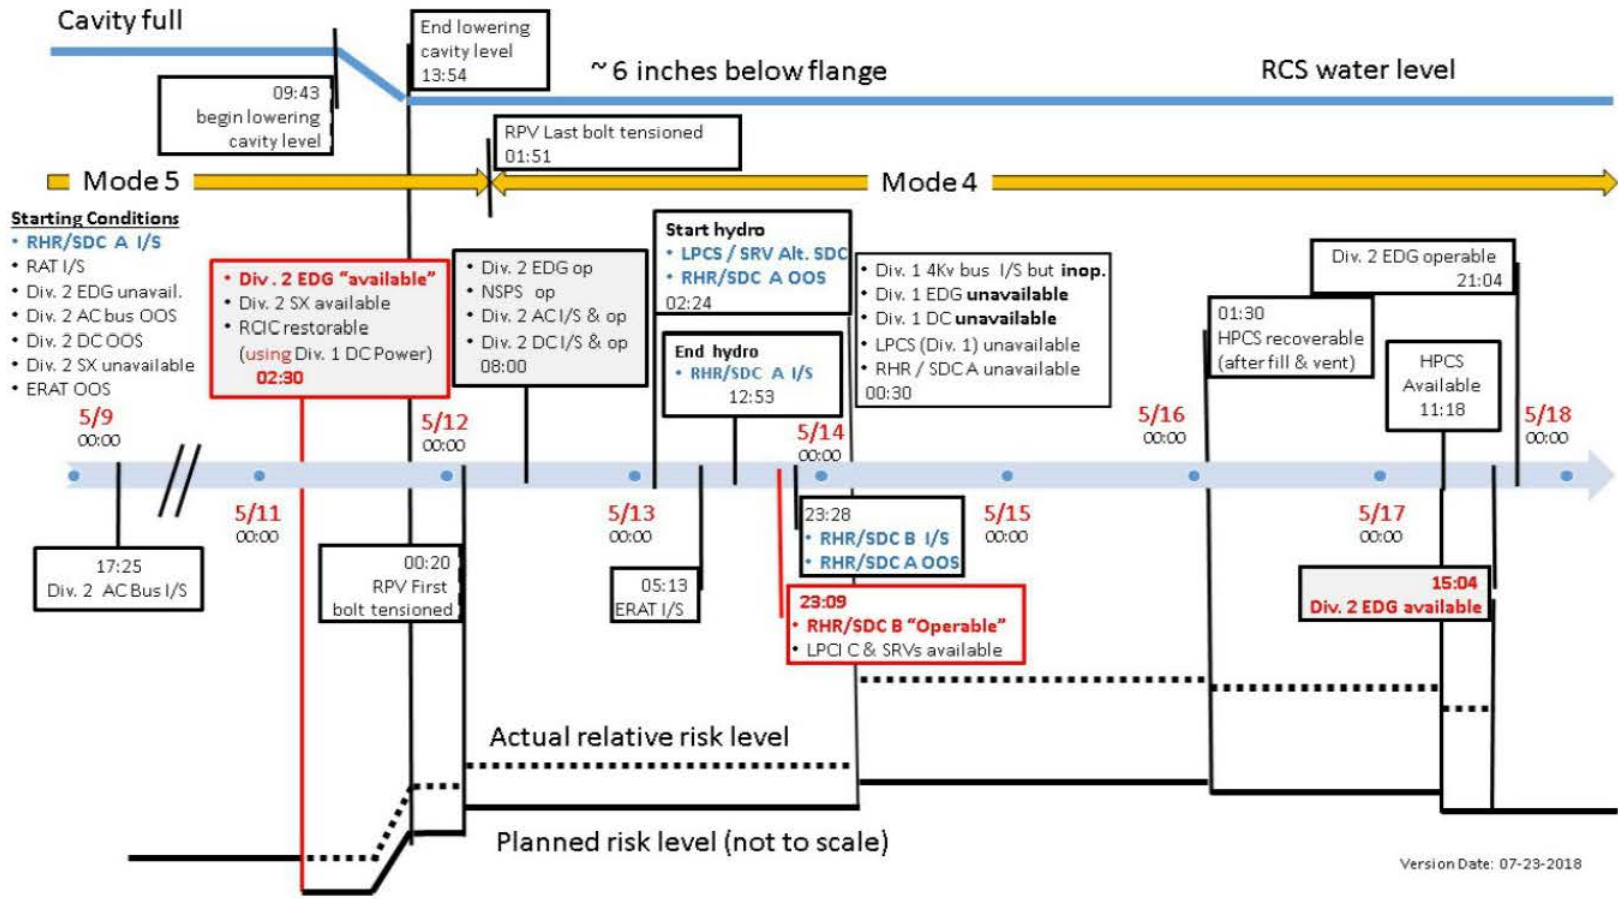
The Division 2 EDG unplanned unavailability started after the reactor had been refueled and the associated reactor cavity was full. That is, there was over 23 feet of water above the reactor core. Early in the unavailability, the licensee installed the reactor pressure vessel (RPV) internals, lowered water level to about six inches below the RPV flange, installed and tensioned the reactor vessel head. The unit entered cold shutdown or Mode 4 when the last reactor head bolt was tensioned. See Figure 1 for a time line of these events.
