Dominion Energy Nuclear Connecticut, Inc. 5000 Dominion Boulevard, Glen Allen, VA 23060 DominionEnergy.com

October 8, 2020

DOMINION ENERGY NUCLEAR CONNECTICUT, INC. MILLSTONE POWER STATION UNIT 2 PROPOSED LICENSE AMENDMENT REQUEST TO REVISE THE MILLSTONE UNIT 2 TECHINCAL SPECIFICATIONS FOR STEAM GENERATOR INSPECTION FREQUENCY

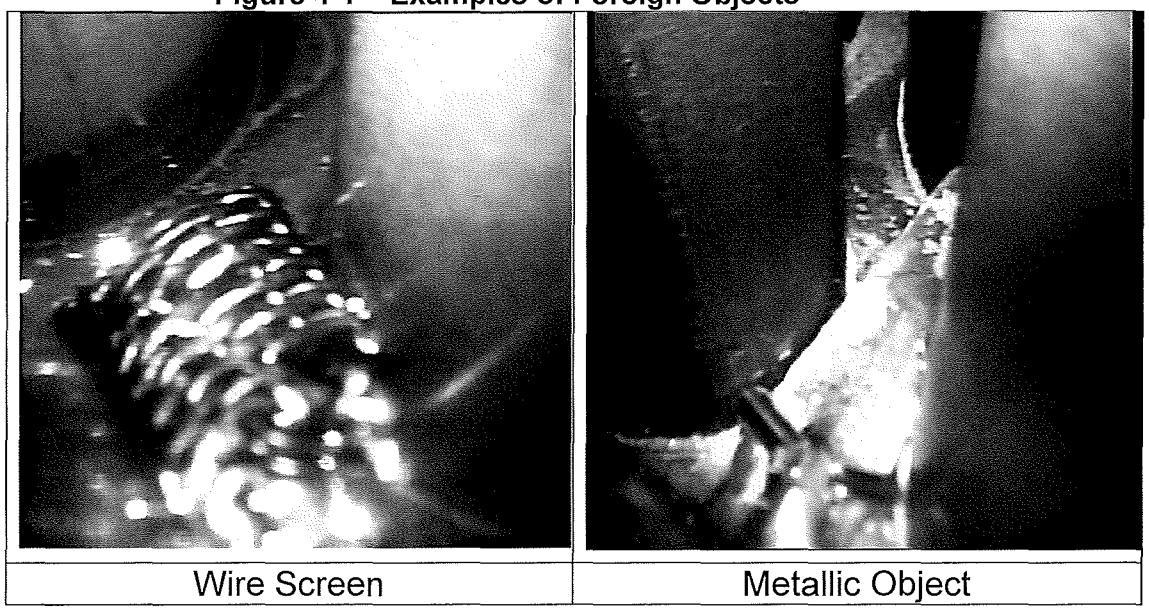
During the 2R24 examination, any new confirmed Possible Loose Part (PLPs), PLP related indications, or new FO wear indications reported by the eddy current examination were investigated by the Secondary Side Inspection (SSI) crew as far as possible and any new objects identified by SSI within the tube bundle region were tested by the +Point[™] eddy current technique. When possible the FO's were removed by Foreign Object Search and Retrieval (FOSAR). The combined examinations were coordinated through the use of the LPT database. Some of the foreign objects identified during this inspection are shown in Figure 4-1 while Figure 4-2 shows foreign objects that were removed.

Figure 4-1 – Examples of Foreign Objects

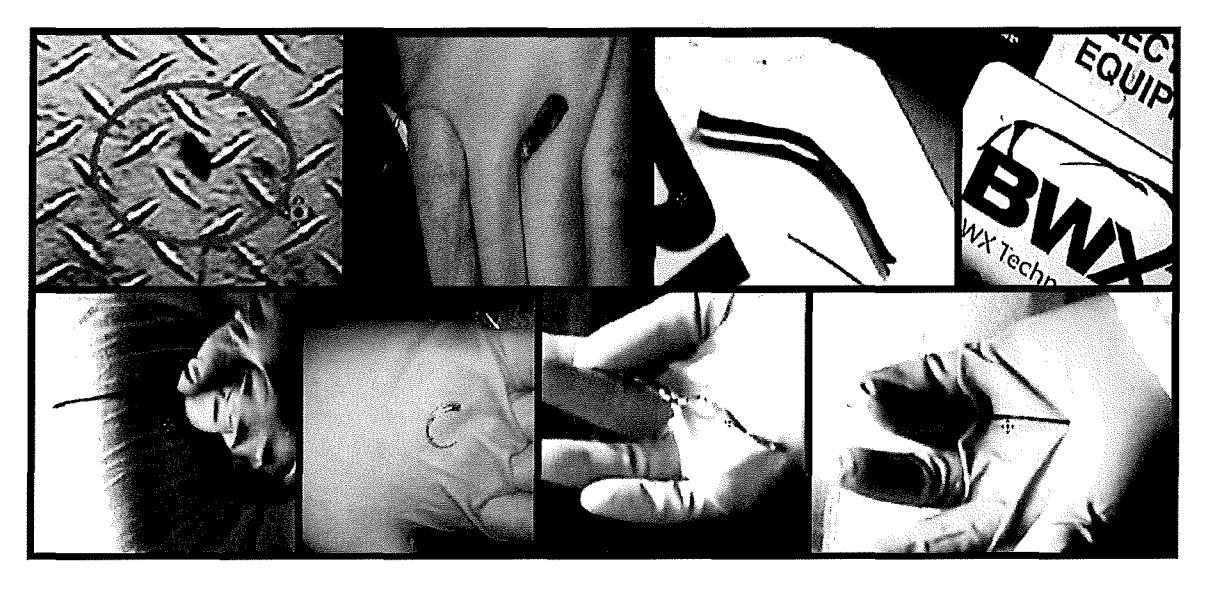
Figure 4-2 – Foreign Objects Retrieved

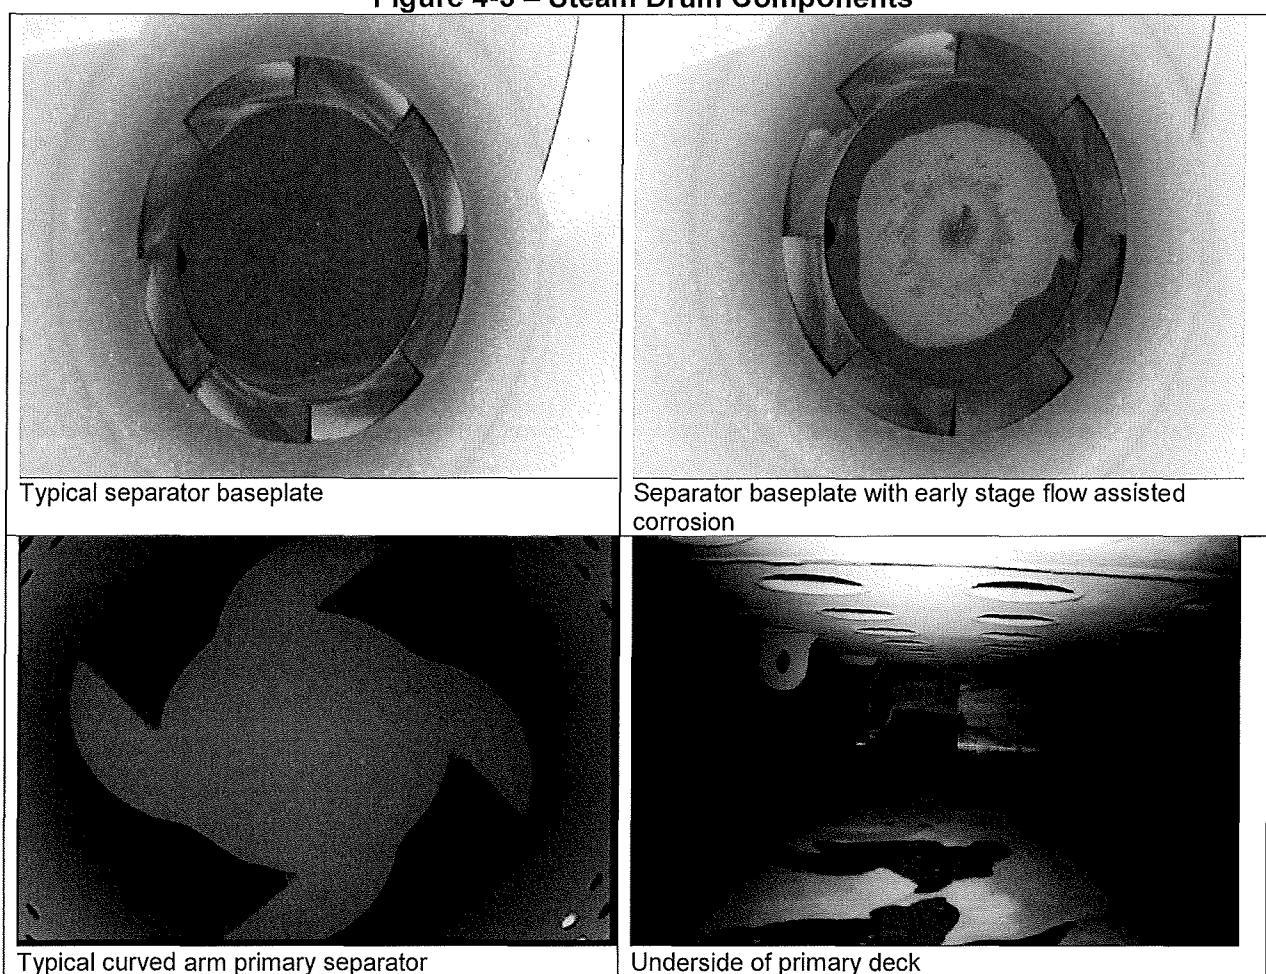
A visual examination of steam drum components was performed in SG25 and SG26. In the areas examined, sludge accumulation was light, with a harder underlying crystalline coating of sludge noted. Due to water clarity issues following refill after DMT, visual inspection of the U-bend structures (arch bars, J-tabs and fan bars) was not possible. Sludge deposits on the primary and secondary moisture separators were light and tightly adhering. Very little deposit was removed from these surfaces when rubbed with a gloved hand. The primary separators examined were in good condition with no evidence of material degradation. The curved arm assemblies within the primary separators were inspected and found to be in good condition. The edges of the steam outlet to the assemblies were sharp, indicating no noticeable flow assisted corrosion. Evidence of early stage flow assisted corrosion of the secondary moisture separators was noted. Severe degradation of these separators can eventually lead to the introduction of loose parts that may migrate to the tube bundle. However, there was no evidence that this degradation has reached any significant depth in SG25 or SG26, and it will not progress to a state where loose parts could be introduced to the SGs over the next three cycles of operation. This condition should be monitored during future outages.

Figure 4-3 – Steam Drum Components

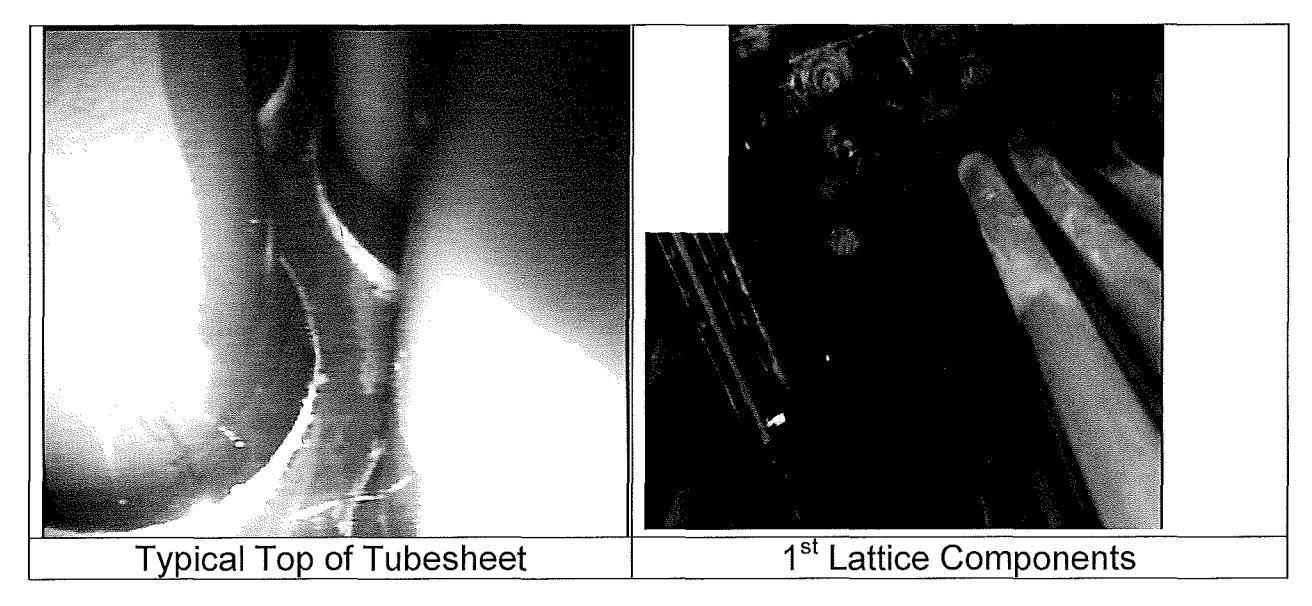
Figure 4-4 – Lower Bundle Components
