PRECURSOR DESCRIPTION AND DATA

NSIC Accession Number: 109295

Title: Borated Water Storage Tank Level Indication Fails at Oconee

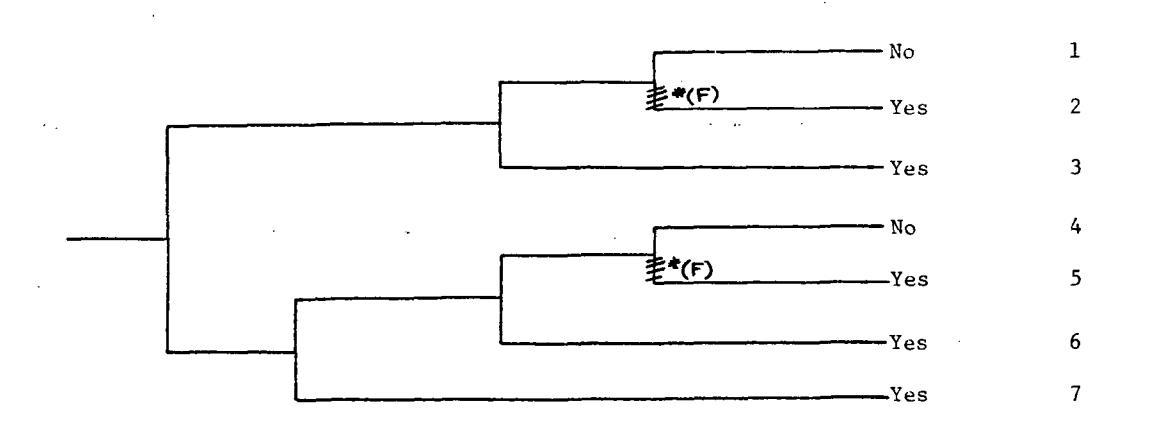
NSIC 109295 - Sequence of Interest for Failure to BWST Level Indication at Oconee 1

* success requires the operator to switch to recirculation without BWST indication after sufficient water has been injected for LP pump NPSH and before the BWST is emptied, and without level indication.
